Building and Timber Pest Inspection Report VR

Inspection Date: Mon, 6 Feb 2023

Property Address: 119A Campbell St, Surry Hills NSW 2010, Australia

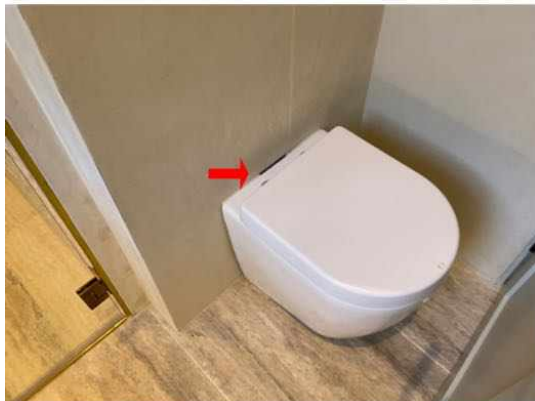
Finding 3.01

Building: Main Building
 Location: Bathroom
 Finding: Sealant - Incomplete
 Information: The sealant in this area has not been completed.

I recommend appointing a handyman to see what necessary works are required.

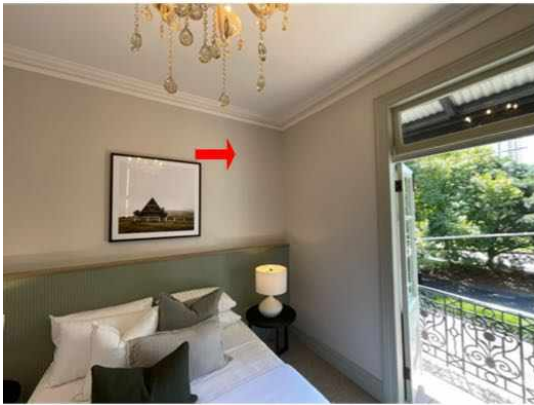
Finding 3.02

Building: Main Building
 Location: Bedroom
 Finding: Damp - Rain penetration
 Information: Rain penetration (also known as penetrating damp) is a common form of dampness that can occur through walls, roofs or openings (e.g. windows).

Common causes include faulty or missing flashing, lack of sealant and lateral damp.

The cause of the water leak should be addressed to prevent further damage. It is recommended that the water leak be resolved prior to any repairs of the damaged area, which may require localised replacement of building materials and refinishing.

I recommend appointing a builder to see what necessary works are required.

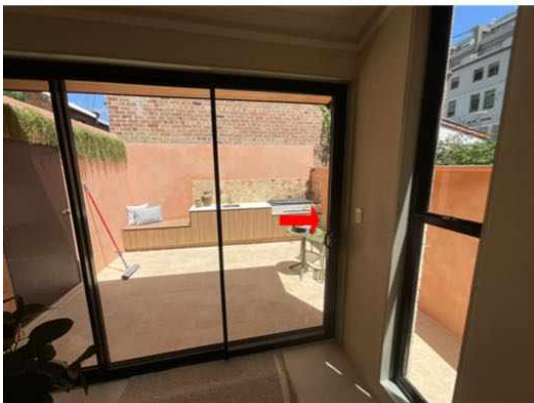
Finding 3.03

Building:	Main Building
Location:	Lounge Room
Finding:	Installation - substandard
Information:	The installation of the door frame appears to have been completed to a substandard level of workmanship or is incomplete (Not plumb).

Although the door can still shut I would recommend appointing the builder to see what necessary works are required so that the door does not hit the frame when closing.

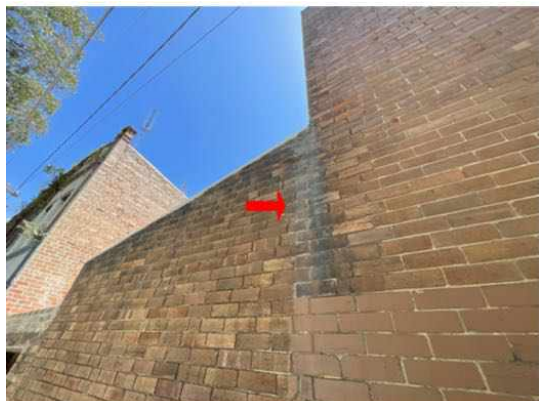
Finding 3.04

Building:	Main Building
Location:	Exterior walls - left side
Finding:	Brickwork - Cracking noticeable
Information:	There were several cracks and or crack repairs evident to external brickwork.

Noticeable cracks are a common occurrence in external brickwork and are a likely result of age expected building movement, general expansion, and/or contraction of building materials in different weather conditions.

It is highly advised that a qualified bricklayer be appointed to provide necessary works to cracked brickwork to prevent any further damage.

Always monitor these cracks and contact a building inspector should cracks widen, lengthen, or become more numerous.

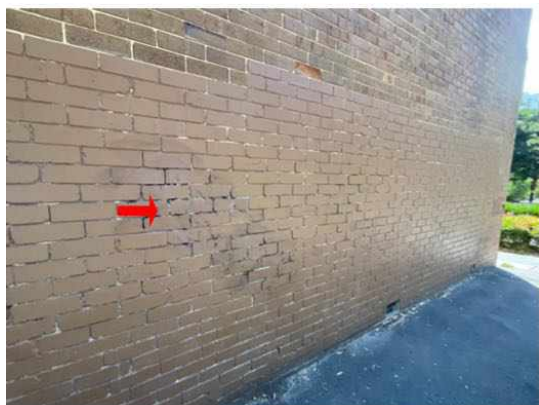
Finding 3.05

Building:	Main Building
Location:	Exterior walls - left side
Finding:	Brickwork - Deteriorated mortar
Information:	Mortar, or 'bedding', is the material which fills joints and intersections between bricks in masonry walls and structures. Sections of mortar in this brickwork were identified as having deteriorated.

Mortar deterioration can be addressed by a bricklayer.

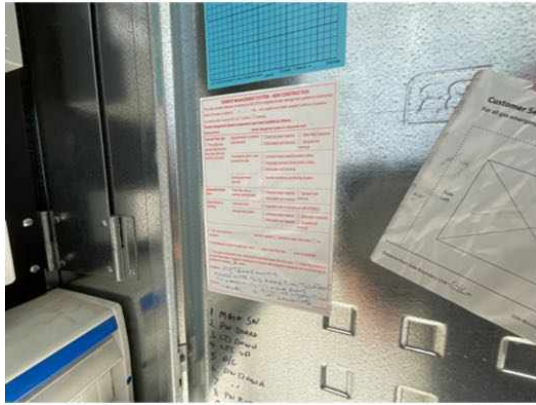
Building: Main Building
 Location: All Areas
 Finding: Evidence of a previous termite management system was identified
 Information: There are a number of factors which indicate the presence of a previously installed or applied termite barrier. The most common are a durable notice (to the inside of your meter box) observable physical barriers installed to building perimeter and in ground reticulation systems.

Where a Termite Management System has been identified you should refer to the type

of barrier date of installation warranty conditions and any documentation provided by a builder or past owner. Consult the company who installed the barrier to confirm whether the system is still under warranty.
