# Building and Timber Pest Inspection Report VR

Inspection Date: Thu, 9 Feb 2023

Property Address: 34 Napier St, Paddington NSW 2021, Australia

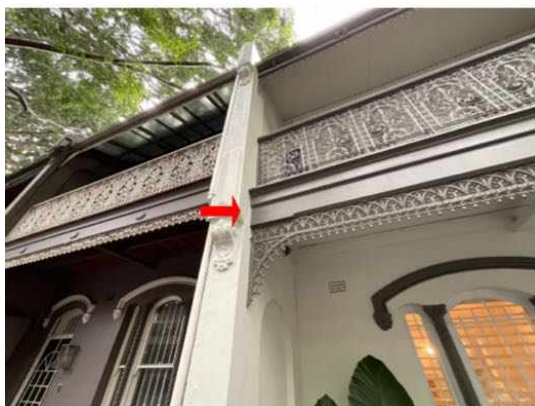
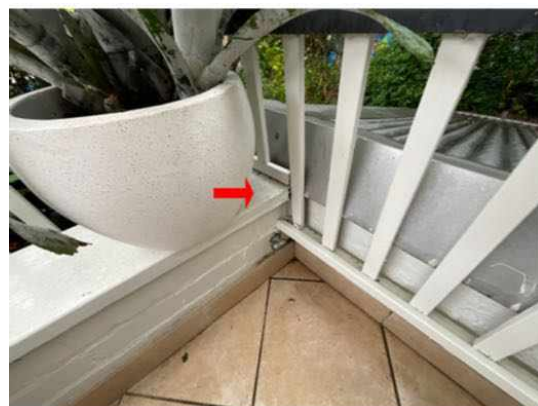
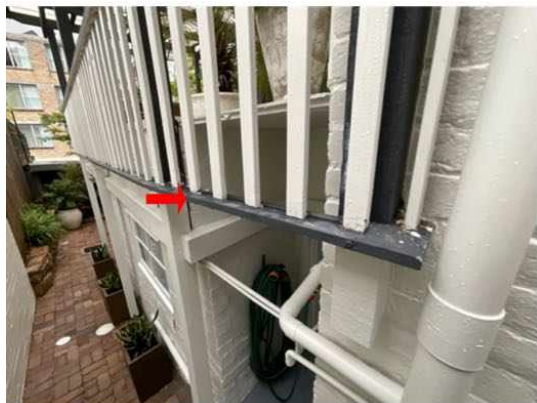
#### Finding 3.01

Building: Main Building  
Location: All External Areas  
Finding: Wood rot  
Information: This building element shows evidence of wood rot. Wood rot, also known as Fungal Decay, occurs when timbers and other cellulose building materials are exposed to damp conditions on an ongoing basis. This could be the result of exposure to weathering over a prolonged period of time, or the attraction of excessive moisture from other abutting building materials.

Early intervention and regular maintenance, particularly of exterior timbers, will prolong the useful life of these building elements. Prior to any works being performed, the cause of the moisture that has created the visible wood rot should be identified and addressed in a suitable manner. Replacement of affected timbers may then be a necessary step in protecting surrounding building elements from such deterioration.

A qualified carpenter or registered builder may also be required to replace affected building materials.

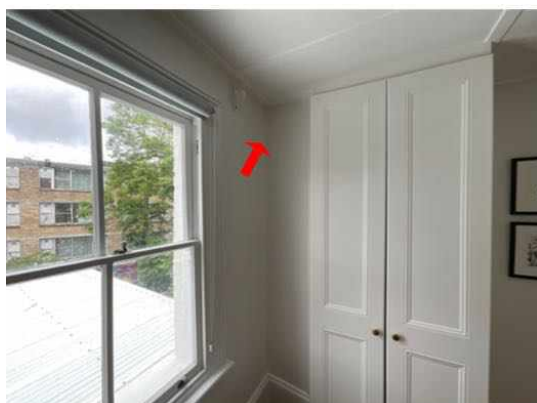
### Finding 3.02

Building:	Main Building
Location:	Office
Finding:	Damp - Rain penetration
Information:	Rain penetration (also known as penetrating damp) is a common form of dampness that can occur through walls, roofs or openings (e.g. windows).

Common causes include faulty or missing flashing, lack of sealant and lateral damp.

The cause of the water leak should be addressed to prevent further damage. It is recommended that the water leak be resolved prior to any repairs of the damaged area, which may require localised replacement of building materials and refinishing.

I recommend appointing a builder to see what necessary works are required.

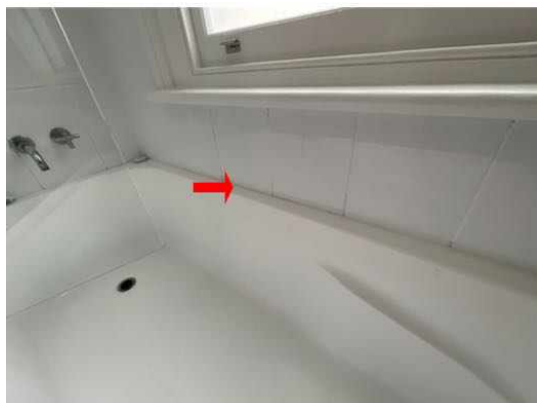
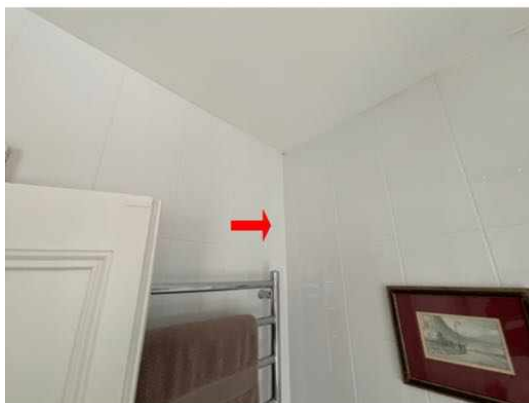
### Finding 3.03

Building:	Main Building
Location:	Bathroom
Finding:	Sealant and grouting - Missing or damaged
Information:	It was noted on inspection that sealant or grout is degraded to the tiled shower alcove and or other areas of the bathroom. Different materials and floor areas move at different rates, generally causing cracking to grout or sealant at this point. A flexible

sealant is required to allow for expected expansion and contraction, while keeping the joint water tight and protective of all associated building materials. Flexible and mould resistant materials should be applied to affected areas to prevent any subsequent water damage that is likely to occur. Regular maintenance and replacement of damage or missing or damaged sealant and grout is highly recommended to the wet areas, as this is a regular wear and tear defect. Sealant and grouting in areas that come into regular contact with water should be maintained for the long term care of your property. A sealant specialist or tiling contractor should be appointed to complete these works.

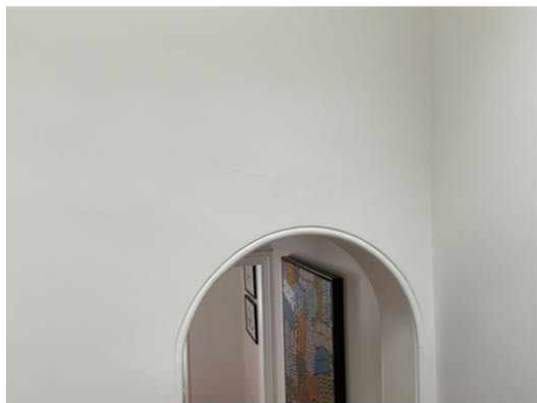
### Finding 3.04

Building:	Main Building
Location:	Throughout
Finding:	Cracking - Damage Category 1 - Fine (up to 1mm)
Information:	Although fine cracks are quite noticeable, they are often only considered to be an appearance defect, and usually do not indicate any structural damage. Generally, the cause of a fine crack is indicative of a separation between building materials and finishes (e.g. paint, plaster, etc.) along joints.

Cracking of this nature can generally be repaired with minor sanding, filling and/or repainting. Such works should be performed by a qualified painter or a general handyman.

Monitoring of all cracking should be conducted frequently. Always contact a building inspector should cracks widen, lengthen, or become more numerous.

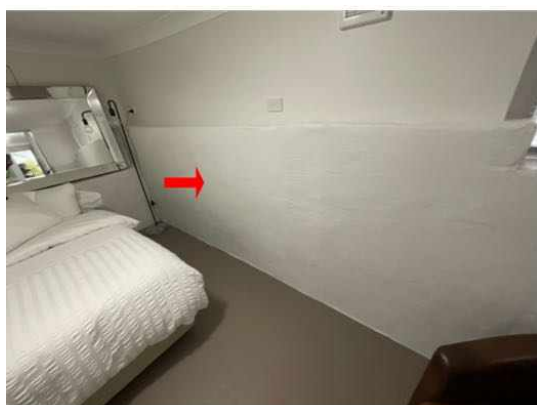
### Finding 3.05

Building:	Main Building
Location:	Lower Level
Finding:	Interior walls - Lateral damp
Information:	Lateral penetrating damp refers to the sideways movement of moisture. The implications of unmanaged damp range from mould fungi growth, wood rot and decaying building materials, to finishes including lifting, bubbling, peeling and staining of paint, plaster and wallpaper.

Structural waterproofing barriers or tanking barriers are often used to protect internal surfaces against the affects of lateral penetrating dampness. These types of work are generally undertaken where the source of the penetrating damp cannot be prevented.

Consultation with a damp proofing contractor is advised to address the cause of the damp and to perform remedial works as necessary.

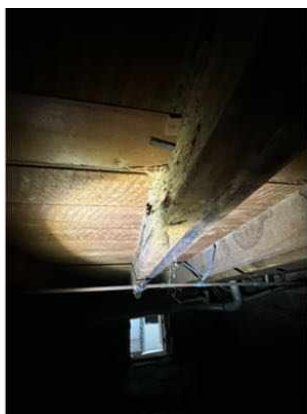
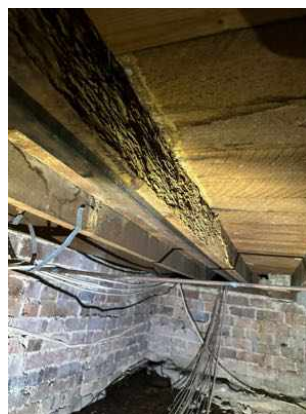
### Finding 3.06

Building:	Main Building
Location:	Subfloor
Finding:	Termite - damage identified
Information:	Despite no live termite or timbered pest activity being indicated, termite damage was

found to have affected this area.

It is advised that the area be visually inspected frequently to ensure that the condition of affected building materials does not worsen.

On further inspection it was noted that a number of the termite effected timbers have had new timbers bolted to the side. There is still a few that haven't had this done and I would recommend appointing a carpenter to see what necessary works are required.

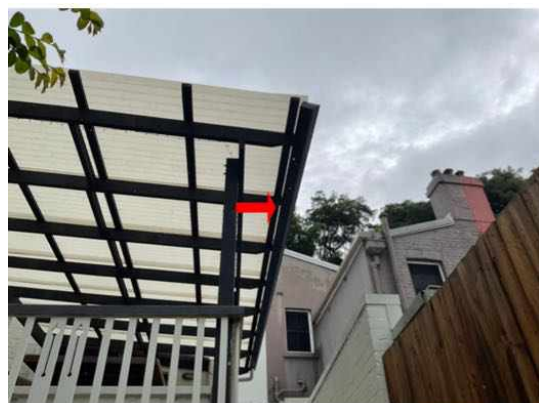
### Finding 3.07

Building: Main Building  
Location: Roof Exterior  
Finding: Fitting or fixture - Loose (Roof Guttering)  
Information: The fitting in this area is loose and requires adjustment to tighten.

If left unmanaged, the fitting may further deteriorate, causing potential for the development of other minor secondary defects.

A relevant tradesperson should be appointed to perform these rectification works at discretion of the client.

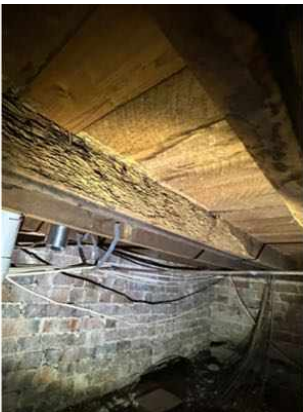
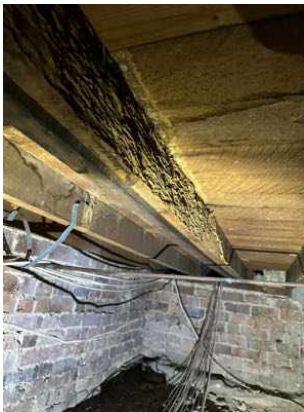
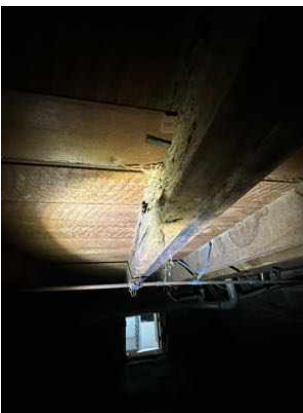
### Finding 5.01

Building: Main Building  
Location: Subfloor  
Finding: Termite - damage identified  
Information: Despite no live termite or timbered pest activity being indicated, termite damage was found to have affected this area.

It is advised that the area be visually inspected frequently to ensure that the condition of affected building materials does not worsen.

A building contractor should be appointed to provide a further invasive inspection. I would also recommend appointing a pest controller to see what necessary works are required to install a termite Management system at the property.

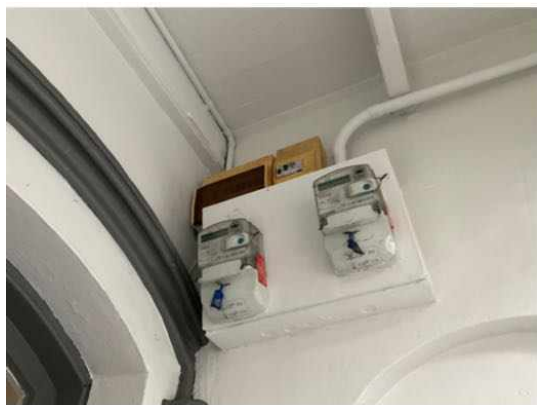
## Finding 6.01

Building:	Main Building
Location:	All Areas
Finding:	Termite Management System - no evidence of a chemical installation
Information:	The application of a post-construction chemical termite barrier is highly recommended for all properties, particularly if live termite activity has been found on the site previously. Such barriers are highly effective in preventing termite attack on any timber building elements throughout the property.

A durable notice should be placed in the switchboard unit to indicate current termite barriers. At the time of inspection, it appeared as though no termite management system has been installed, with no evidence to suggest preventative works taking place.

The client may consider gaining further advice from a pest controller as to the costs and procedures involved with this application. It is recommended that obtaining such advice be a short-term priority.

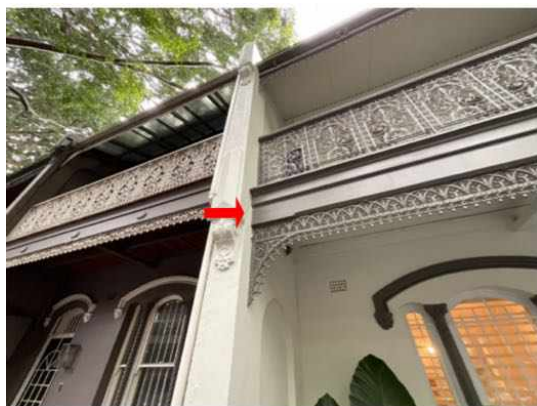
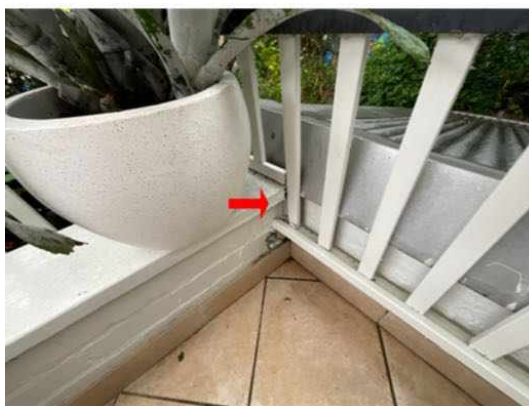
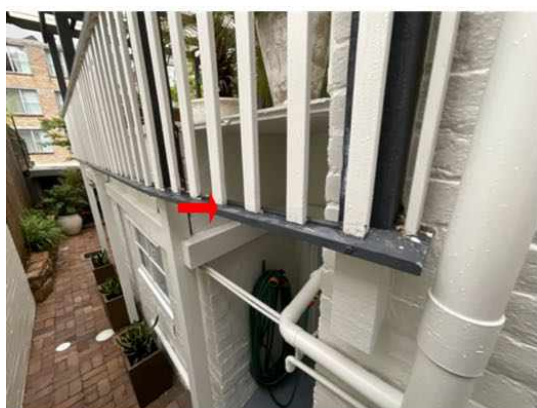
### Finding 7.01

Building:	Main Building
Location:	All External Areas
Finding:	Fungal decay - present (localised)
Information:	Fungal decay also known as wood decay or wood rot generally refers to the deterioration of timber elements when in contact with excessive levels of moisture for a prolonged period of time.

The development of fungal decay is accelerated by temperatures in the range of 5degreeC to 40degreeC as well as the presence of oxygen. Generally fungal decay develops on timber elements that are in use in an external environment which are

exposed to rain penetration.

In this case although the affected timber element is in a decaying state the extent of any visible damage appears to be localised to a specific area and is yet to spread to other parts of the building element or affect adjoining structures. The fungal decay is therefore likely to be of a relatively superficial nature with minimal impact on the structural integrity or tensile strength of the timber element.

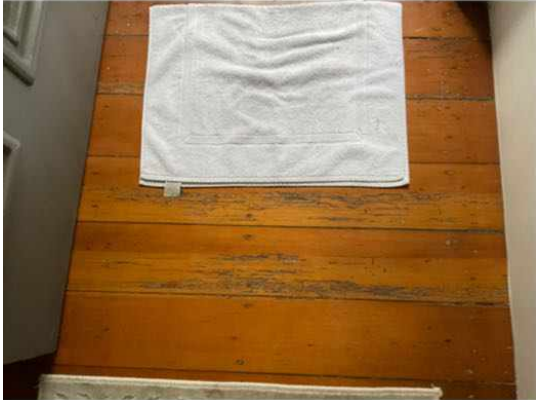
### Finding 8.01

Building:	Main Building
Location:	Flooring
Finding:	Evidence of wood borer activity identified
Information:	Wood borers small beetles that colonise in exposed timber elements are a common timber pest that are regularly mistaken for termites.

The Lyctid borer which generally attacks hardwoods such as subfloor and roofing structures is generally identified by a fine dust surrounding the affected timbers.

As no live wood borer activity was identified treatment is not required at this time.
