Building and Timber Pest Inspection Report VR

Inspection Date: Wed, 15 Mar 2023

Property Address: 363 S Dowling St, Darlinghurst NSW 2010, Australia

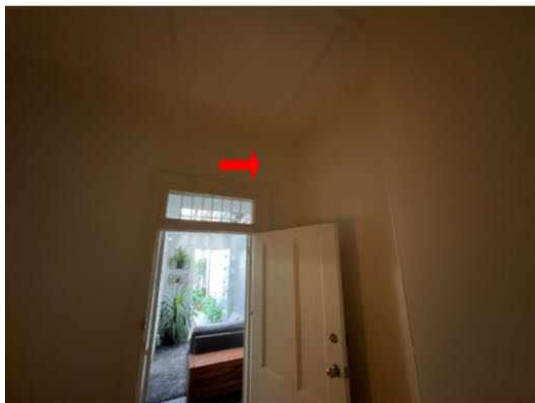
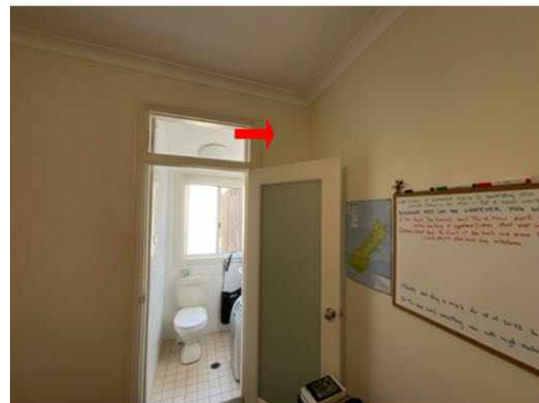
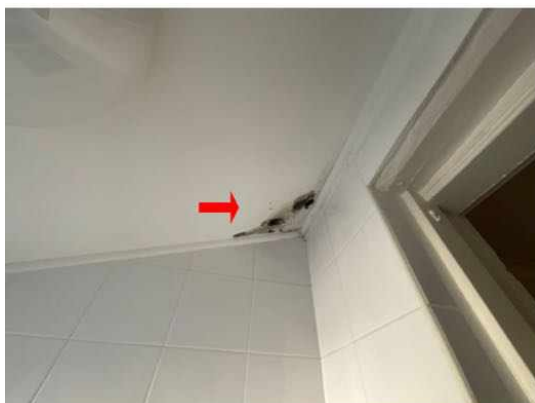
Finding 2.01

Common causes include faulty or missing flashing, lack of sealant and lateral damp.

The cause of the water leak should be addressed to prevent further damage. It is recommended that the water leak be resolved prior to any repairs of the damaged area, which may require localised replacement of building materials and refinishing.

I recommend appointing a builder to see what necessary works are required.

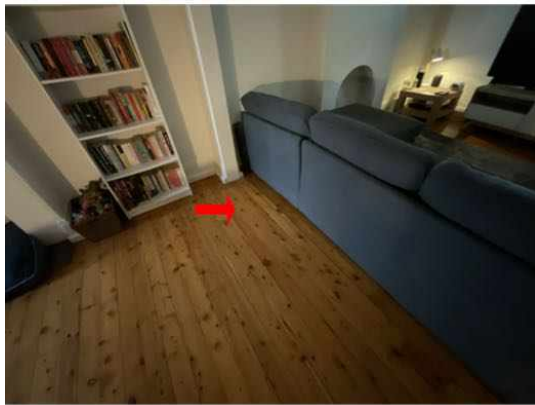
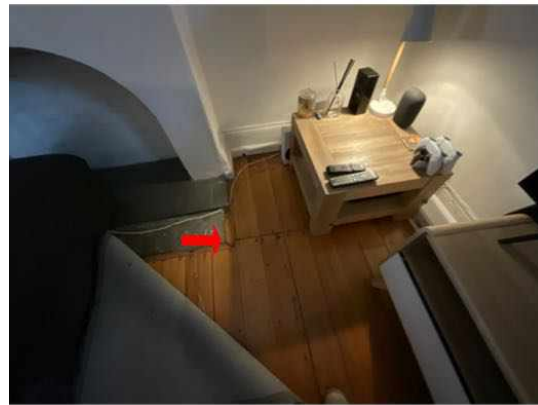
Finding 2.02

Building: Main Building
 Location: Lounge Room
 Finding: Flooring - Lifting
 Information: The flooring in this area has lifted.

Due to there being no access to the subfloor in this area I would recommend a builder for a invasive inspection to rule out that there is a tree root under the house in this area.

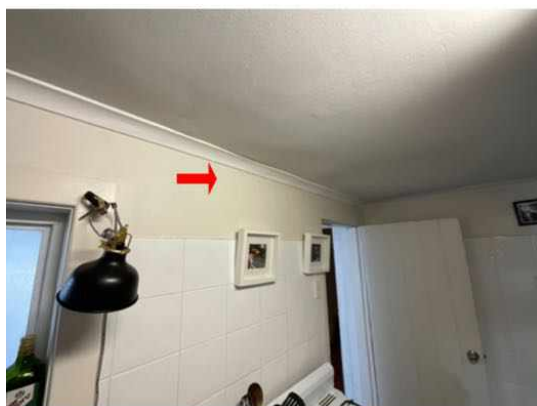
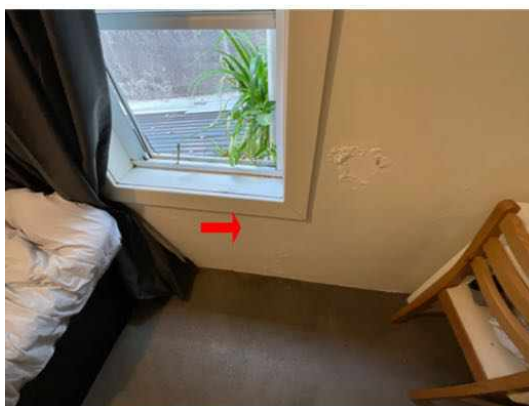
Finding 2.03

Building: Main Building
 Location: Kitchen & Bedroom
 Finding: Damp - Rain penetration
 Information: Rain penetration (also known as penetrating damp) is a common form of dampness that can occur through walls, roofs or openings (e.g. windows).

Common causes include faulty or missing flashing, lack of sealant and lateral damp.

The cause of the water leak should be addressed to prevent further damage. It is recommended that the water leak be resolved prior to any repairs of the damaged area, which may require localised replacement of building materials and refinishing.

I recommend appointing a builder to see what necessary works are required.

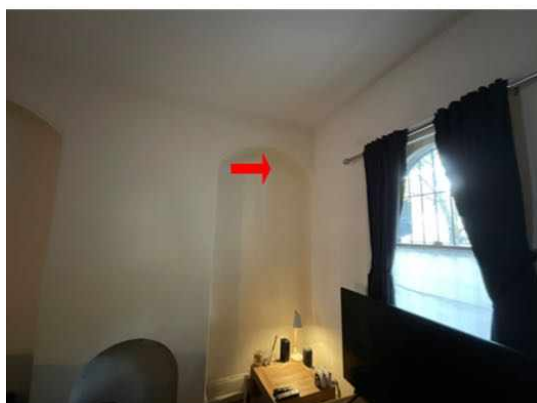
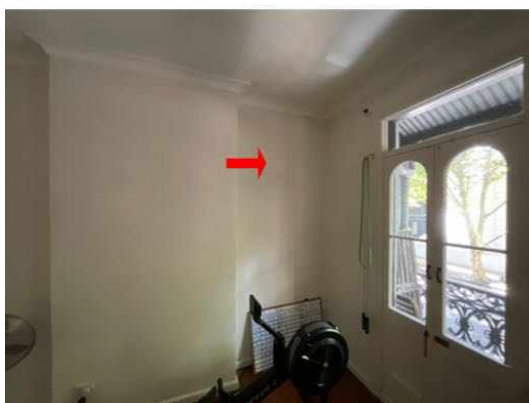
Finding 2.04

Building:	Main Building
Location:	Bedroom 1 & Lounge Room
Finding:	Damp - Rain penetration
Information:	Rain penetration (also known as penetrating damp) is a common form of dampness that can occur through walls, roofs or openings (e.g. windows).

Common causes include faulty or missing flashing, lack of sealant and lateral damp.

The cause of the water leak should be addressed to prevent further damage. It is recommended that the water leak be resolved prior to any repairs of the damaged area, which may require localised replacement of building materials and refinishing.

I recommend appointing a builder to see what necessary works are required.

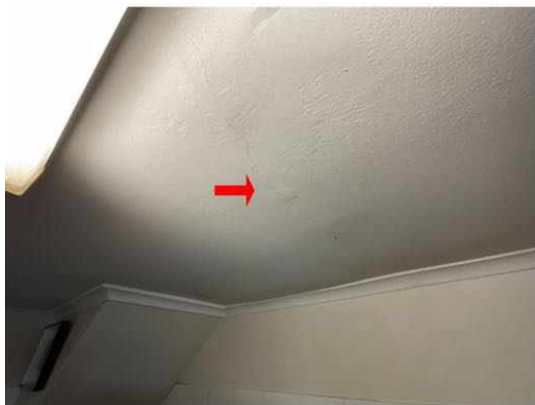
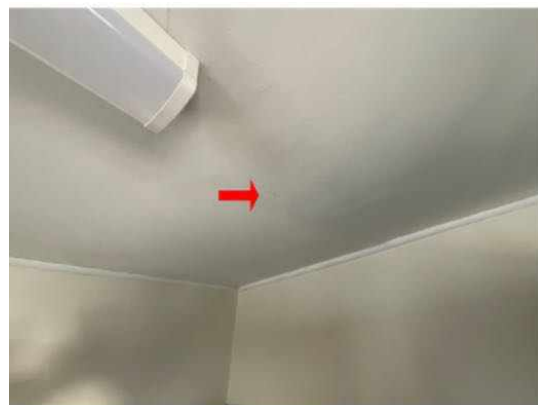
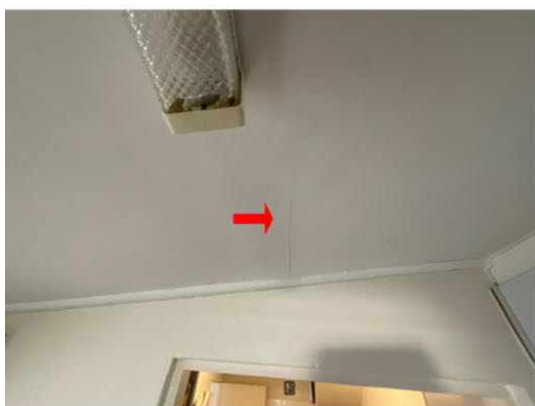
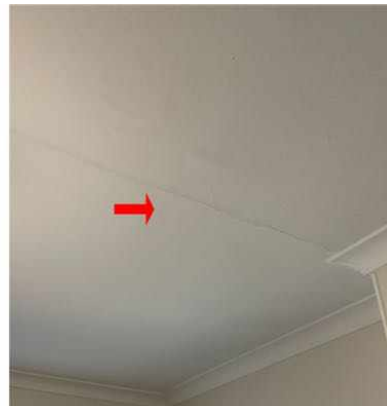
Finding 3.01

Building:	Main Building
Location:	Throughout
Finding:	Cracking - Damage Category 1 - Fine (up to 1mm)

Information: Although fine cracks are quite noticeable, they are often only considered to be an appearance defect, and usually do not indicate any structural damage. Generally, the cause of a fine crack is indicative of a separation between building materials and finishes (e.g. paint, plaster, etc.) along joins.

Cracking of this nature can generally be repaired with minor sanding, filling and/or repainting. Such works should be performed by a qualified painter or a general handyman.

Monitoring of all cracking should be conducted frequently. Always contact a building inspector should cracks widen, lengthen, or become more numerous.

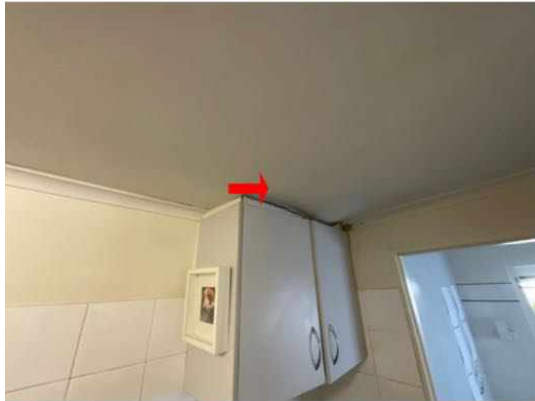
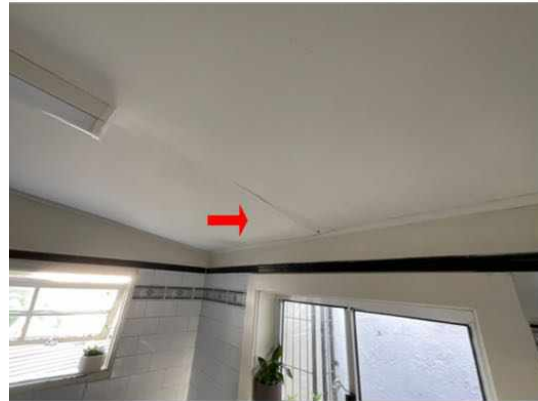
Finding 3.02

Building: Main Building
Location: Kitchen & Bathroom
Finding: Ceiling - Water damaged (No moisture detected)
Information: Water damage to the ceiling lining is generally an indication of excessive moisture being present in the roof void, usually via a leak to the roof covering.

Where water damage is evident to the ceiling, the primary requirement is to identify and rectify the source of the leak. A roofing plumber should be appointed as soon as possible to identify the leak and perform rectification works as necessary, ensuring the

water damage is restricted.

Once the leak is repaired, consultation with relevant tradespeople, including plasterers and painters, is advised. Rectification works may include replacement of ceiling lining or minor repainting, depending on the extent of the damage.

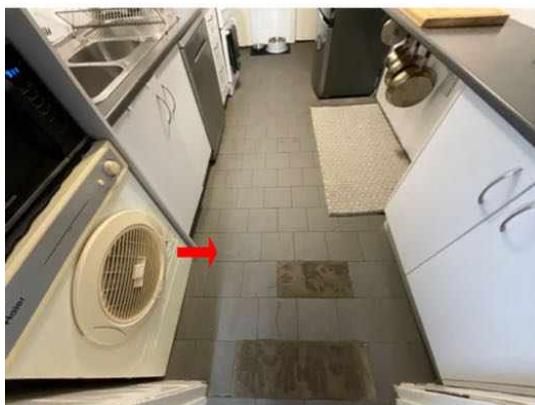
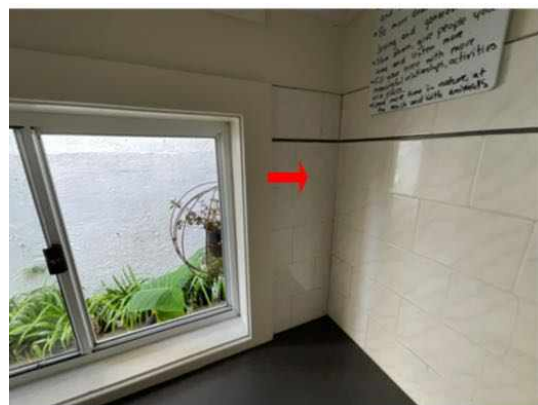
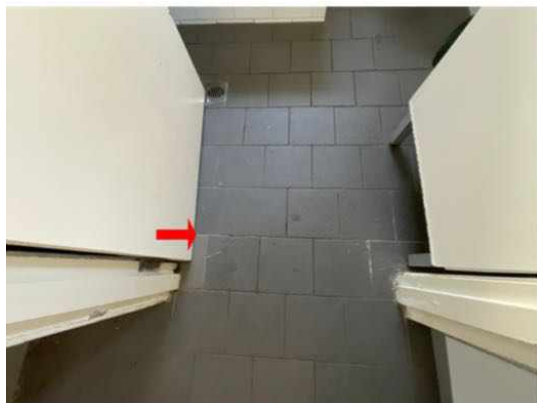
Finding 3.03

Building: Main Building
 Location: Kitchen, Laundry & Bathroom
 Finding: Tile - Cracked or damaged
 Information: Cracking was evident to the tiling in this area at the time of inspection.

I recommend appointing a tiling contractor to see what necessary works are required to replace any damaged tiles.

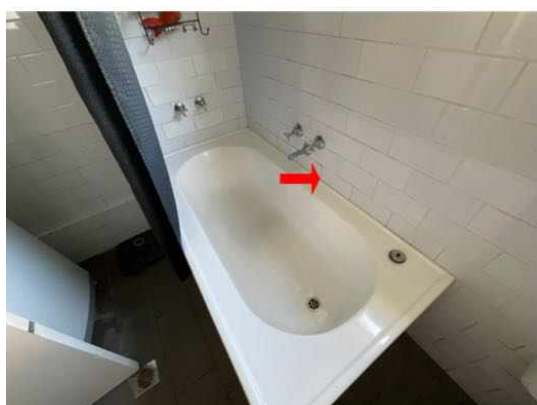
Finding 3.04

Building:	Main Building
Location:	Bathroom
Finding:	Sealant and grouting - Missing or damaged
Information:	It was noted on inspection that sealant or grout is degraded to the tiled areas.

Different materials and floor areas move at different rates, generally causing cracking to grout or sealant at this point. A flexible sealant is required to allow for expected expansion and contraction, while keeping the joint water tight and protective of all associated building materials.

Flexible and mould resistant materials should be applied to affected areas to prevent any subsequent water damage that is likely to occur. Regular maintenance and replacement of damage or missing or damaged sealant and grout is highly recommended to the wet areas, as this is a regular wear and tear defect. Sealant and grouting in areas that come into regular contact with water should be maintained for the long term care of your property.

A sealant specialist or tiling contractor should be appointed to complete these works.

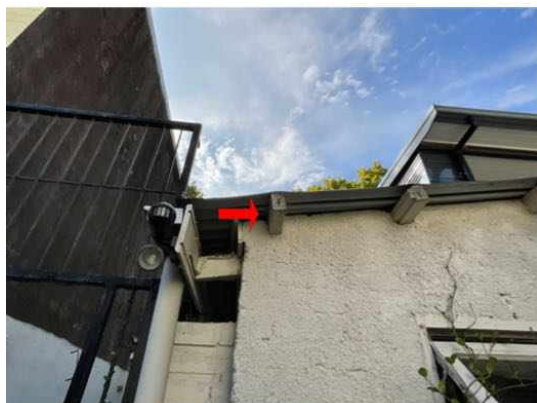
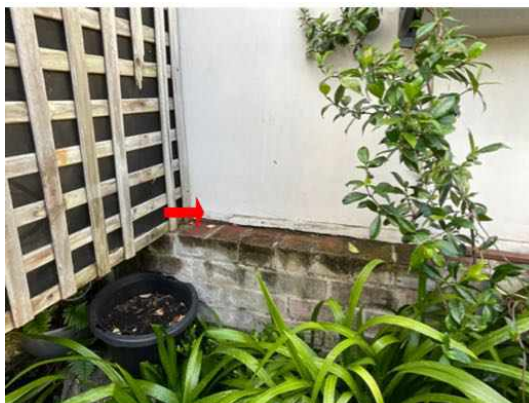
Finding 3.05

Location:	All External Areas
Finding:	Wood rot
Information:	This building element shows evidence of wood rot. Wood rot, also known as Fungal Decay, occurs when timbers and other cellulose building materials are exposed to damp conditions on an ongoing basis. This could be the result of exposure to weathering over a prolonged period of time, or the attraction of excessive moisture from other abutting building materials.

Early intervention and regular maintenance, particularly of exterior timbers, will prolong the useful life of these building elements. Prior to any works being performed, the cause of the moisture that has created the visible wood rot should be identified and addressed in a suitable manner. Replacement of affected timbers may then be a necessary step in protecting surrounding building elements from such deterioration.

A qualified carpenter or registered builder may also be required to replace affected building materials.

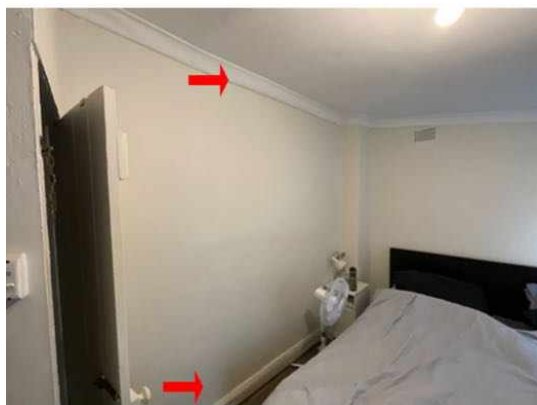
Finding 3.06

Building:	Main Building
Location:	Bedroom
Finding:	Damp - Rain penetration
Information:	Rain penetration (also known as penetrating damp) is a common form of dampness that can occur through walls, roofs or openings (e.g. windows).

Common causes include faulty or missing flashing, cracked tiles, degraded pointing, lack of sealant and blocked weep holes. Rain penetration can also occur when water tracks horizontally under the lip of eaves and roof linings with insufficient angles, or by tracking across wall ties.

Although there was no moisture detected at the leak does appear to be addressed I would recommend appointing a roofing contractor to see what necessary works are required. I would also recommend appointing a builder to repair any building elements that had been damaged from the water ingress.

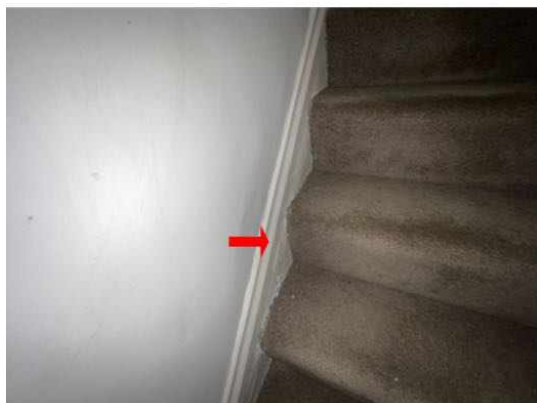
Finding 3.07

Building:	Main Building
Location:	Stairs - Internal
Finding:	Wood rot
Information:	This building element shows evidence of wood rot. Wood rot, also known as Fungal Decay, occurs when timbers and other cellulose building materials are exposed to damp conditions on an ongoing basis. This could be the result of exposure to excessive moisture over a prolonged period of time.

I recommend appointing a builder for a further invasive inspection to rule out that there is no termite damage in this area.

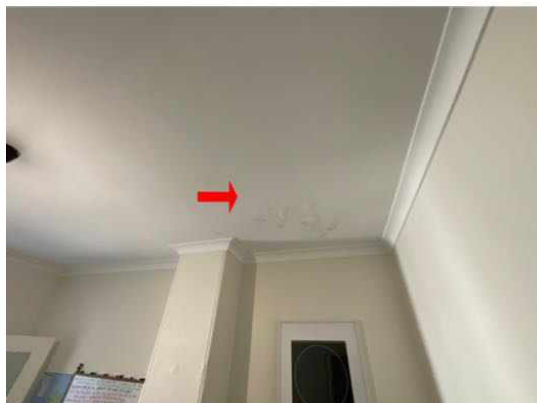
Finding 3.08

Building:	Main Building
Location:	Bedroom 2
Finding:	Ceiling - Water stained
Information:	Water staining to ceiling linings in this area was evident at the time of inspection. Water staining indicates that surfaces have been exposed to excessive moisture over time. The minerals and other elements in the water lead to staining, which may graduate to corrosion and deterioration if left unmanaged.

Although there was no moisture detected in the ceiling I would recommend monitoring and acting on one of the following.

Where water staining is active, a licensed plumber must be consulted to identify the cause of the staining and to provide advice on any reparation works that may be required. Replacement of any damaged structures is advised.

Conversely, where water staining is old and inactive, affected building materials may be repaired or replaced at client discretion.

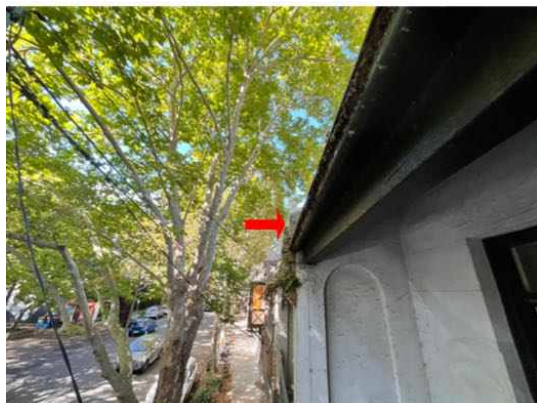
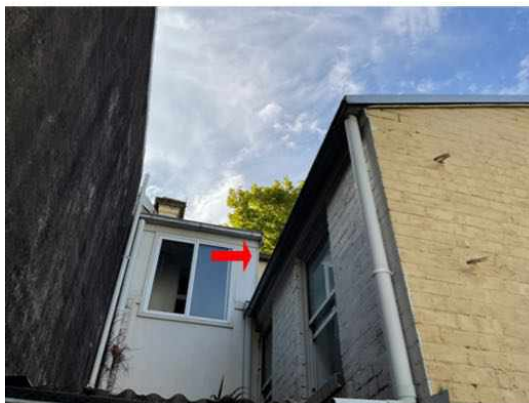
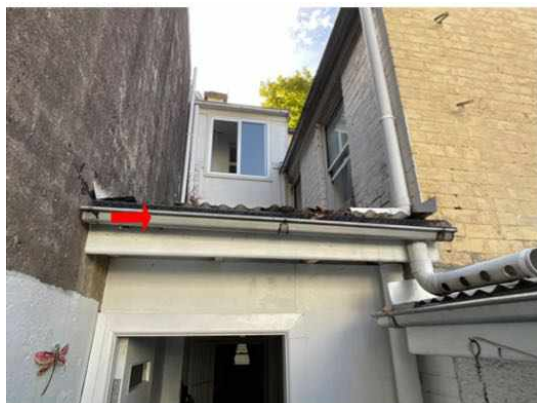
Finding 3.09

Building: Main Building
Location: Roof Exterior
Finding: Roof plumbing - Insufficient fall
Information: There is an insufficient fall in the roof drainage, which means that the angle is inadequate to facilitate movement of rainwater. This is resulting in pooling of water in the area, creating the potential for water damage to associated building elements.

Without adequate roof drainage, premature rust and decay of the roof plumbing structures is imminent. The development of such deterioration is likely to lead to the formation of secondary defects to adjoining wall sections and roofing elements.

Adjustment by a roofing plumber is required as soon as possible to prevent any further damage to the area.

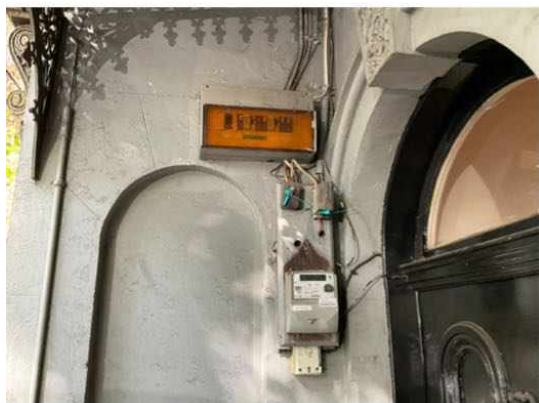
Finding 6.01

Building:	Main Building
Location:	All Areas
Finding:	Termite Management System - no evidence of a chemical installation
Information:	The application of a post-construction chemical termite barrier is highly recommended for all properties, particularly if live termite activity has been found on the site previously. Such barriers are highly effective in preventing termite attack on any timber building elements throughout the property.

system has been installed, with no evidence to suggest preventative works taking place.

The client may consider gaining further advice from a pest controller as to the costs and procedures involved with this application. It is recommended that obtaining such advice be a short-term priority.

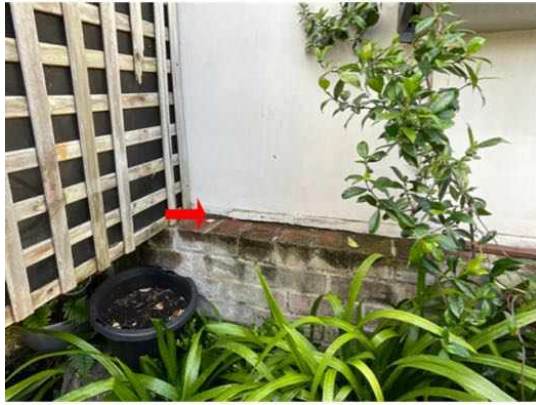
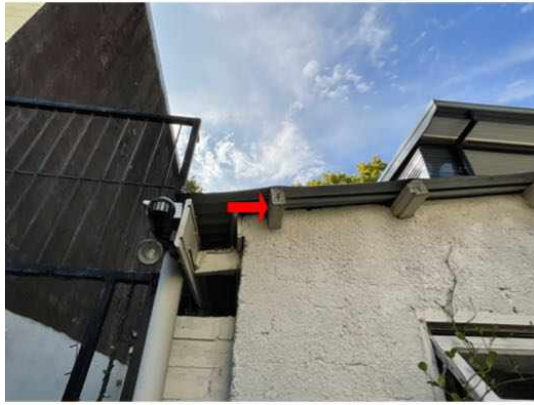
Finding 7.01

Building:	Main Building
Location:	All External Areas
Finding:	Fungal decay - present (localised)
Information:	Fungal decay also known as wood decay or wood rot generally refers to the deterioration of timber elements when in contact with excessive levels of moisture for a prolonged period of time.

The development of fungal decay is accelerated by temperatures in the range of 5degreeC to 40degreeC as well as the presence of oxygen. Generally fungal decay develops on timber elements that are in use in an external environment which are exposed to rain penetration.

In this case although the affected timber element is in a decaying state the extent of any visible damage appears to be localised to a specific area and is yet to spread to other parts of the building element or affect adjoining structures. The fungal decay is therefore likely to be of a relatively superficial nature with minimal impact on the structural integrity or tensile strength of the timber element.

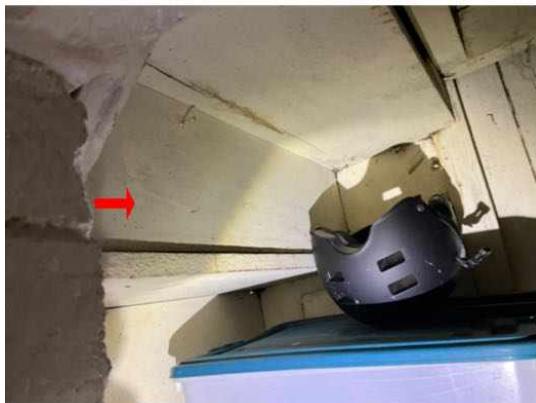
Finding 8.01

The Lyctid borer which generally attacks hardwoods such as subfloor and roofing structures is generally identified by a fine dust surrounding the affected timbers.

As no live wood borer activity was identified treatment is not required at this time.
