Building and Timber Pest Inspection Report VR

Inspection Date: Tue, 5 Sep 2023

Property Address: 447 Crown Street, Surry Hills

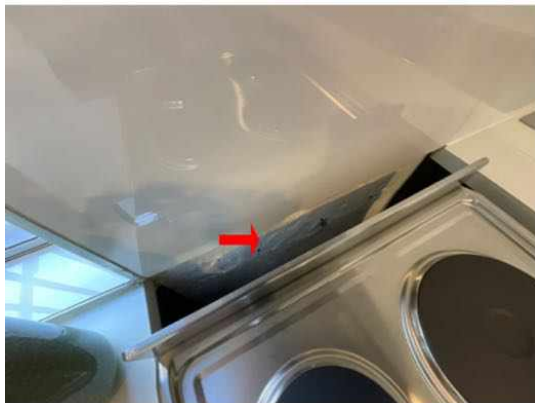
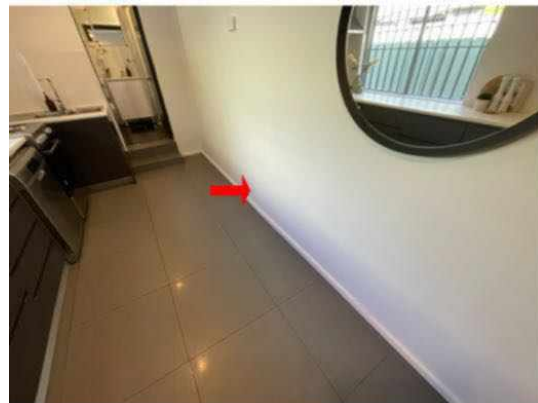
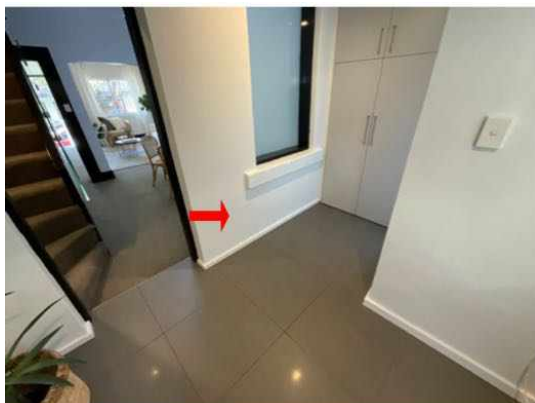
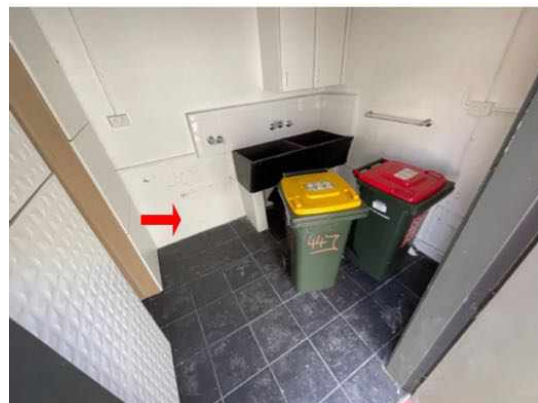
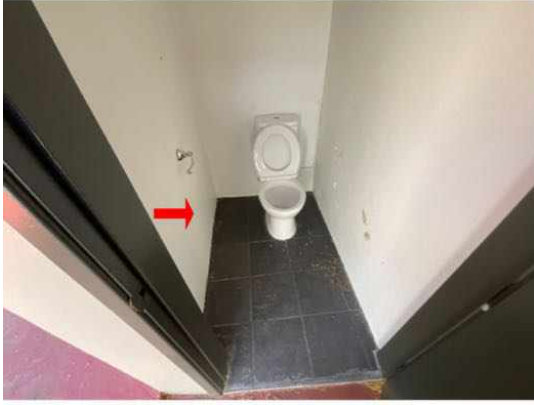
Finding 2.01

Building: Main Building
Location: Kitchen, Laundry & WC
Finding: Damp - Rising
Information: Rising damp describes the upward movement of water in low sections of building elements (e.g. walls) by capillary action - the movement of water through porous materials such as bricks, sandstone or mortar.

- It was noted at the time of inspection that there was a moderate - high reading of rising damp detected in sections of the walls throughout the building. I recommend appointing a damp proofing specialist to see what necessary works are required. A new DPC will need to be installed in sections of the walls throughout.

I recommend appointing a damp proofing specialist to see what necessary works are required.

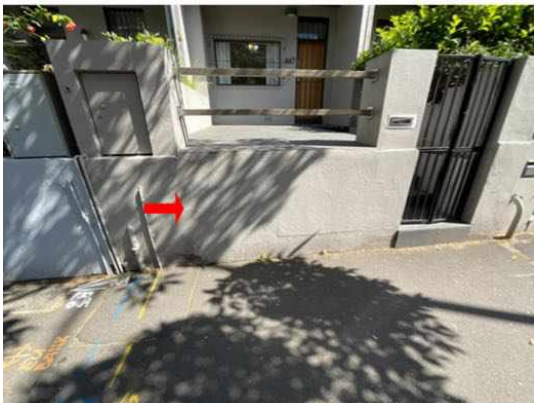
Finding 3.01

Building:	Yard
Location:	Exterior walls - front
Finding:	Cracking - Damage Category 2 - Noticeable (up to 5mm)
Information:	Noticeable cracks are a common occurrence as a result of many primary defects. Such causes may include age, general wear and tear, expected building movement, general expansion/contraction of building materials in different weather conditions, and/or minor failings in the installation or application of building materials.

I recommend monitoring and if further cracking is evident appoint a bricklayer to see what works are required.

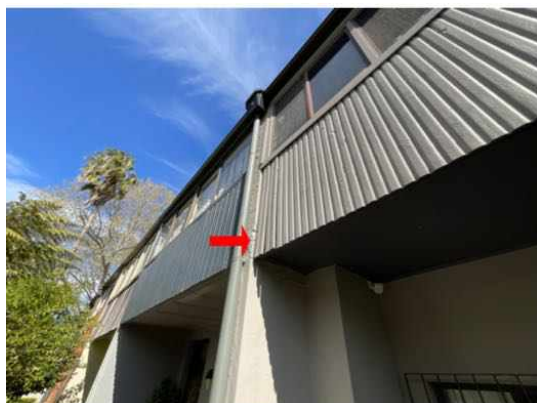
Finding 3.02

Building:	Main Building
Location:	Exterior walls - front
Finding:	Nails - Popping
Information:	Popped nails were identified at the time of inspection. Nails and screws are held by the

friction between them and the surface that they are applied to. Over time, the nails and screws can back out, which is often a result of general ageing and deterioration of the building structure.

Re-fastening of popped nails will help to maintain the stability of these, and associated, building elements. Such minor works will also help to improve the appearance of the affected area and secure the linings. These works should be performed by a qualified carpenter at client discretion.

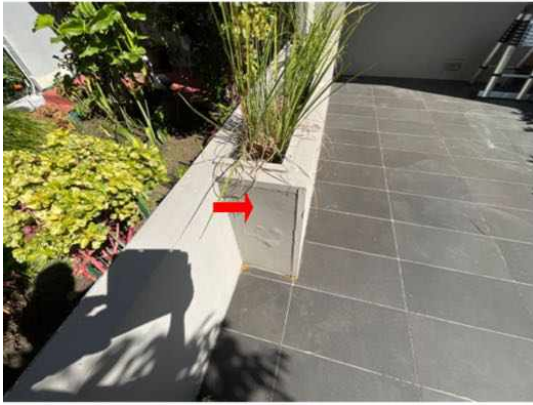
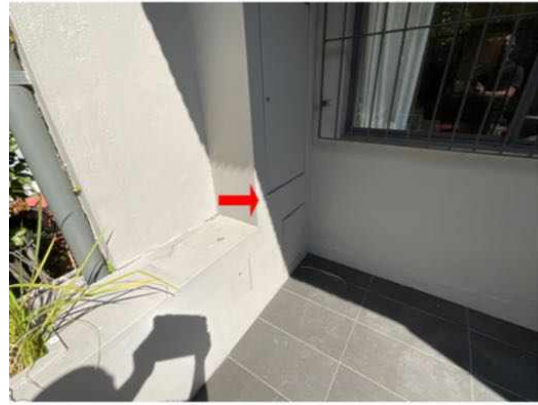
Finding 3.03

Building:	Main Building
Location:	Exterior walls - front
Finding:	Cracking - Damage Category 1 - Fine (up to 1mm)
Information:	Although fine cracks are quite noticeable, they are often only considered to be an appearance defect, and usually do not indicate any structural damage. Generally, the cause of a fine crack is indicative of a separation between building materials and finishes (e.g. paint, plaster, etc.) along joins.

Cracking of this nature can generally be repaired with minor sanding, filling and/or repainting. Such works should be performed by a qualified painter or a general handyman.

Monitoring of all cracking should be conducted frequently. Always contact a building inspector should cracks widen, lengthen, or become more numerous.

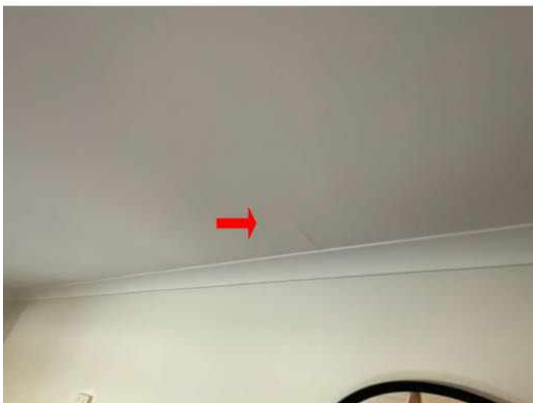
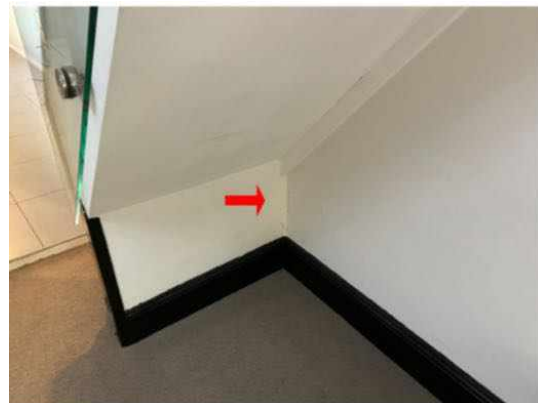
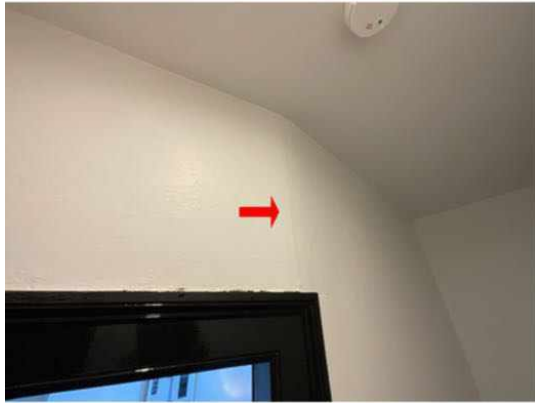
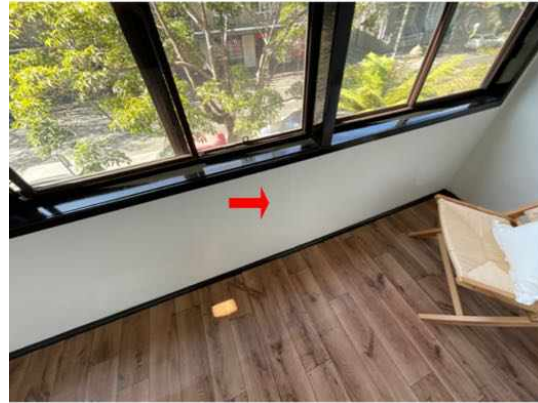
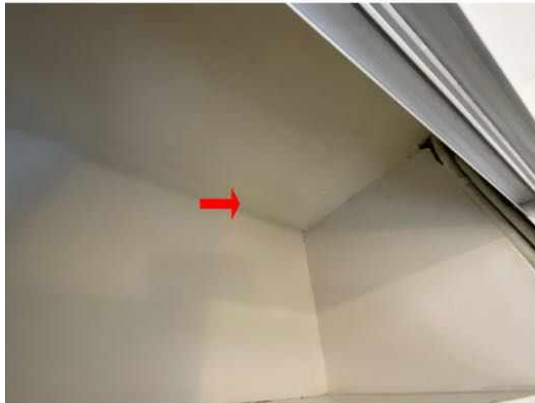
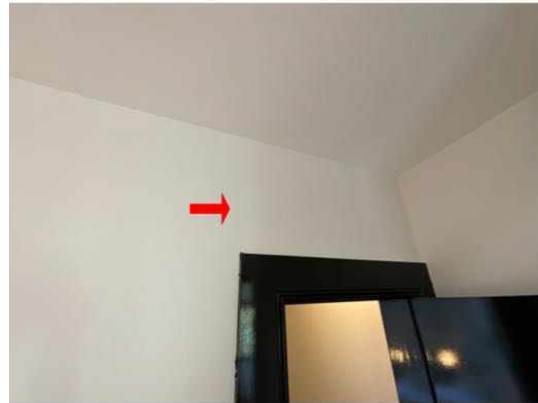
Finding 3.04

Building: Main Building

Location: Throughout

Finding: Cracking - Damage Category 1 - Fine (up to 1mm)

Information: Although fine cracks are quite noticeable, they are often only considered to be an appearance defect, and usually do not indicate any structural damage. Generally, the cause of a fine crack is indicative of a separation between building materials and finishes (e.g. paint, plaster, etc.) along joints.

Cracking of this nature can generally be repaired with minor sanding, filling and/or repainting. Such works should be performed by a qualified painter or a general handyman.

Monitoring of all cracking should be conducted frequently. Always contact a building inspector should cracks widen, lengthen, or become more numerous.

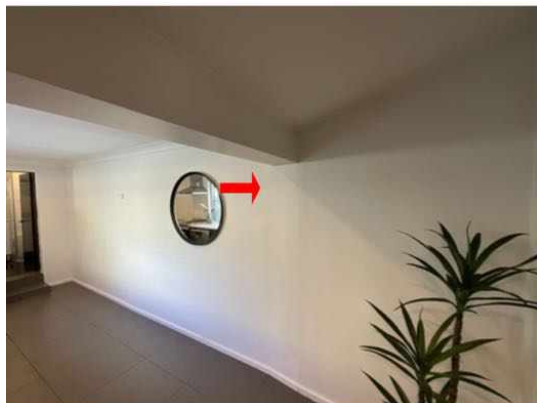
Finding 3.05

Building:	Main Building
Location:	Kitchen
Finding:	Damp - Rain penetration
Information:	Rain penetration (also known as penetrating damp) is a common form of dampness that can occur through walls, roofs or openings (e.g. windows).

Common causes include faulty or missing flashing, lack of sealant and lateral damp.

On further inspection it was noted that there has been roof sheets replaced above this area.

Due to there still being moisture I recommend appointing a builder to see what necessary works are required.

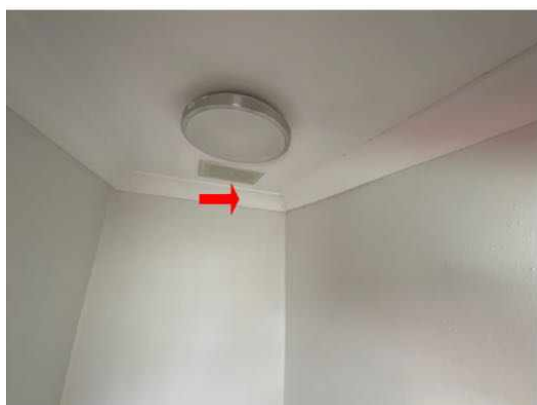
Finding 3.06

Building:	Main Building
Location:	Toilet (WC)
Finding:	Ceiling - Water stained
Information:	Water staining to ceiling linings in this area was evident at the time of inspection. Water staining indicates that surfaces have been exposed to excessive moisture over time. The minerals and other elements in the water lead to staining, which may graduate to corrosion and deterioration if left unmanaged.

Although there was no moisture detected in the ceiling I would recommend monitoring and acting on one of the following.

Where water staining is active, a licensed plumber must be consulted to identify the cause of the staining and to provide advice on any reparation works that may be required. Replacement of any damaged structures is advised.

Conversely, where water staining is old and inactive, affected building materials may be repaired or replaced at client discretion.

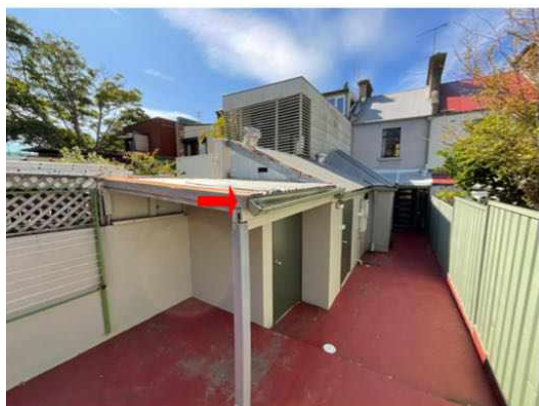
Finding 3.07

Building:	Main Building
Location:	Roof Exterior

Finding: Fitting or fixture - Loose (Guttering)
 Information: The fitting in this area is loose and requires adjustment to tighten.

If left unmanaged, the fitting may further deteriorate, causing potential for the development of other minor secondary defects.

A relevant tradesperson should be appointed to perform these rectification works at discretion of the client.

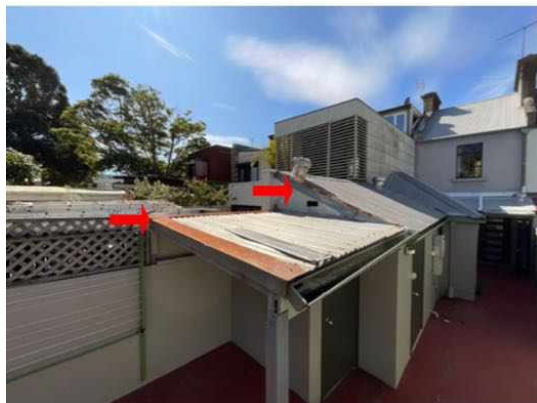
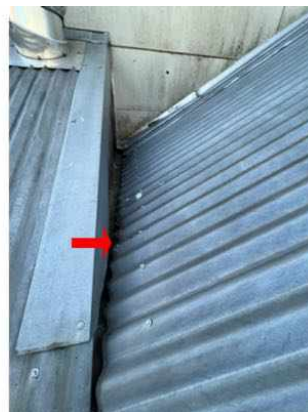
Finding 3.08

Building: Main Building
 Location: Roof Exterior
 Finding: Building element - Rusted or corroded
 Information: This building element shows evidence of rusting and corrosion, which is likely to have developed as a result of excessive exposure to moisture and or inadequate coatings.

As surface rust provides no protection to the underlying iron, the deteriorating condition is likely to worsen if not addressed in the short-term future.

Where possible, the use of galvanized (treated) metals or aluminium coated metals aid in rust prevention, as does regular general maintenance. Rust formation can be controlled with coatings, such as paint, that isolate the iron from the environment.

Rusting and corrosion should be managed by ideally removing or limiting the affected surface from exposure to moisture.

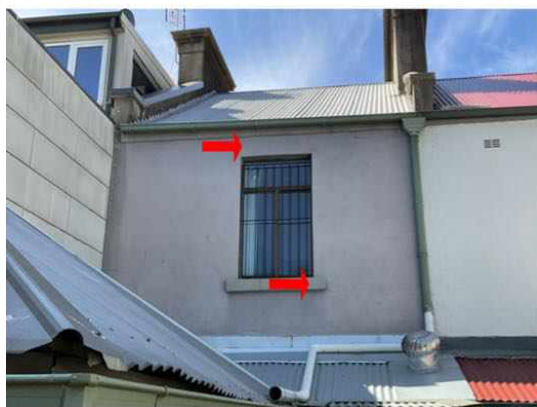
Finding 3.09

Building:	Main Building
Location:	Exterior walls - rear
Finding:	Cracking - Damage Category 2 - Noticeable (up to 5mm)
Information:	Noticeable cracks are a common occurrence as a result of many primary defects. Such causes may include age, general wear and tear, expected building movement, general expansion/contraction of building materials in different weather conditions, and/or minor failings in the installation or application of building materials.

I recommend monitoring and if further cracking is evident appoint a bricklayer to see what works are required.

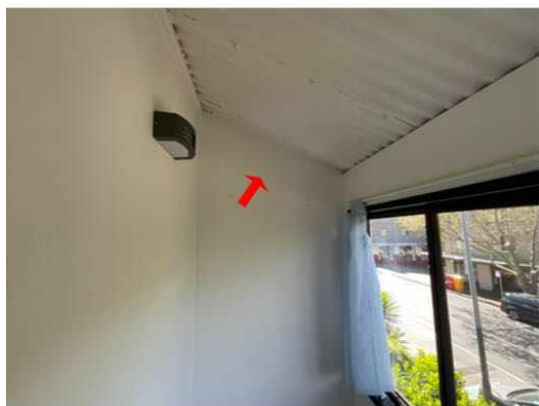
Finding 3.10

Building:	Main Building
Location:	Bedroom
Finding:	Damp - Rain penetration
Information:	Rain penetration (also known as penetrating damp) is a common form of dampness that can occur through walls, roofs or openings (e.g. windows).

Common causes include faulty or missing flashing, lack of sealant and lateral damp.

The cause of the water leak should be addressed to prevent further damage. It is

recommended that the water leak be resolved prior to any repairs of the damaged area, which may require localised replacement of building materials and refinishing.

I recommend appointing a builder to see what necessary works are required.

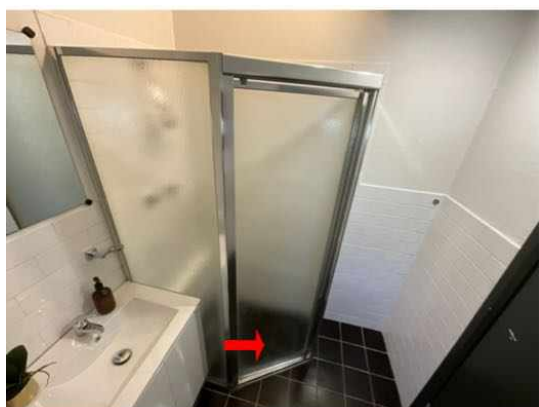
Finding 3.11

Building:	Main Building
Location:	Bathroom
Finding:	Aluminium Door - Binding/jamming
Information:	Binding and/or jamming of this door is evident during standard operation. This defect inhibits the functionality of the affected door as well as creating potential for secondary defects to associated building elements, such as damage to the floor covering.

For minor causes, a qualified carpenter or general handyperson should be appointed to perform minor rectification works at client discretion.

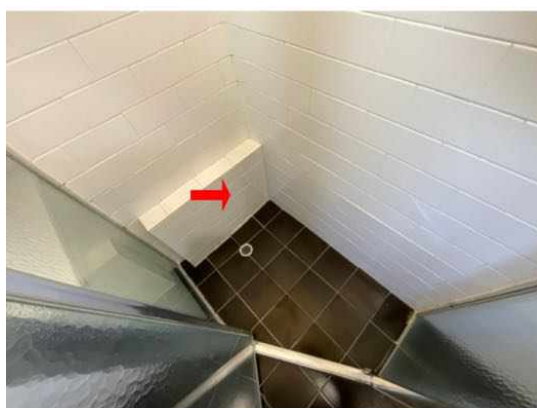
Finding 3.12

Building:	Main Building
Location:	Bathroom
Finding:	Sealant and grouting - Missing or damaged
Information:	It was noted on inspection that sealant or grout is degraded to the tiled areas.

Different materials and floor areas move at different rates, generally causing cracking to grout or sealant at this point. A flexible sealant is required to allow for expected expansion and contraction, while keeping the joint water tight and protective of all associated building materials.

Flexible and mould resistant materials should be applied to affected areas to prevent any subsequent water damage that is likely to occur. Regular maintenance and replacement of damage or missing or damaged sealant and grout is highly recommended to the wet areas, as this is a regular wear and tear defect. Sealant and grouting in areas that come into regular contact with water should be maintained for the long term care of your property.

A sealant specialist or tiling contractor should be appointed to complete these works.

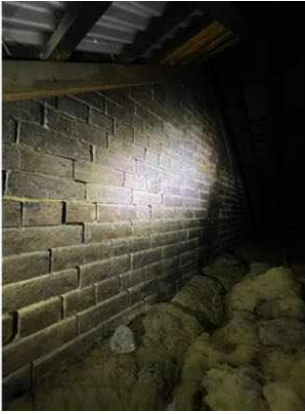
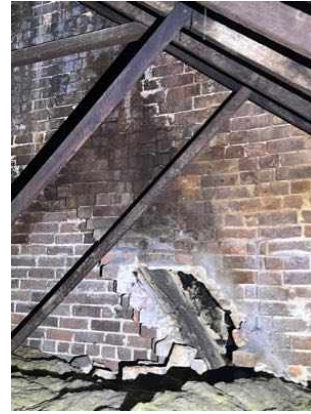
Finding 3.13

Building:	Main Building
Location:	Roof Void
Finding:	Brickwork - Deteriorated mortar
Information:	Mortar, or 'bedding', is the material which fills joints and intersections between bricks in masonry walls and structures. Sections of mortar in this brickwork were identified as having deteriorated.

Mortar deterioration can be addressed by a bricklayer.

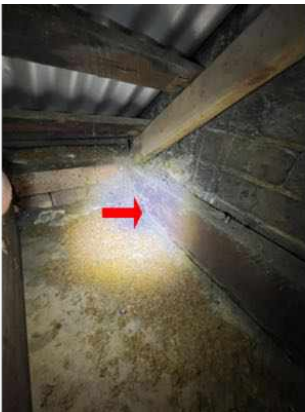
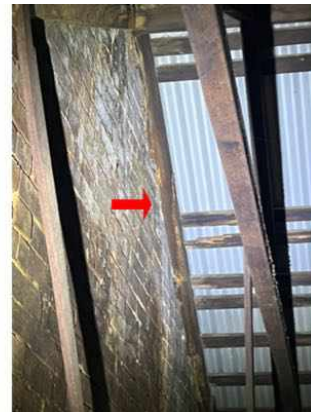
Finding 3.14

Building:	Main Building
Location:	Roof Void
Finding:	Termite - damage identified
Information:	Despite no live termite or timbered pest activity being indicated, termite damage was found to have affected this area.

A building contractor should be appointed to provide a further invasive inspection and to see what necessary works are required.

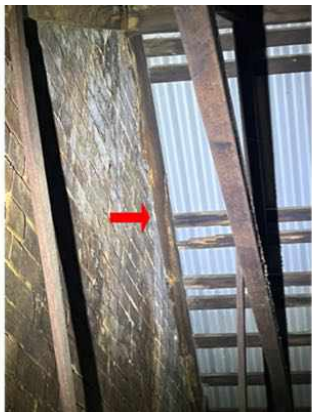
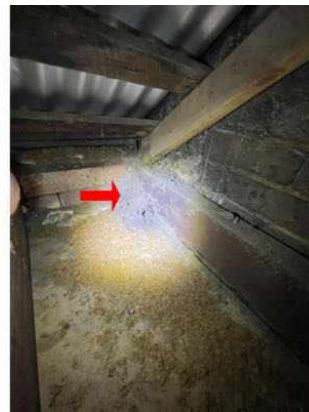
Finding 5.01

Building:	Main Building
Location:	Roof Void
Finding:	Termite - damage identified

Information: Despite no live termite or timbered pest activity being indicated, termite damage was found to have affected this area.

A building contractor should be appointed to provide a further invasive inspection and to see what necessary works are required.

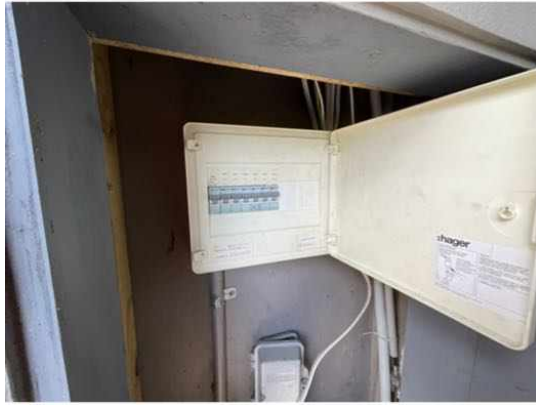
Finding 6.01

Building: Main Building
 Location: All Areas
 Finding: Termite Management System - no evidence of a chemical installation
 Information: The application of a post-construction chemical termite barrier is highly recommended for all properties, particularly if live termite activity has been found on the site previously. Such barriers are highly effective in preventing termite attack on any timber building elements throughout the property.

A durable notice should be placed in the switchboard unit to indicate current termite barriers. At the time of inspection, it appeared as though no termite management system has been installed, with no evidence to suggest preventative works taking place.

The client may consider gaining further advice from a pest controller as to the costs and procedures involved with this application. It is recommended that obtaining such advice be a short-term priority.
