Building and Timber Pest Inspection Report VR

Inspection Date: Fri, 13 Oct 2023

Property Address: 2 Ryder Street, Darlinghurst

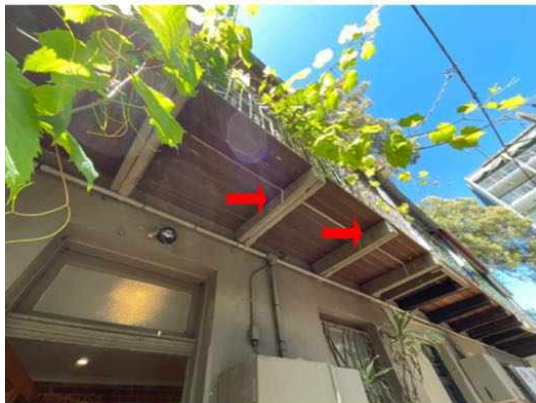
Finding 1.01

Building:	Main Building
Location:	Balcony
Finding:	Wood rot
Information:	This building element shows evidence of wood rot. Wood rot, also known as Fungal Decay, occurs when timbers and other cellulose building materials are exposed to damp conditions on an ongoing basis. This could be the result of exposure to weathering over a prolonged period of time, or the attraction of excessive moisture from other abutting building materials.

Early intervention and regular maintenance, particularly of exterior timbers, will prolong the useful life of these building elements. Prior to any works being performed, the cause of the moisture that has created the visible wood rot should be identified and addressed in a suitable manner. Replacement of affected timbers may then be a necessary step in protecting surrounding building elements from such deterioration.

A qualified carpenter or registered builder may also be required to replace affected building materials.

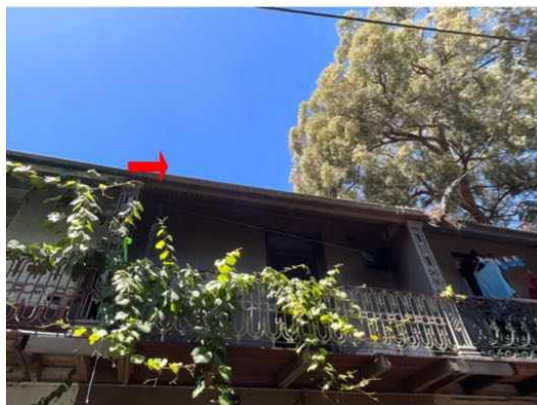
Finding 3.01

Location: Roof Exterior
 Finding: Gutters - Blocked
 Information: Roof plumbing structures, such as guttering and downpipes, should be free of all debris to prevent blockages. Blockages of the guttering and downpipes will lead to pooling and accumulated water overflows, which is likely to subsequently flood eaves and exterior walls.

Blocked gutters are likely to lead to high levels of moisture in the affected areas. Such moisture will not only cause rust and decay of the associated building materials, but can also provide conditions that are conducive to termite and timber pest activity. Blockages in gutters should therefore be removed to ensure dry conditions are maintained.

Consult a Licensed Plumber for further specific advice on remedial works that may be required. In the interim, it is highly advised that blocked gutters be removed by the homeowner or a general handyperson as a matter of urgency.

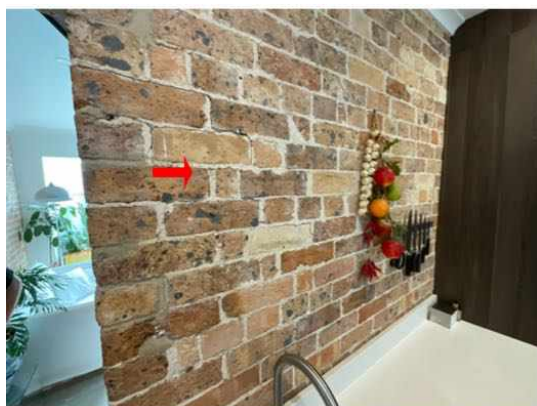
Finding 3.02

Building: Main Building
 Location: Kitchen
 Finding: Brickwork - Cracking noticeable
 Information: There were several cracks and or crack repairs evident to external brickwork.

Noticeable cracks are a common occurrence in external brickwork and are a likely result of age expected building movement, general expansion, and/or contraction of building materials in different weather conditions.

It is highly advised that a qualified bricklayer be appointed to provide necessary works to cracked brickwork to prevent any further damage.

Always monitor these cracks and contact a building inspector should cracks widen, lengthen, or become more numerous.

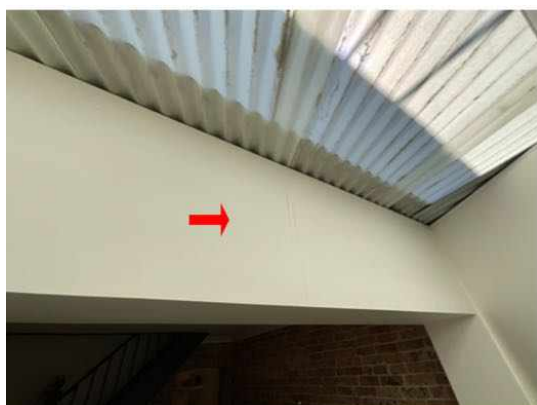
Finding 3.03

Building:	Main Building
Location:	Lounge Room
Finding:	Walls - Water stained
Information:	Water staining to sections of the walls in this area was evident at the time of inspection. Water staining indicates that surfaces have been exposed to excessive moisture over time. The minerals and other elements in the water lead to staining, which may graduate to corrosion and deterioration if left unmanaged.

Although there was no moisture detected I would recommend monitoring and acting on the following.

Where water staining is active, a licensed plumber must be consulted to identify the cause of the staining and to provide advice on any reparation works that may be required. Replacement of any broken or damaged structures is advised.

Conversely, where water staining is old and inactive, affected building materials may be repaired or replaced at client discretion.

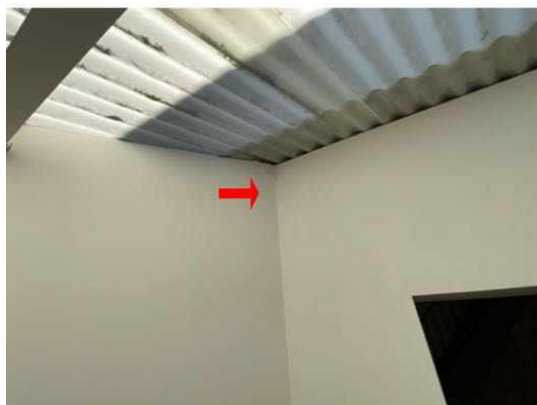
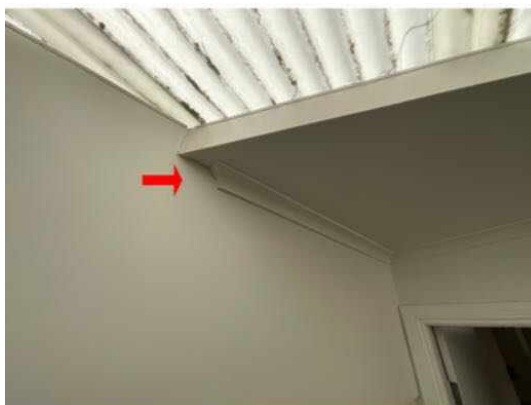
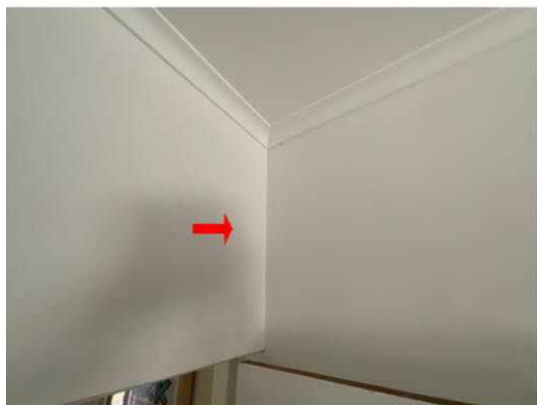
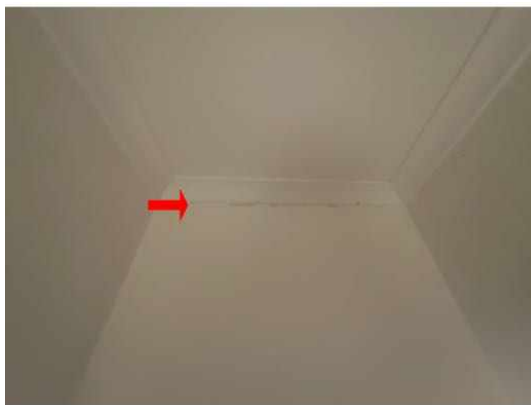
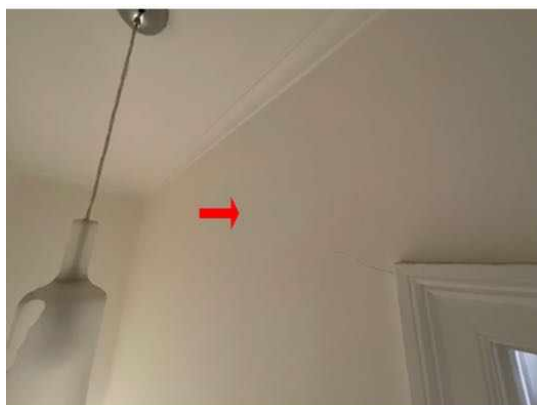
Finding 3.04

Building:	Main Building
Location:	Throughout

Finding: Cracking - Damage Category 1 - Fine (up to 1mm)

Information: Although fine cracks are quite noticeable, they are often only considered to be an appearance defect, and usually do not indicate any structural damage. Generally, the cause of a fine crack is indicative of a separation between building materials and finishes (e.g. paint, plaster, etc.) along joins.

Cracking of this nature can generally be repaired with minor sanding, filling and/or repainting. Such works should be performed by a qualified painter or a general handyman.

Monitoring of all cracking should be conducted frequently. Always contact a building inspector should cracks widen, lengthen, or become more numerous.

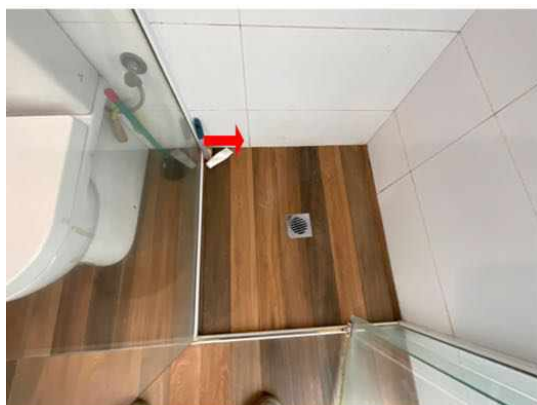
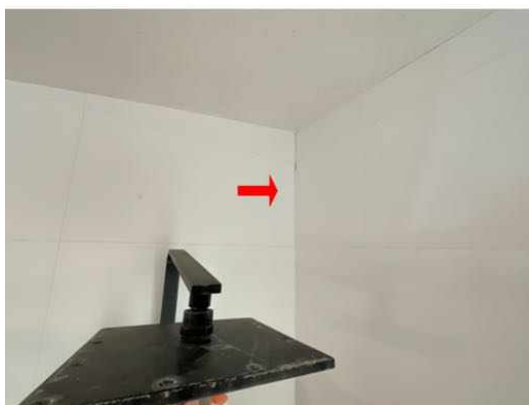
Finding 3.05

Building:	Main Building
Location:	Bathroom
Finding:	Sealant and grouting - Missing or damaged
Information:	It was noted on inspection that sealant or grout is degraded to the tiled areas.

Different materials and floor areas move at different rates, generally causing cracking to grout or sealant at this point. A flexible sealant is required to allow for expected expansion and contraction, while keeping the joint water tight and protective of all associated building materials.

Flexible and mould resistant materials should be applied to affected areas to prevent any subsequent water damage that is likely to occur. Regular maintenance and replacement of damage or missing or damaged sealant and grout is highly recommended to the wet areas, as this is a regular wear and tear defect. Sealant and grouting in areas that come into regular contact with water should be maintained for the long term care of your property.

A sealant specialist or tiling contractor should be appointed to complete these works.

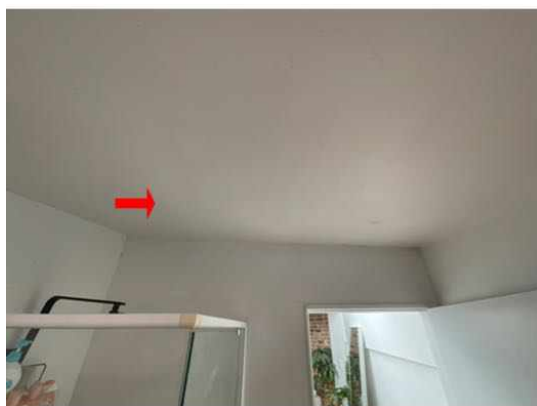
Finding 3.06

Building:	Main Building
Location:	Bathroom
Finding:	Mould - Present
Information:	Generally, the client is advised to ensure that the general environment is free of moisture and humidity to aid in the prevention of mould formation and development.

Any mould found during the inspection should be cleaned by a cleaning contractor or the homeowner as applicable.

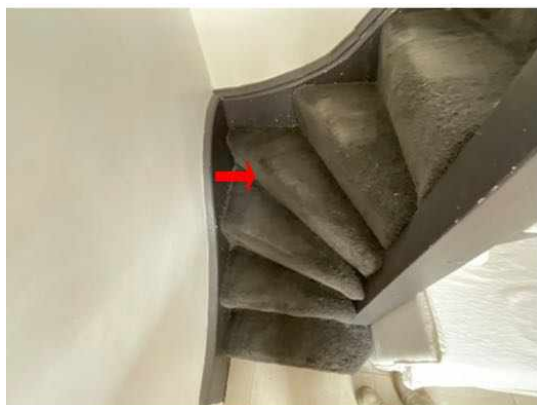
Finding 3.07

Building:	Main Building
Location:	Stairs - Internal
Finding:	Nails - Popping
Information:	Popped nails were identified at the time of inspection. Nails and screws are held by the friction between them and the surface that they are applied to. Over time, the nails and screws can back out, which is often a result of general ageing and deterioration of the building structure.

Re-fastening of popped nails will help to maintain the stability of these, and associated, building elements. Such minor works will also help to improve the appearance of the affected area and secure the linings. These works should be performed by a qualified carpenter at client discretion.

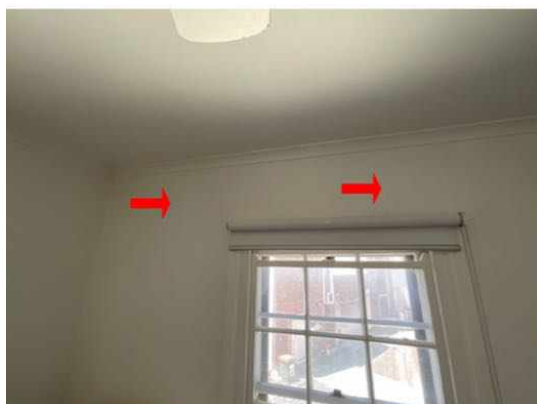
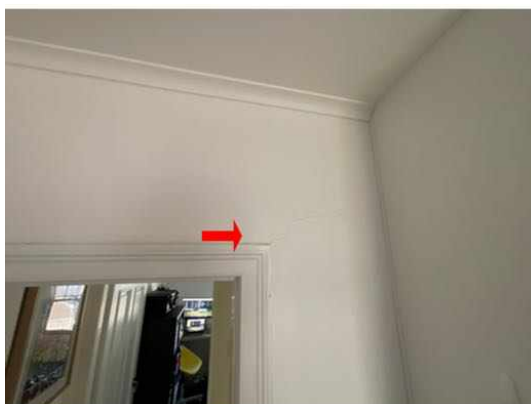
Finding 3.08

Building:	Main Building
Location:	Bedrooms
Finding:	Cracking - Damage Category 2 - Noticeable (up to 5mm)
Information:	Noticeable cracks are a common occurrence as a result of many primary defects. Such causes may include age, general wear and tear, expected building movement, general expansion/contraction of building materials in different weather conditions,

and/or minor failings in the installation or application of building materials.

I recommend monitoring and if further cracking is evident appoint a bricklayer to see what works are required.

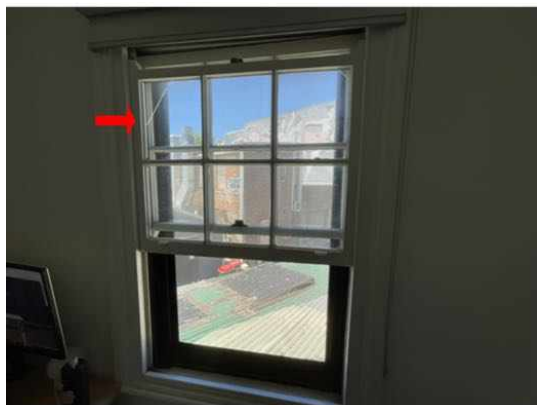
Finding 3.09

Building:	Main Building
Location:	Window
Finding:	Glass - Cracked
Information:	Cracks were identified in the glass in this area. Cracking in glass is generally the result of impact damage, and is likely to develop further when left unmanaged.

A qualified glazier is required to repair the glass.

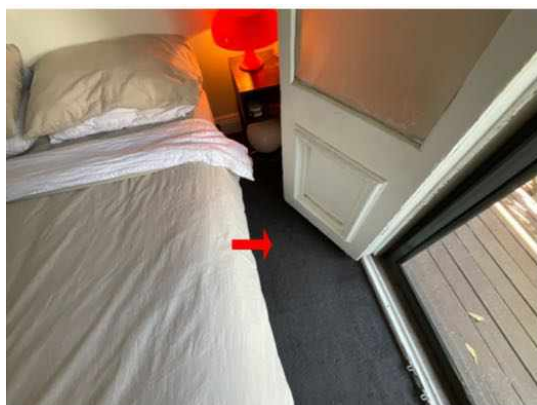
Finding 3.10

Building:	Main Building
Location:	Bedroom 2
Finding:	Flooring - Squeaking
Information:	It was noted at the time of inspection that there was areas that have squeaking floorboards.

This is caused when there is movement between the flooring and the joists. Although the flooring is structurally sound I would recommend appointing a carpenter at the clients discretion to see what works are required.

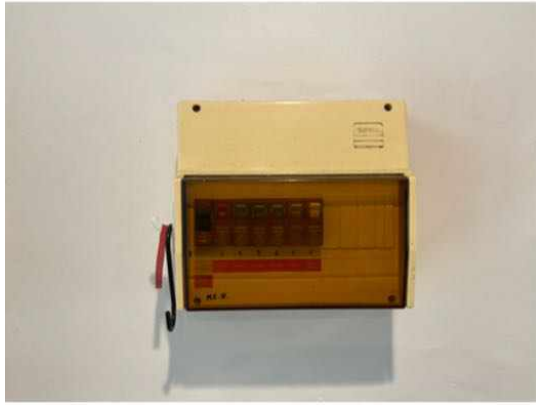
Finding 6.01

Building:	Main Building
Location:	All Areas
Finding:	Termite Management System - no evidence of a chemical installation
Information:	The application of a post-construction chemical termite barrier is highly recommended for all properties, particularly if live termite activity has been found on the site previously. Such barriers are highly effective in preventing termite attack on any timber building elements throughout the property.

A durable notice should be placed in the switchboard unit to indicate current termite barriers. At the time of inspection, it appeared as though no termite management system has been installed, with no evidence to suggest preventative works taking place.

The client may consider gaining further advice from a pest controller as to the costs and procedures involved with this application. It is recommended that obtaining such advice be a short-term priority.
