Building and Timber Pest Inspection Report VR

Inspection Date: Tue, 17 Oct 2023

Property Address: 27 Mort Street, Surry Hills

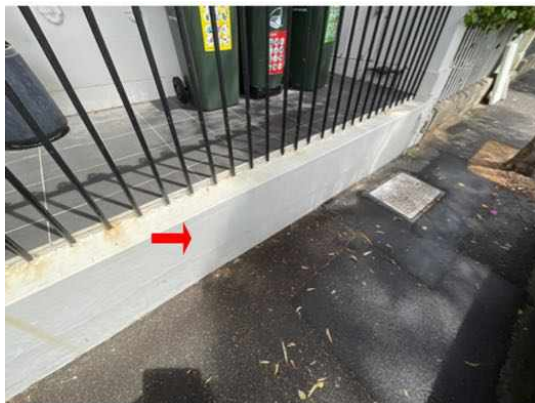
Finding 3.01

Building:	Main Building
Location:	Exterior walls
Finding:	Cracking - Damage Category 2 - Noticeable (up to 5mm)
Information:	Noticeable cracks are a common occurrence as a result of many primary defects. Such causes may include age, general wear and tear, expected building movement, general expansion/contraction of building materials in different weather conditions, and/or minor failings in the installation or application of building materials.

I recommend monitoring and if further cracking is evident appoint a bricklayer to see what works are required.

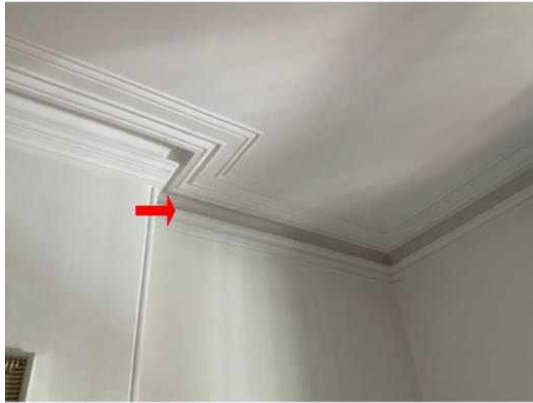
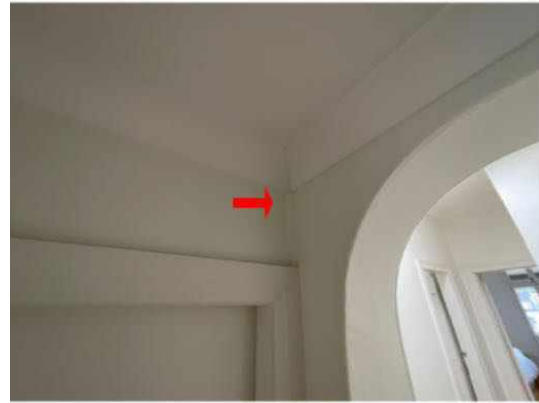
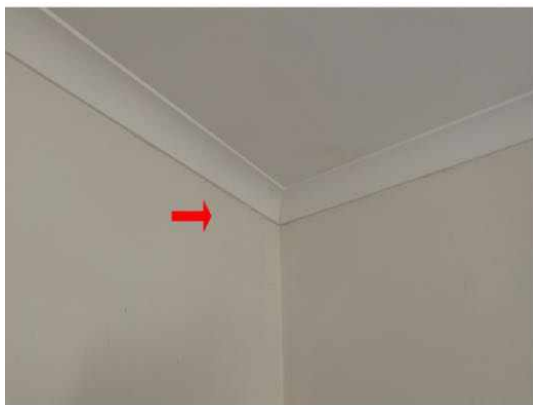
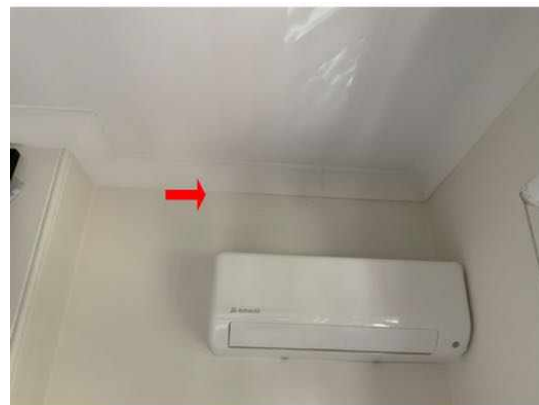
Finding 3.02

Building:	Main Building
Location:	Throughout
Finding:	Cracking - Damage Category 1 - Fine (up to 1mm)
Information:	Although fine cracks are quite noticeable, they are often only considered to be an appearance defect, and usually do not indicate any structural damage. Generally, the cause of a fine crack is indicative of a separation between building materials and finishes (e.g. paint, plaster, etc.) along joins.

Cracking of this nature can generally be repaired with minor sanding, filling and/or repainting. Such works should be performed by a qualified painter or a general handyman.

Monitoring of all cracking should be conducted frequently. Always contact a building inspector should cracks widen, lengthen, or become more numerous.

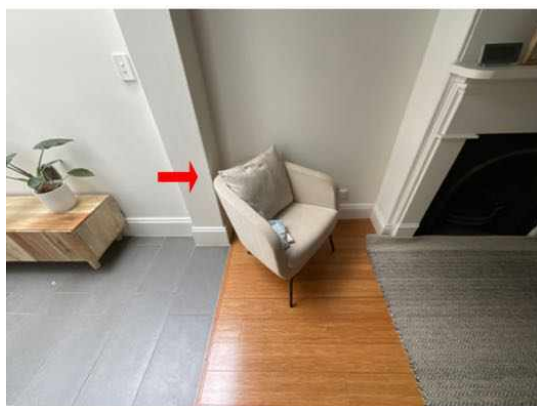
Finding 3.03

Building:	Main Building
Location:	Lounge Room
Finding:	Damp - Rising
Information:	Rising damp describes the upward movement of water in low sections of building elements (e.g. walls) by capillary action - the movement of water through porous materials such as bricks, sandstone or mortar.

Rising damp is generally managed by the installation of a damp proof course during construction. A Damp Proof Course (DPC) is an impermeable barrier at the base of the wall above ground level.

I recommend appointing a damp proofing specialist to see what necessary works are required.

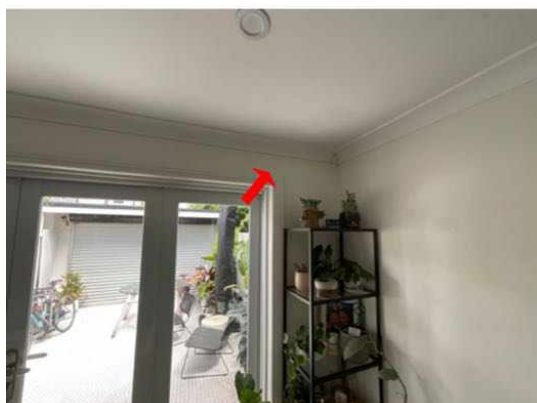
Finding 3.04

Building:	Main Building
Location:	Dining Room
Finding:	Damp - Rain penetration
Information:	Rain penetration (also known as penetrating damp) is a common form of dampness that can occur through walls, roofs or openings (e.g. windows).

Common causes include faulty or missing flashing, lack of sealant and lateral damp.

The cause of the water leak should be addressed to prevent further damage. It is recommended that the water leak be resolved prior to any repairs of the damaged area, which may require localised replacement of building materials and refinishing.

I recommend appointing a builder to see what necessary works are required.

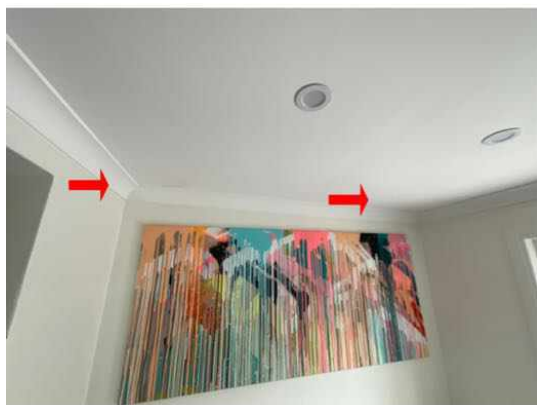
Finding 3.05

Building:	Main Building
Location:	Dining Room
Finding:	Ceiling - Water stained
Information:	Water staining to ceiling linings in this area was evident at the time of inspection. Water staining indicates that surfaces have been exposed to excessive moisture over time. The minerals and other elements in the water lead to staining, which may graduate to

corrosion and deterioration if left unmanaged.

Although there was no moisture detected in the ceiling I would recommend monitoring and acting on one of the following.

Where water staining is active, a licensed plumber must be consulted to identify the cause of the staining and to provide advice on any reparation works that may be required. Replacement of any damaged structures is advised.

Conversely, where water staining is old and inactive, affected building materials may be repaired or replaced at client discretion.

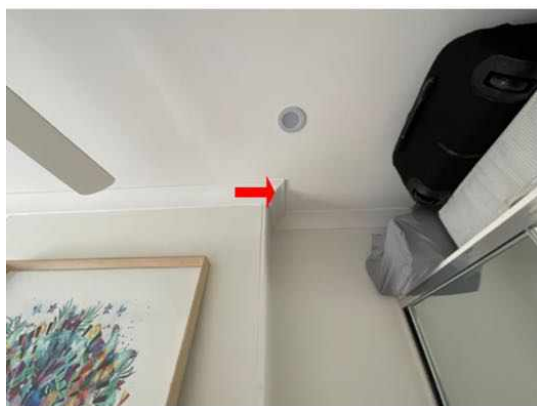
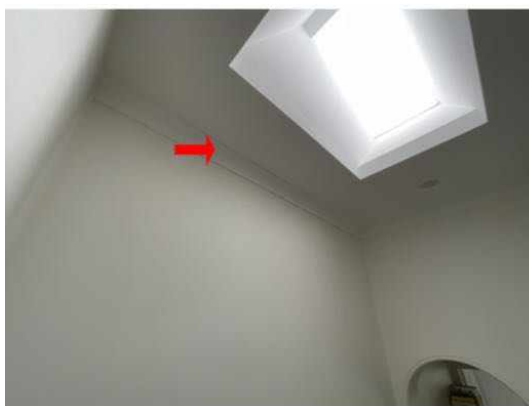
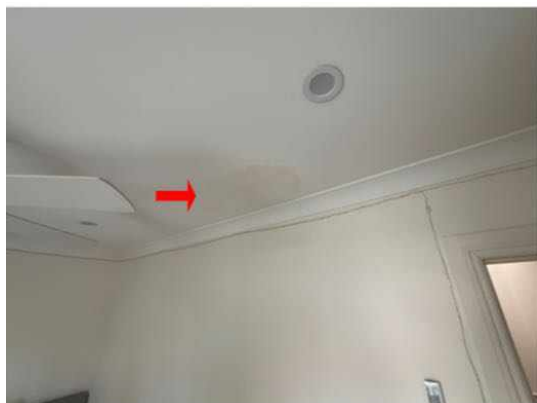
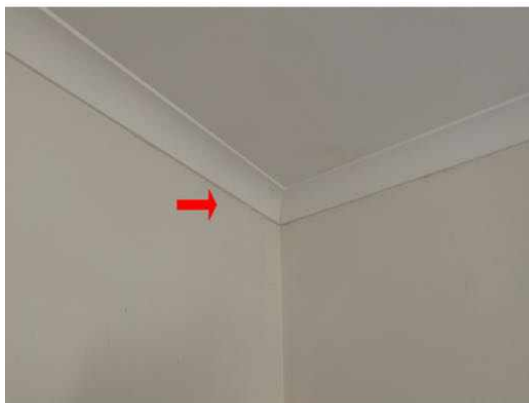
Finding 3.06

Building:	Main Building
Location:	Upstairs
Finding:	Ceiling - Water stained
Information:	Water staining to ceiling linings in this area was evident at the time of inspection. Water staining indicates that surfaces have been exposed to excessive moisture over time. The minerals and other elements in the water lead to staining, which may graduate to corrosion and deterioration if left unmanaged.

Although there was no moisture detected in the ceiling I would recommend monitoring and acting on one of the following.

Where water staining is active, a licensed plumber must be consulted to identify the cause of the staining and to provide advice on any reparation works that may be required. Replacement of any damaged structures is advised.

Conversely, where water staining is old and inactive, affected building materials may be repaired or replaced at client discretion.

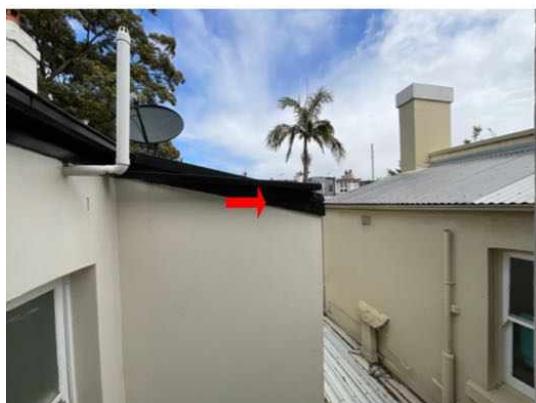
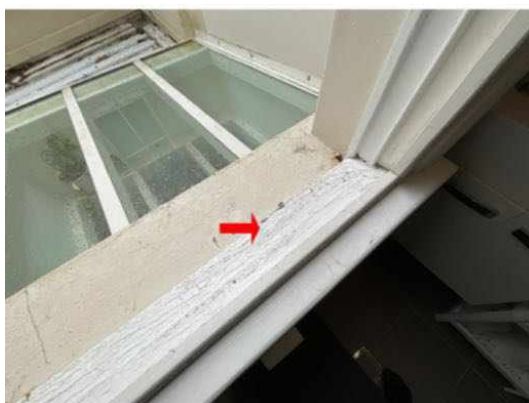
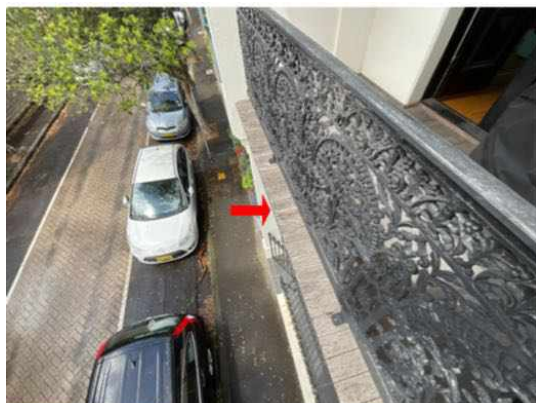
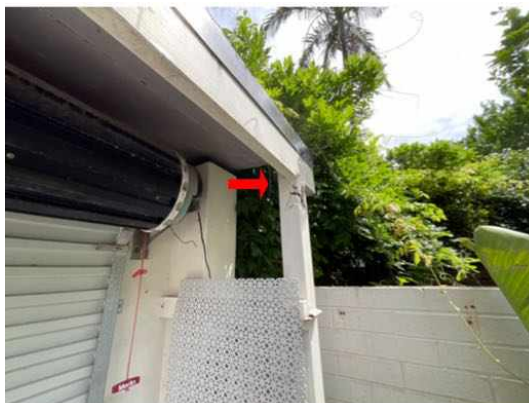
Finding 3.07

Building:	Main Building
Location:	External Areas
Finding:	Wood rot
Information:	This building element shows evidence of wood rot. Wood rot, also known as Fungal Decay, occurs when timbers and other cellulose building materials are exposed to damp conditions on an ongoing basis. This could be the result of exposure to weathering over a prolonged period of time, or the attraction of excessive moisture from other abutting building materials.

Early intervention and regular maintenance, particularly of exterior timbers, will prolong the useful life of these building elements. Prior to any works being performed, the cause of the moisture that has created the visible wood rot should be identified and addressed in a suitable manner. Replacement of affected timbers may then be a necessary step in protecting surrounding building elements from such deterioration.

A qualified carpenter or registered builder may also be required to replace affected building materials.

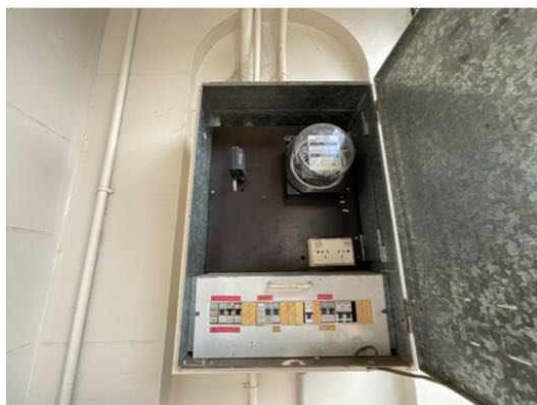
Finding 5.01

Building:	Main Building
Location:	All Areas
Finding:	Termite Management System - no evidence of a chemical installation
Information:	The application of a post-construction chemical termite barrier is highly recommended for all properties, particularly if live termite activity has been found on the site previously. Such barriers are highly effective in preventing termite attack on any timber building elements throughout the property.

A durable notice should be placed in the switchboard unit to indicate current termite barriers. At the time of inspection, it appeared as though no termite management system has been installed, with no evidence to suggest preventative works taking place.

The client may consider gaining further advice from a pest controller as to the costs and procedures involved with this application. It is recommended that obtaining such

advice be a short-term priority.

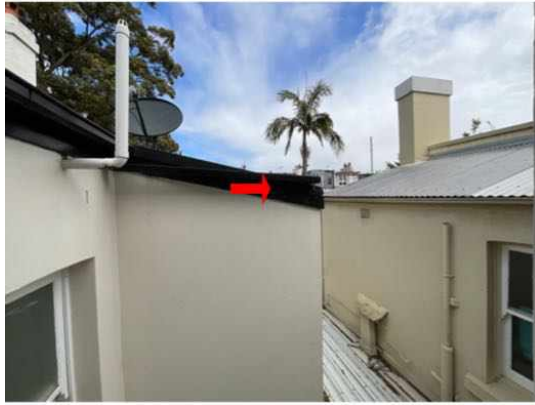
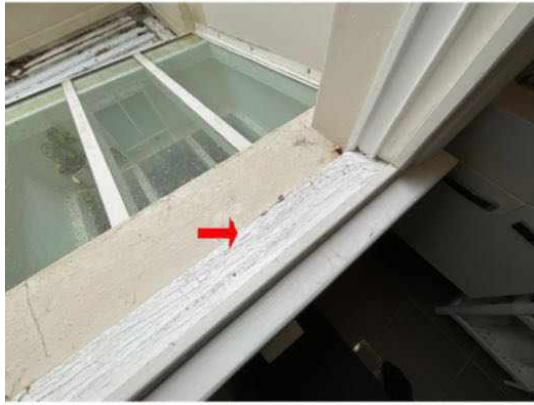
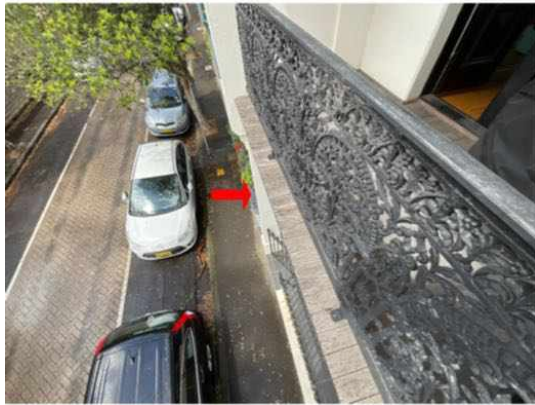
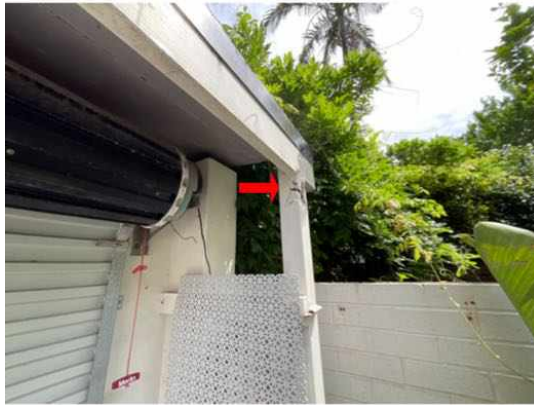
Finding 7.01

Building:	Main Building
Location:	External Areas
Finding:	Fungal decay - present (localised)
Information:	Fungal decay also known as wood decay or wood rot generally refers to the deterioration of timber elements when in contact with excessive levels of moisture for a prolonged period of time.

The development of fungal decay is accelerated by temperatures in the range of 5degreeC to 40degreeC as well as the presence of oxygen. Generally fungal decay develops on timber elements that are in use in an external environment which are exposed to rain penetration.

In this case although the affected timber element is in a decaying state the extent of any visible damage appears to be localised to a specific area and is yet to spread to other parts of the building element or affect adjoining structures. The fungal decay is therefore likely to be of a relatively superficial nature with minimal impact on the structural integrity or tensile strength of the timber element.
