Building and Timber Pest Inspection Report VR

Inspection Date: Sat, 7 Oct 2023

Property Address: 657 South Dowling Street, Surry Hills

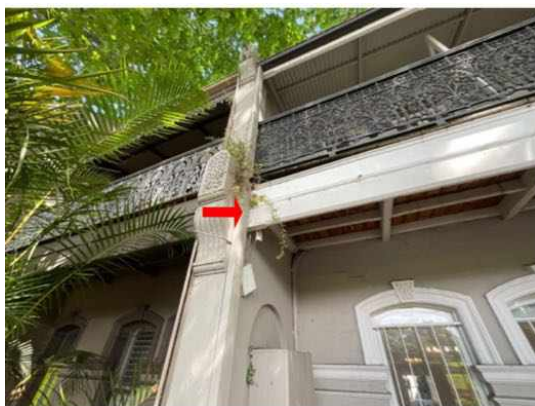
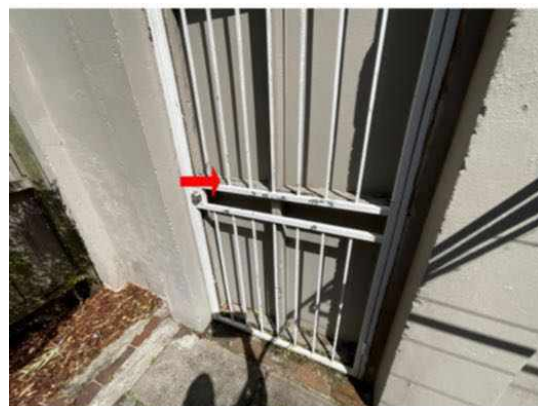
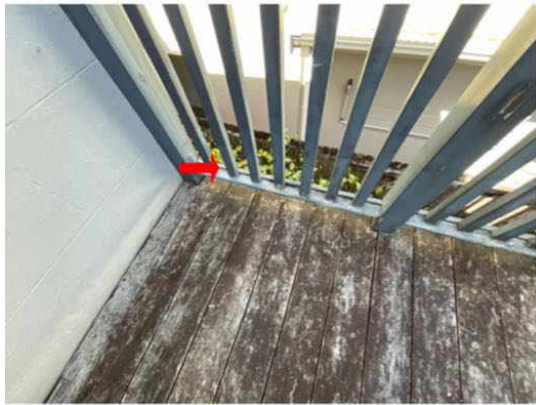
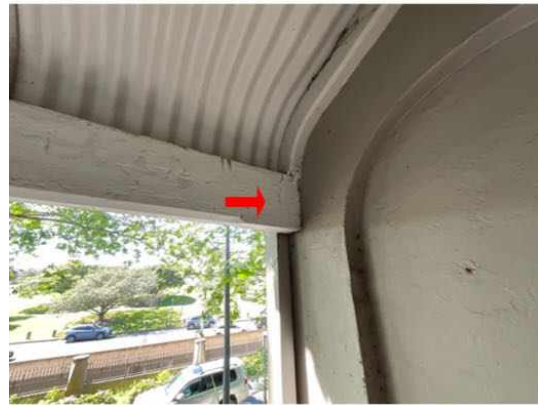
Finding 3.01

Building:	Main Building
Location:	External Areas
Finding:	Wood rot
Information:	This building element shows evidence of wood rot. Wood rot, also known as Fungal Decay, occurs when timbers and other cellulose building materials are exposed to damp conditions on an ongoing basis. This could be the result of exposure to weathering over a prolonged period of time, or the attraction of excessive moisture from other abutting building materials.

Early intervention and regular maintenance, particularly of exterior timbers, will prolong the useful life of these building elements. Prior to any works being performed, the cause of the moisture that has created the visible wood rot should be identified and addressed in a suitable manner. Replacement of affected timbers may then be a necessary step in protecting surrounding building elements from such deterioration.

A qualified carpenter or registered builder may also be required to replace affected building materials.

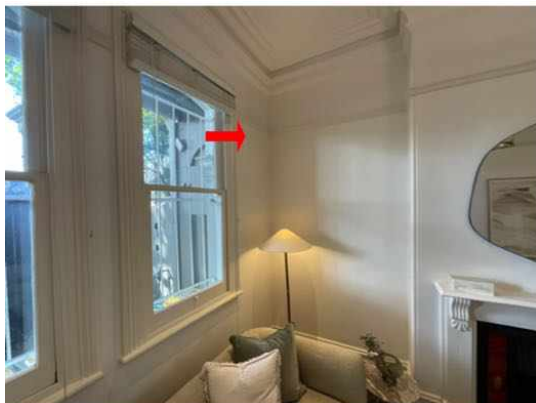
Finding 3.02

Building:	Main Building
Location:	Lounge Room
Finding:	Damp - Rain penetration
Information:	Rain penetration (also known as penetrating damp) is a common form of dampness that can occur through walls, roofs or openings (e.g. windows).

Common causes include faulty or missing flashing, lack of sealant and lateral damp.

The cause of the water leak should be addressed to prevent further damage. It is recommended that the water leak be resolved prior to any repairs of the damaged area, which may require localised replacement of building materials and refinishing.

I recommend appointing a builder to see what necessary works are required.

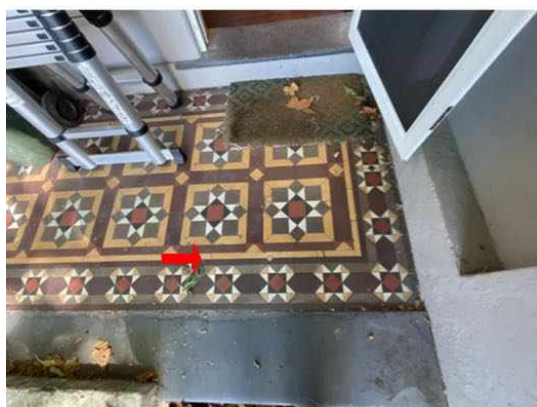
Finding 3.03

Building:	Main Building
Location:	Front Porch
Finding:	Tile - Cracked or damaged
Information:	Cracking was evident to the tiling in this area at the time of inspection.

I recommend appointing a tiling contractor to see what necessary works are required

to replace any damaged tiles.

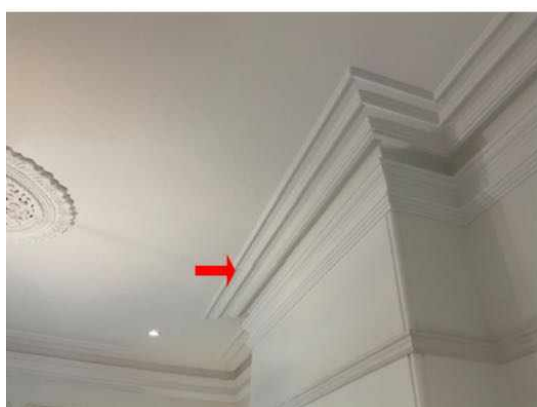
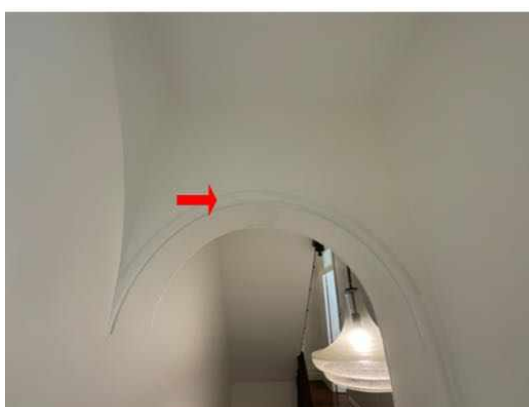
Finding 3.04

Building:	Main Building
Location:	Throughout
Finding:	Cracking - Damage Category 1 - Fine (up to 1mm)
Information:	Although fine cracks are quite noticeable, they are often only considered to be an appearance defect, and usually do not indicate any structural damage. Generally, the cause of a fine crack is indicative of a separation between building materials and finishes (e.g. paint, plaster, etc.) along joins.

Cracking of this nature can generally be repaired with minor sanding, filling and/or repainting. Such works should be performed by a qualified painter or a general handyman.

Monitoring of all cracking should be conducted frequently. Always contact a building inspector should cracks widen, lengthen, or become more numerous.

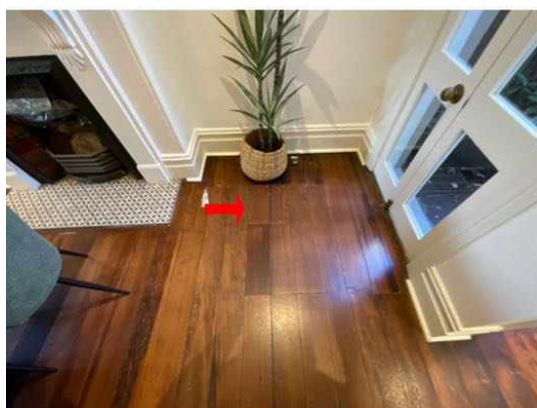
Finding 3.05

Building:	Main Building
Location:	Dining Room

Bouncy floors generally indicate that the floorboards or the subfloor structures are coming loose from the joists that they are installed on. Bouncy flooring may also be the result of gaps between flooring and joist structures, which require packing.

The client is advised to seek quotations for required repairs from a Registered Builder.

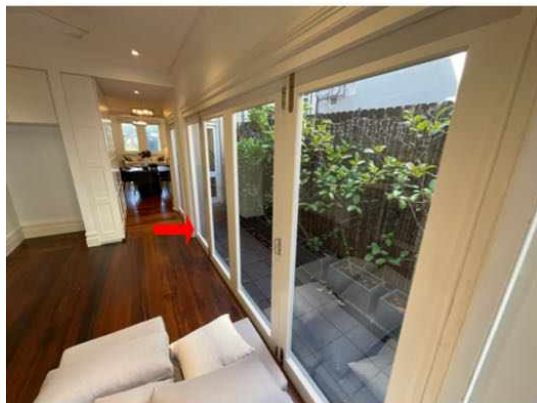
Finding 3.06

Building: Main Building
 Location: Kitchen
 Finding: Door - Stiff to slide
 Information: The door in this area was jammed and difficult to slide along the associated tracks at the time of the inspection.

Generally, factors such as general age of the building element and a lack of maintenance are the usual causes for this type of defect.

Replacement of door hardware or tracks may be required, as well as minor repairs and cleaning. A registered builder or general handy person will be required to repair the affected doors.

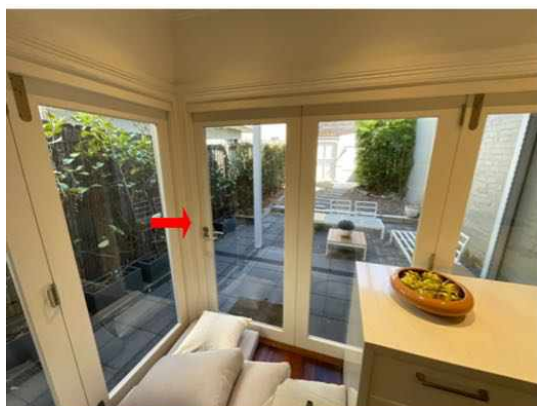
Finding 3.07

Building: Main Building
 Location: Kitchen
 Finding: Door - Binding/jamming
 Information: Binding and/or jamming of this door is evident during standard operation. This defect inhibits the functionality of the affected door as well as creating potential for secondary defects to associated building elements, such as damage to the floor covering.

For minor causes, a qualified carpenter or general handyperson should be appointed to perform minor rectification works at client discretion.

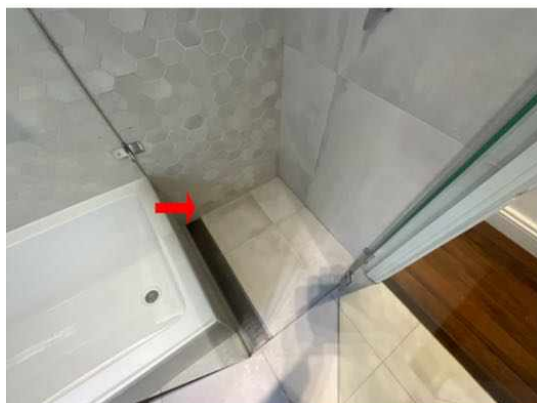
Finding 3.08

Building: Main Building
 Location: Bathroom
 Finding: Sealant and grouting - Missing or damaged
 Information: It was noted on inspection that sealant or grout is degraded to the tiled areas.

Different materials and floor areas move at different rates, generally causing cracking to grout or sealant at this point. A flexible sealant is required to allow for expected expansion and contraction, while keeping the joint water tight and protective of all associated building materials.

Flexible and mould resistant materials should be applied to affected areas to prevent any subsequent water damage that is likely to occur. Regular maintenance and replacement of damage or missing or damaged sealant and grout is highly recommended to the wet areas, as this is a regular wear and tear defect. Sealant and grouting in areas that come into regular contact with water should be maintained for the long term care of your property.

A sealant specialist or tiling contractor should be appointed to complete these works.

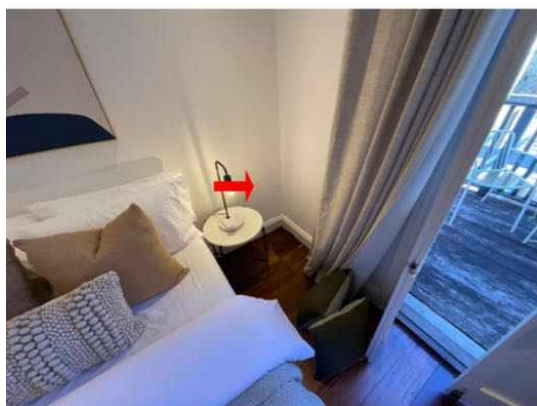
Finding 3.09

Building:	Main Building
Location:	Bedroom
Finding:	Damp - Rain penetration
Information:	Rain penetration (also known as penetrating damp) is a common form of dampness that can occur through walls, roofs or openings (e.g. windows).

Common causes include faulty or missing flashing, lack of sealant and lateral damp.

The cause of the water leak should be addressed to prevent further damage. It is recommended that the water leak be resolved prior to any repairs of the damaged area, which may require localised replacement of building materials and refinishing.

I recommend appointing a builder to see what necessary works are required.

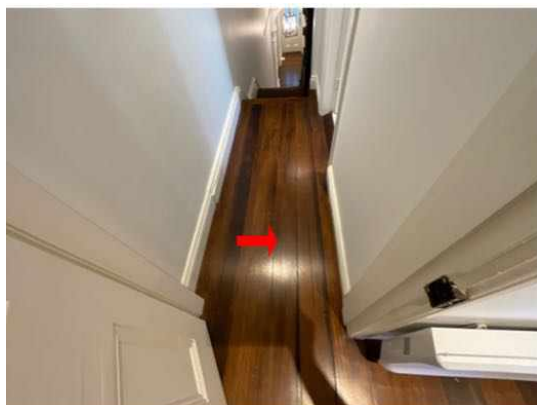
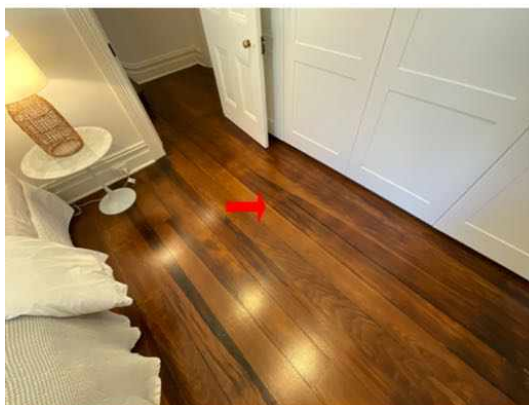
Finding 3.10

Building:	Main Building
Location:	Upstairs
Finding:	Nails - Popping
Information:	Popped nails were identified at the time of inspection. Nails and screws are held by the friction between them and the surface that they are applied to. Over time, the nails and screws can back out, which is often a result of general ageing and deterioration of the building structure.

Re-fastening of popped nails will help to maintain the stability of these, and associated, building elements. Such minor works will also help to improve the appearance of the affected area and secure the linings. These works should be performed by a qualified carpenter at client discretion.

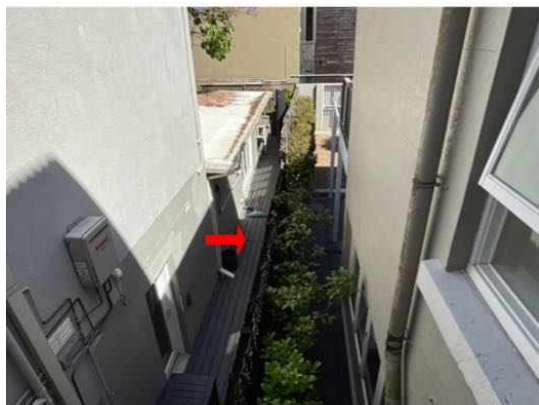
Finding 3.11

Building:	Yard
Location:	Fencing
Finding:	Fencing - Deteriorated
Information:	It was noted at the time of inspection that sections of the fencing throughout the property have deteriorated. Typically fencing deteriorates due to age and or wear, rot and or rust which is generally expected for a structure of this age, due to prolonged

exposure to weather conditions. Sometimes inadequate installation or maintenance can be to blame.

If left unattended, it is likely that further damage will occur. It is suspected that repair of several elements of the fencing may be required however replacement may be a consideration of the client also.

A licensed fencing contractor should be appointed to provide further advice and perform rectification works as necessary.

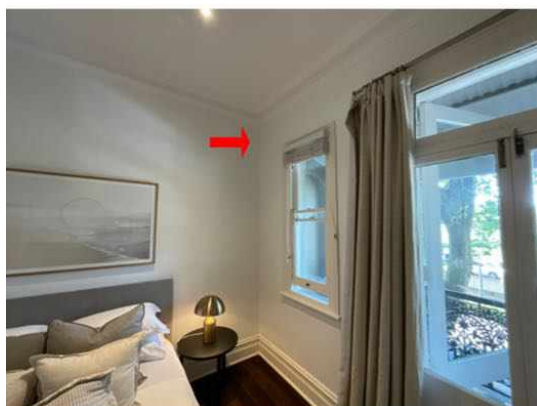
Finding 3.12

Building:	Main Building
Location:	Bedroom 2
Finding:	Damp - Rain penetration
Information:	Rain penetration (also known as penetrating damp) is a common form of dampness that can occur through walls, roofs or openings (e.g. windows).

Common causes include faulty or missing flashing, lack of sealant and lateral damp.

The cause of the water leak should be addressed to prevent further damage. It is recommended that the water leak be resolved prior to any repairs of the damaged area, which may require localised replacement of building materials and refinishing.

I recommend appointing a builder to see what necessary works are required.

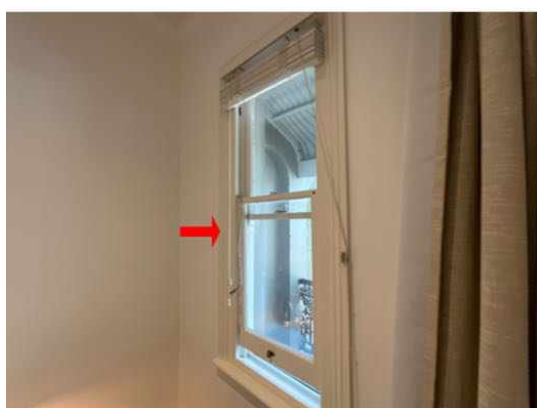
Finding 3.13

Building:	Main Building
Location:	Window
Finding:	Windows - Sash cords missing
Information:	Sashes are the moveable panes of windows that primarily slide vertically over each other to expose one half of the window area. Each sash is provided with springs balances and/or compression weather-stripping, which act to hold the window in place in one position.

To facilitate this operation the weight of the glazed panel is usually balanced by steel weights or counterbalances. The sash weight is connected by a cord or chain that runs over a pulley at the top of the frame. These cords are prone to degradation over time and replacement is required.

Repairing or replacing sash cords involves some work and is often best completed by an experienced carpenter or specialist window restorer. It is advised that such works be completed to improve the operational state of the affected window.

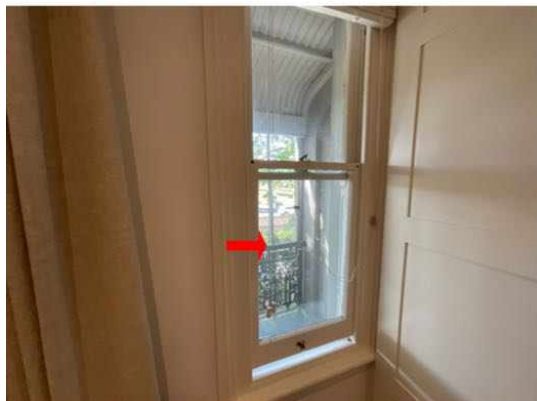
Finding 3.14

Building:	Main Building
Location:	Window

Finding: Glass - Cracked
Information: Cracks were identified in the glass in this area. Cracking in glass is generally the result of impact damage, and is likely to develop further when left unmanaged.

A qualified glazier is required to repair the glass.

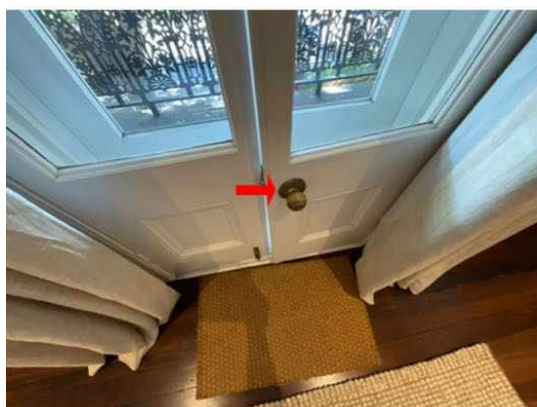
Finding 3.15

Building: Main Building
Location: Bedroom 2
Finding: Fitting or fixture - Loose (Door Handle)
Information: The fitting in this area is loose and requires adjustment to tighten.

If left unmanaged, the fitting may further deteriorate, causing potential for the development of other minor secondary defects.

A relevant tradesperson should be appointed to perform these rectification works at discretion of the client.

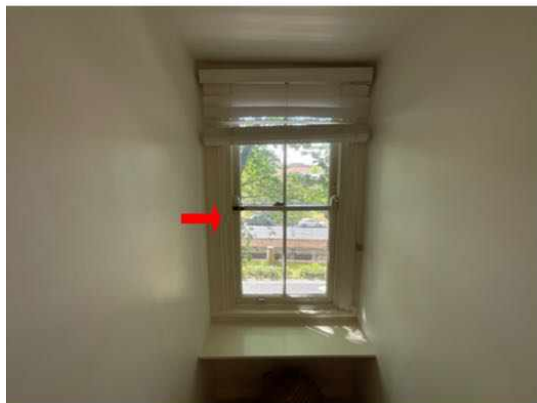
Finding 3.16

Building: Main Building
Location: Window

Finding: Windows - Sash balances broken

Information: Sashes are the moveable panes of windows that primarily slide vertically over each other to expose one half of the window area. Each sash is provided with springs balances and/or compression weather-stripping, which act to hold the window in place in one position.

The sash balance mechanism will need replacement to allow the window to function as intended. Such works may be completed by a qualified carpenter or registered builder.

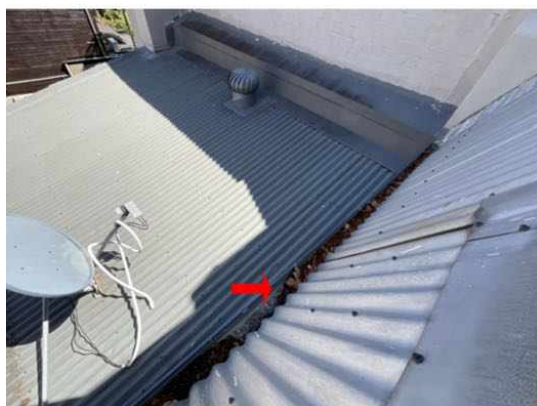
Finding 3.17

Building: Main Building

Blocked gutters are likely to lead to high levels of moisture in the affected areas. Such moisture will not only cause rust and decay of the associated building materials, but can also provide conditions that are conducive to termite and timber pest activity. Blockages in gutters should therefore be removed to ensure dry conditions are maintained.

Consult a Licensed Plumber for further specific advice on remedial works that may be required. In the interim, it is highly advised that blocked gutters be removed by the homeowner or a general handyperson as a matter of urgency.

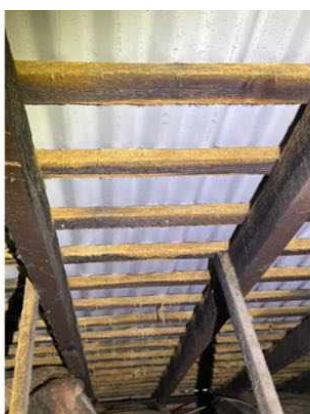
Finding 3.18

Building:	Main Building
Location:	Roof Void
Finding:	Chemical delignification identified
Information:	Chemical delignification also known as wood defibration refers to the chemical breakdown of timber building elements. This breakdown of the Lignin deteriorates the wood impacting on the structural integrity and tensile strength of the affected building element.

Chemical delignification is most common near marine environments due to the high levels of salt in the air however this deterioration may also occur in other areas where timber elements are frequently exposed to damaging gases chemicals etc.

I recommend appointing a roofing contractor to see what necessary works are required.

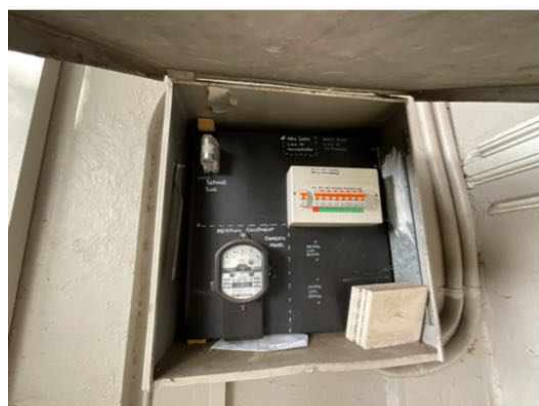
Building:	Main Building
Location:	All Areas
Finding:	Termite Management System - no evidence of a chemical installation
Information:	The application of a post-construction chemical termite barrier is highly recommended for all properties, particularly if live termite activity has been found on the site previously. Such barriers are highly effective in preventing termite attack on any timber building elements throughout the property.

A durable notice should be placed in the switchboard unit to indicate current termite barriers. At the time of inspection, it appeared as though no termite management system has been installed, with no evidence to suggest preventative works taking place.

The client may consider gaining further advice from a pest controller as to the costs and procedures involved with this application. It is recommended that obtaining such advice be a short-term priority.

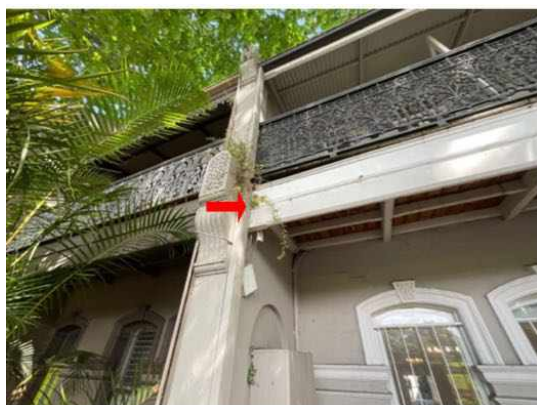
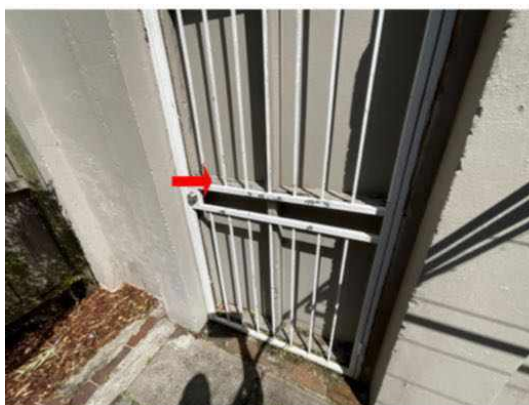
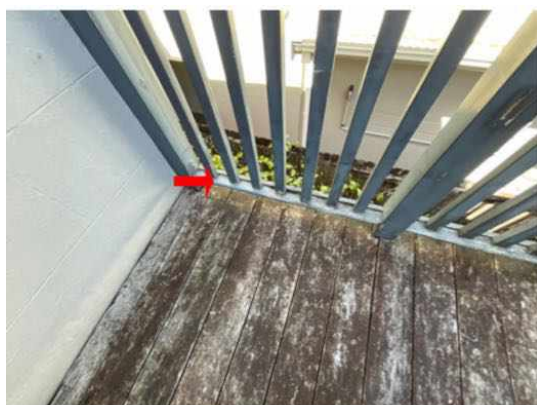
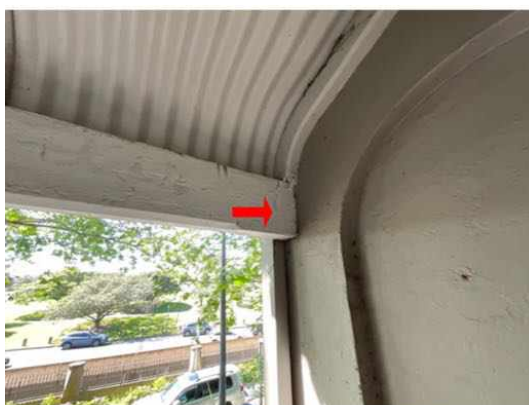
Finding 7.01

Building:	Main Building
Location:	External Areas
Finding:	Fungal decay - present (localised)
Information:	Fungal decay also known as wood decay or wood rot generally refers to the deterioration of timber elements when in contact with excessive levels of moisture for a prolonged period of time.

The development of fungal decay is accelerated by temperatures in the range of 5degreeC to 40degreeC as well as the presence of oxygen. Generally fungal decay develops on timber elements that are in use in an external environment which are exposed to rain penetration.

In this case although the affected timber element is in a decaying state the extent of any visible damage appears to be localised to a specific area and is yet to spread to other parts of the building element or affect adjoining structures. The fungal decay is therefore likely to be of a relatively superficial nature with minimal impact on the structural integrity or tensile strength of the timber element.

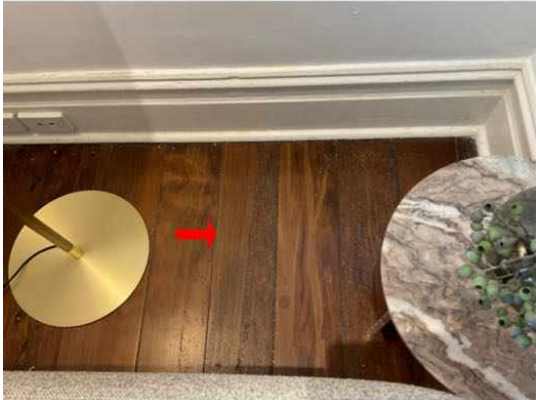
Finding 8.01

structures is generally identified by a fine dust surrounding the affected timbers.

As no live wood borer activity was identified treatment is not required at this time.
