Building and Timber Pest Inspection Report VR

Inspection Date: Tue, 30 Jan 2024

Property Address: 13A Meagher St, Chippendale NSW 2008,
Australia

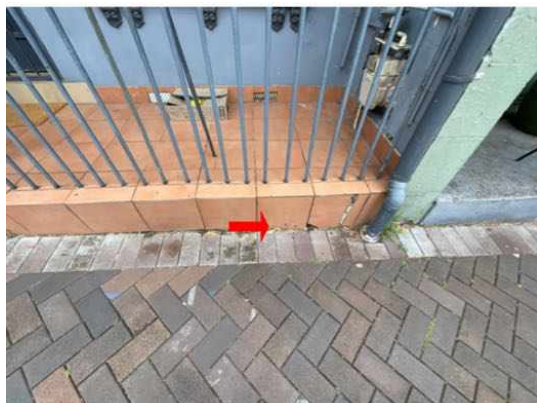
Finding 3.01

Building:	Main Building
Location:	Front Porch
Finding:	Tile - Cracked or damaged
Information:	Cracking was evident to the tiling in this area at the time of inspection. I recommend appointing a tiling contractor to see what necessary works are required to replace any damaged tiles.

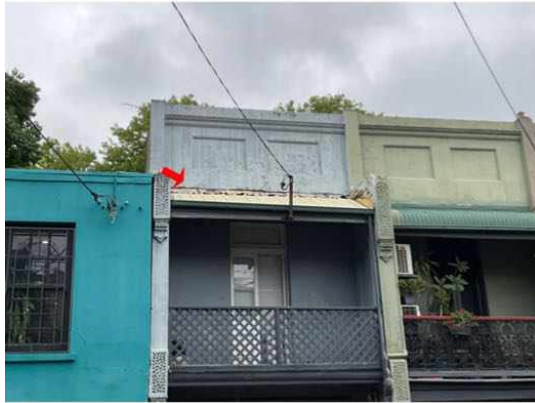
Finding 3.02

Building:	Main Building
Location:	Roof Exterior
Finding:	Roof plumbing - Loose flashing
Information:	Metal and other material flashings are applied to seals and intersections between roof coverings and building elements. They are designed to aid in weatherproofing of roof joins, and require regular inspection and maintenance as they are more subject to rust-related deterioration.

The flashing in this section of the exterior roofing appears to have come loose from its original fixing. It is suspected that this minor defect has occurred as a result of general deterioration over time.

Re-fixing and potential replacement of certain areas of flashing is advised to promote adequate roof drainage and protection from water penetration. Failure to perform these works may result in water damage and accelerated deterioration of associated building elements.

A roofing contractor or roofing plumber should be appointed to restore the flashing to a fully operational state.

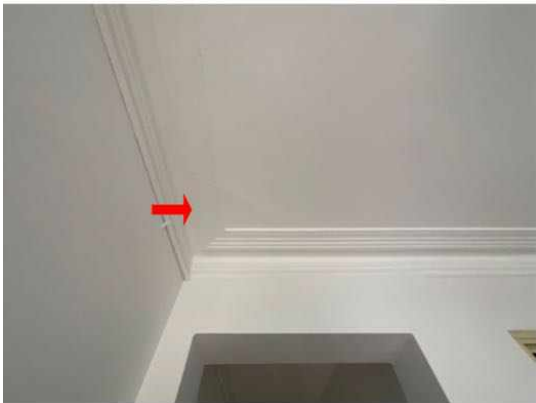
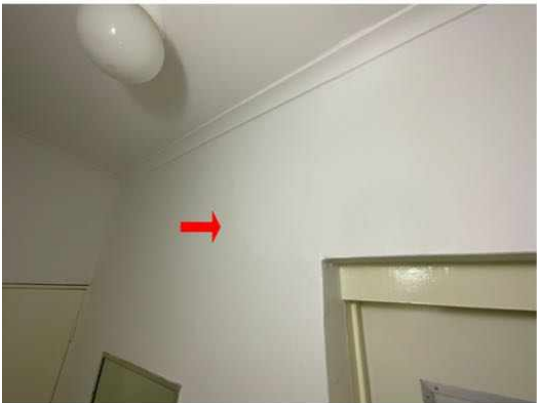
Finding 3.03

Building:	Main Building
Location:	Throughout
Finding:	Cracking - Damage Category 1 - Fine (up to 1mm)
Information:	Although fine cracks are quite noticeable, they are often only considered to be an appearance defect, and usually do not indicate any structural damage. Generally, the cause of a fine crack is indicative of a separation between building materials and finishes (e.g. paint, plaster, etc.) along joins.

Cracking of this nature can generally be repaired with minor sanding, filling and/or repainting. Such works should be performed by a qualified painter or a general handyman.

Monitoring of all cracking should be conducted frequently. Always contact a building inspector should cracks widen, lengthen, or become more numerous.

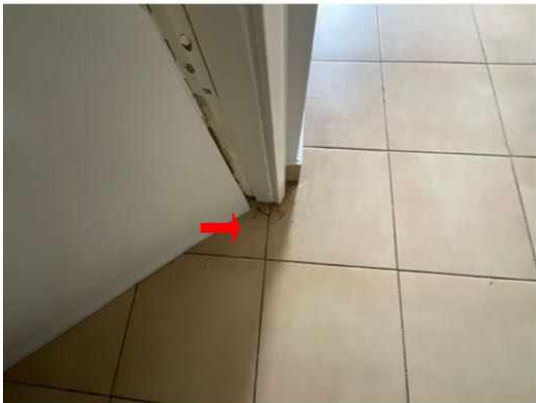
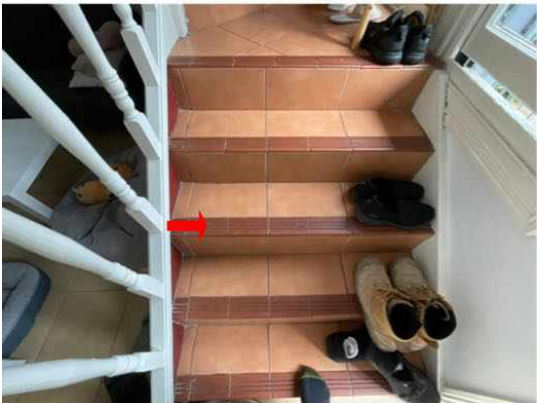
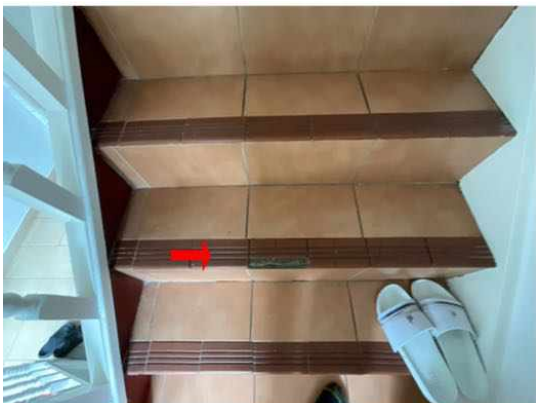
Finding 3.04

Building: Main Building
Location: Hallway, Internal Stairs
Finding: Tile - Cracked or damaged
Information: Cracking was evident to the tiling in this area at the time of inspection.

I recommend appointing a tiling contractor to see what necessary works are required to replace any damaged tiles.

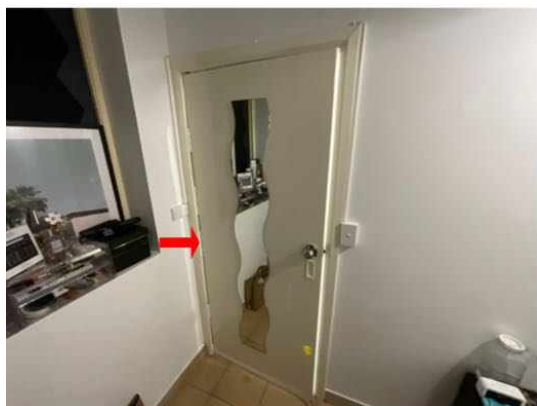
Finding 3.05

Building: Main Building
Location: Bedroom
Finding: Door - Binding/jamming
Information: Binding and/or jamming of this door is evident during standard operation. This defect inhibits the functionality of the affected door as well as creating potential for secondary defects to associated building elements, such as damage to the floor covering.

For minor causes, a qualified carpenter or general handyperson should be appointed to perform minor rectification works at client discretion.

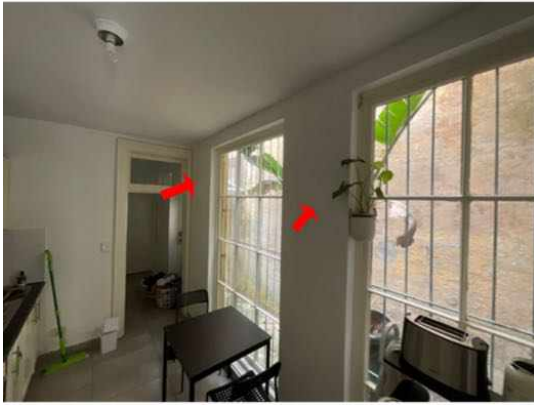
Finding 3.06

Building: Main Building
Location: Kitchen
Finding: Interior walls - Lateral damp
Information: Lateral penetrating damp refers to the sideways movement of moisture. The implications of unmanaged damp range from mould fungi growth, wood rot and decaying building materials, to finishes including lifting, bubbling, peeling and staining of paint, plaster and wallpaper.

Structural waterproofing barriers or tanking barriers are often used to protect internal surfaces against the affects of lateral penetrating dampness. These types of work are generally undertaken where the source of the penetrating damp cannot be prevented.

Consultation with a damp proofing contractor is advised to address the cause of the damp and to perform remedial works as necessary.

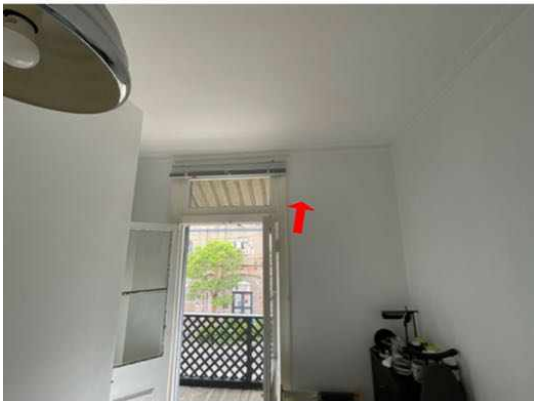
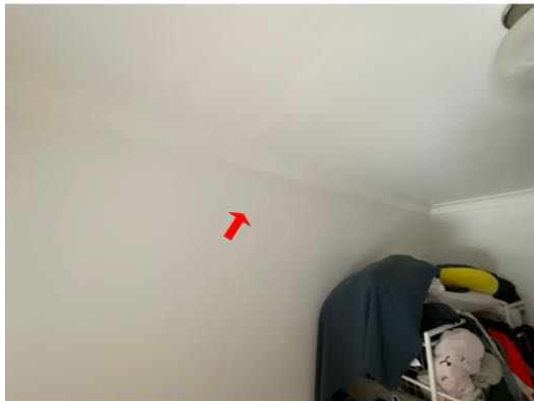
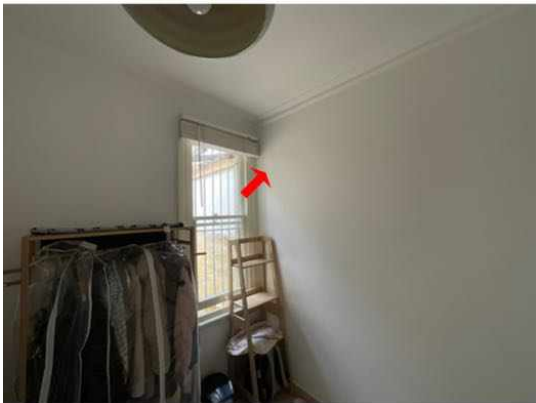
Finding 3.07

Building: Main Building
 Location: Upstairs
 Finding: Damp - Rain penetration
 Information: Rain penetration (also known as penetrating damp) is a common form of dampness that can occur through walls, roofs or openings (e.g. windows).

Common causes include faulty or missing flashing, lack of sealant and lateral damp.

The cause of the water leak should be addressed to prevent further damage. It is recommended that the water leak be resolved prior to any repairs of the damaged area, which may require localised replacement of building materials and refinishing.

I recommend appointing a builder to see what necessary works are required.

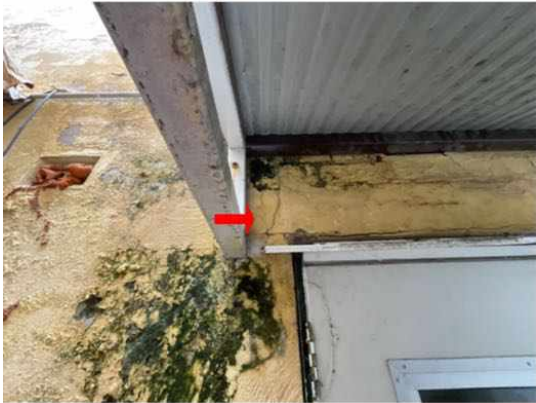
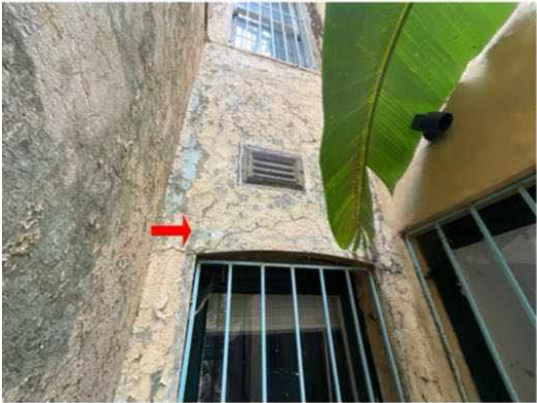
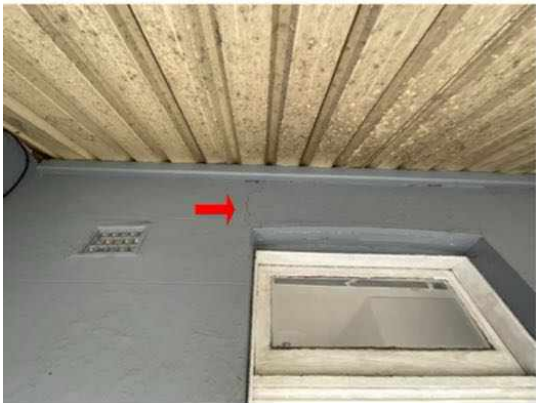
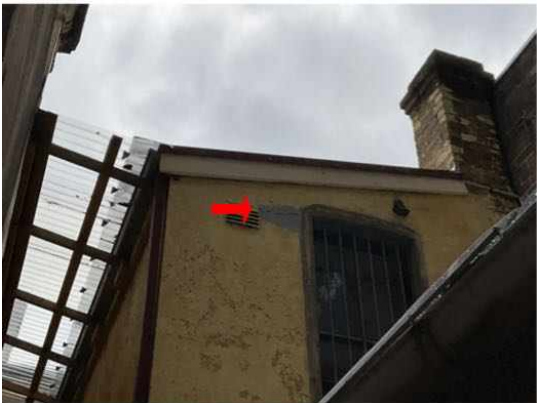
Finding 3.08

Building: Main Building
 Location: Exterior walls
 Finding: Cracking - Damage Category 2 - Noticeable (up to 5mm)
 Information: Noticeable cracks are a common occurrence as a result of many primary defects. Such causes may include age, general wear and tear, expected building movement, general expansion/contraction of building materials in different weather conditions, and/or minor failings in the installation or application of building materials.

I recommend monitoring and if further cracking is evident appoint a bricklayer to see what works are required.

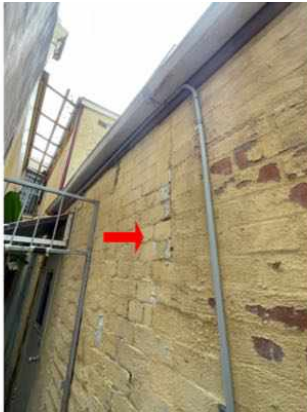
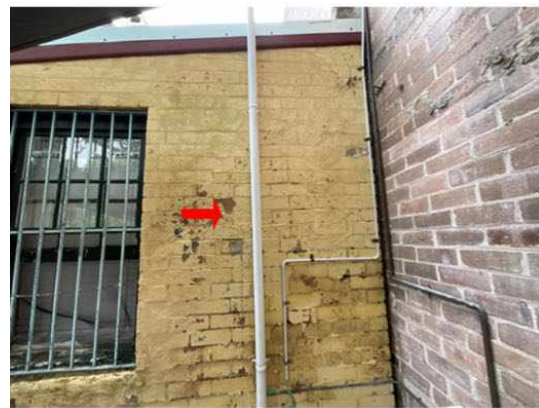
Finding 3.09

Building:	Main Building
Location:	Exterior walls
Finding:	Brickwork - Cracking noticeable
Information:	There were several cracks and or crack repairs evident to external brickwork.

Noticeable cracks are a common occurrence in external brickwork and are a likely result of age expected building movement, general expansion, and/or contraction of building materials in different weather conditions.

It is highly advised that a qualified bricklayer be appointed to provide necessary works to cracked brickwork to prevent any further damage.

Always monitor these cracks and contact a building inspector should cracks widen, lengthen, or become more numerous.

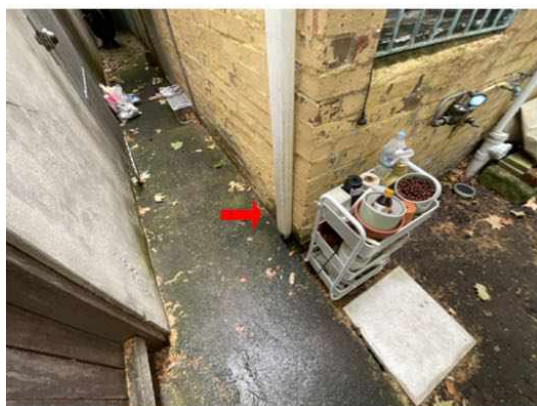
Finding 3.10

Building:	Main Building
Location:	Exterior walls
Finding:	Stormwater drain - Not connected
Information:	The roof plumbing is not adequately connected to stormwater drainage on the site. This disconnection negatively impacts the functional capacity of the roof plumbing.

Where roof plumbing doesn't drain adequately, the area at the base perimeter can become excessively damp, potentially creating an environment that is susceptible to rust and corrosion of surrounding building elements, as well as attracting termites and other pests.

It is highly recommended that a plumber be appointed to further inspect the area and to install adequate drainage equipment where necessary.

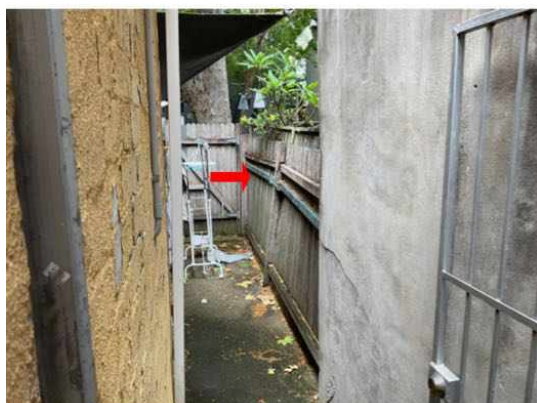
Finding 3.11

Building:	Yard
Location:	Yard - Back
Finding:	Fencing - Deteriorated
Information:	It was noted at the time of inspection that sections of the fencing throughout the property have deteriorated. Typically fencing deteriorates due to age and or wear, rot and or rust which is generally expected for a structure of this age, due to prolonged exposure to weather conditions. Sometimes inadequate installation or maintenance can be to blame.

If left unattended, it is likely that further damage will occur. It is suspected that repair of several elements of the fencing may be required however replacement may be a consideration of the client also.

A licensed fencing contractor should be appointed to provide further advice and perform rectification works as necessary.

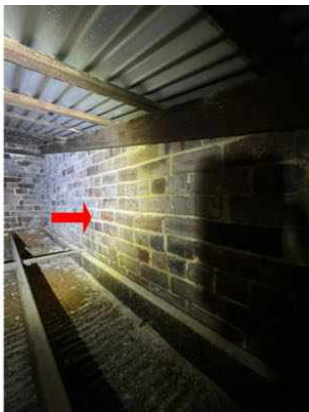
Finding 3.12

Building:	Main Building
Location:	Roof Void
Finding:	Brickwork - Deteriorated mortar

Information: Mortar, or 'bedding', is the material which fills joins and intersections between bricks in masonry walls and structures. Sections of mortar in this brickwork were identified as having deteriorated.

Mortar deterioration can be addressed by a bricklayer.

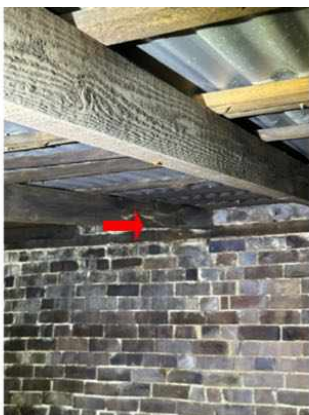
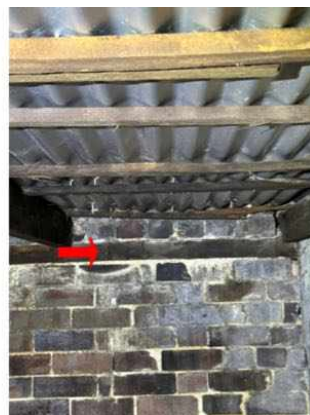
Finding 5.01

Building: Main Building
 Location: Roof Void
 Finding: Termite - damage identified
 Information: Despite no live termite or timbered pest activity being indicated, termite damage was found to have affected this area.

A building contractor should be appointed to provide a further invasive inspection and to see what necessary works are required.

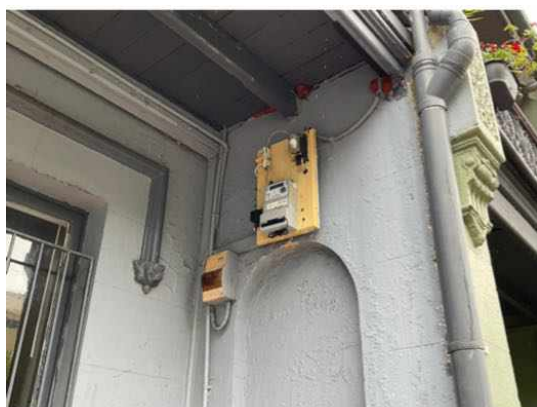
Finding 6.01

Building:	Main Building
Location:	All Areas
Finding:	Termite Management System - no evidence of a chemical installation
Information:	The application of a post-construction chemical termite barrier is highly recommended for all properties, particularly if live termite activity has been found on the site previously. Such barriers are highly effective in preventing termite attack on any timber building elements throughout the property.

A durable notice should be placed in the switchboard unit to indicate current termite barriers. At the time of inspection, it appeared as though no termite management system has been installed, with no evidence to suggest preventative works taking place.

The client may consider gaining further advice from a pest controller as to the costs and procedures involved with this application. It is recommended that obtaining such advice be a short-term priority.

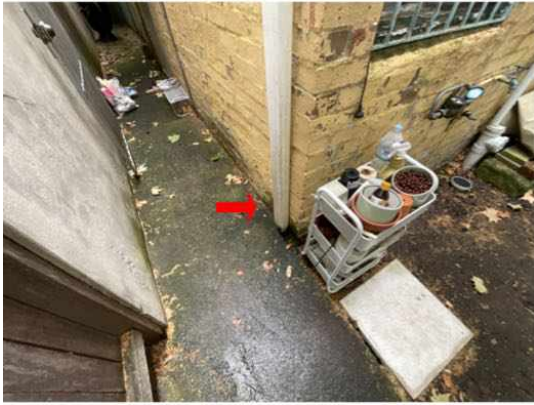
Finding 6.02

Building:	Main Building
Location:	Exterior walls
Finding:	Excessive moisture - identified
Information:	Excessive moisture can attract termites and produce conditions that promote fungal growth and wood decay.

Prior to any remedial works being performed a qualified plumber should be appointed to further inspect the property and to identify the cause of the excessive moisture.

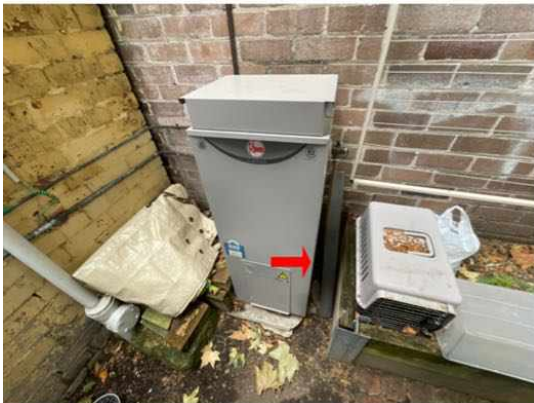
Finding 6.03

Building: Yard
 Location: Yard - Back
 Finding: HWS Overflow - Not Connected
 Information: The Hot Water System (HWS) overflow was found to be disconnected from storm water drainage and is creating excessive moisture in the surrounding area.

It is highly recommended that a licensed plumber be appointed to connect the HWS overflow in order to prevent such an environment from being created.
