Building and Timber Pest Inspection Report VR

Inspection Date: Fri, 12 Apr 2024

Property Address: 2 Windeyer St, Woolloomooloo NSW 2011,
Australia

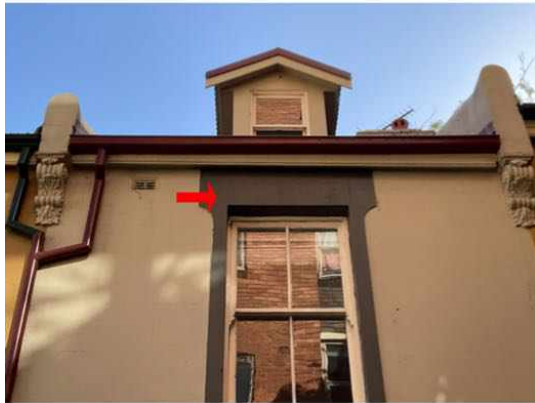
Finding 3.01

Building:	Main Building
Location:	Exterior walls
Finding:	Cracking - Damage Category 2 - Noticeable (up to 5mm)
Information:	Noticeable cracks are a common occurrence as a result of many primary defects. Such causes may include age, general wear and tear, expected building movement, general expansion/contraction of building materials in different weather conditions, and/or minor failings in the installation or application of building materials.

I recommend monitoring and if further cracking is evident appoint a bricklayer to see what works are required.

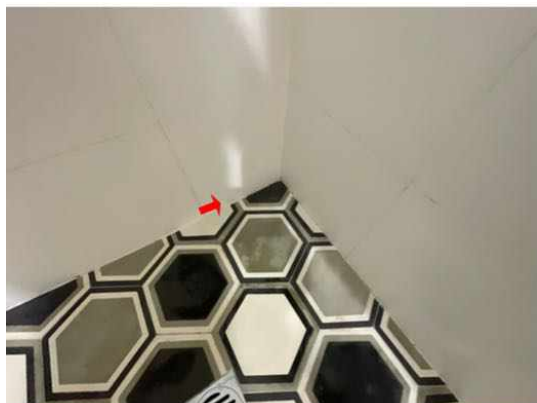
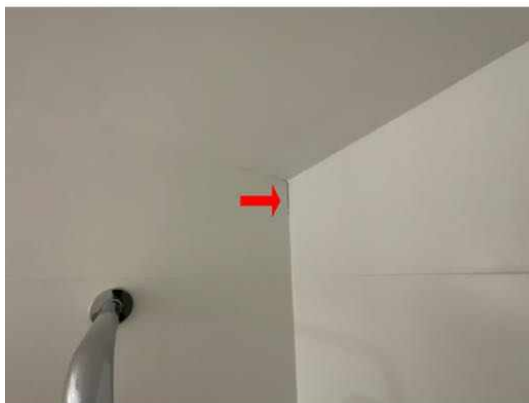
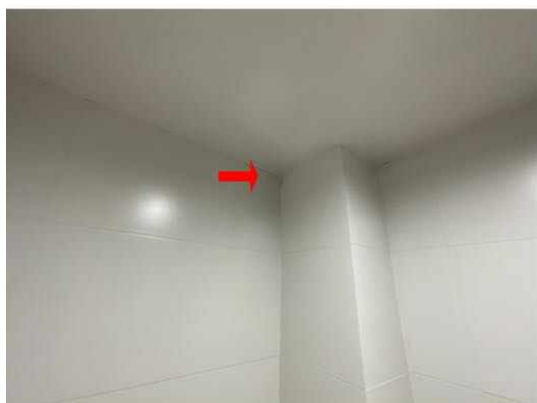
Finding 3.02

Building:	Main Building
Location:	Bathroom
Finding:	Sealant - Deteriorated
Information:	The sealant in this area has deteriorated. Sealant is used to seal between two building materials to make the area water tight.

I recommend appointing a handyman to see what necessary works are required.

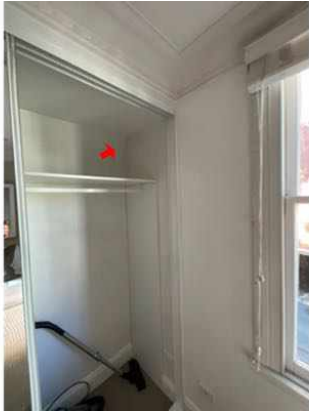
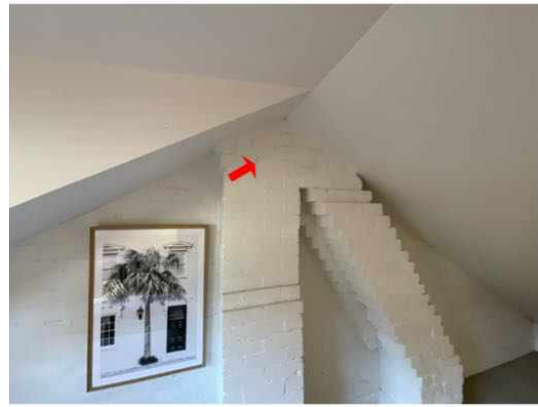
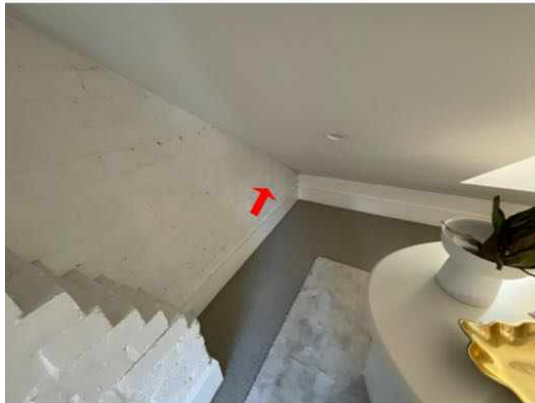
Finding 3.03

Building:	Main Building
Location:	Bedroom 1 & 3
Finding:	Damp - Rain penetration
Information:	Rain penetration (also known as penetrating damp) is a common form of dampness that can occur through walls, roofs or openings (e.g. windows).

Common causes include faulty or missing flashing, lack of sealant and lateral damp.

The cause of the water leak should be addressed to prevent further damage. It is recommended that the water leak be resolved prior to any repairs of the damaged area, which may require localised replacement of building materials and refinishing.

I recommend appointing a builder to see what necessary works are required.

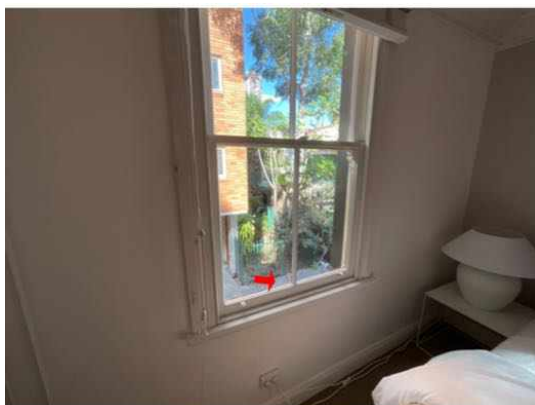
Finding 3.04

Location: Bedroom

Finding: Glass - Cracked

Information: Cracks were identified in the glass in this area. Cracking in glass is generally the result of impact damage, and is likely to develop further when left unmanaged.

A qualified glazier is required to repair the glass.

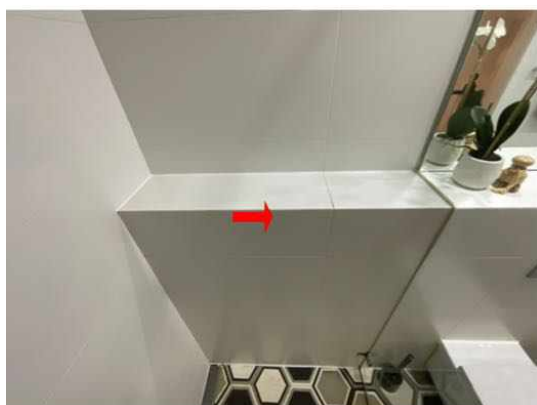
Finding 3.05

Building: Main Building
Location: Bathroom
Finding: Grout - Missing
Information: Grout is missing in this area. Grout is used to protect gaps and crevices in building materials to ensure that they are water-tight and prevent water penetration to the associated structures.

Where grout is missing, a tiling contractor should be appointed to apply grout and re-apply any silicone where necessary. Failure to do so is likely to lead to water damage to the surrounding area.

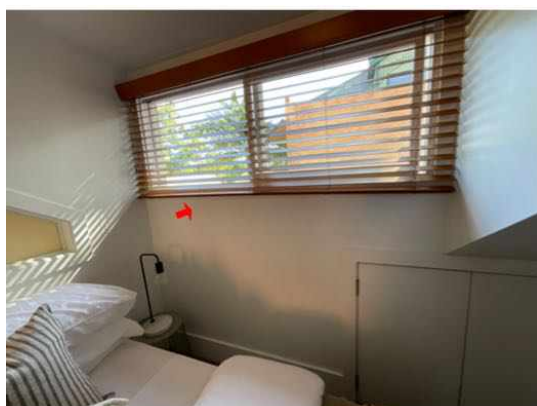
Finding 3.06

Building: Main Building
Location: Bedroom 3
Finding: Painted surface - Bubbling
Information: Sections of paint in this area was found to have bubbled and deteriorated. Paint bubbling is generally an indication of excessive moisture in the area past or present.

Although there was no moisture detected in the wall I would recommend monitoring this area.

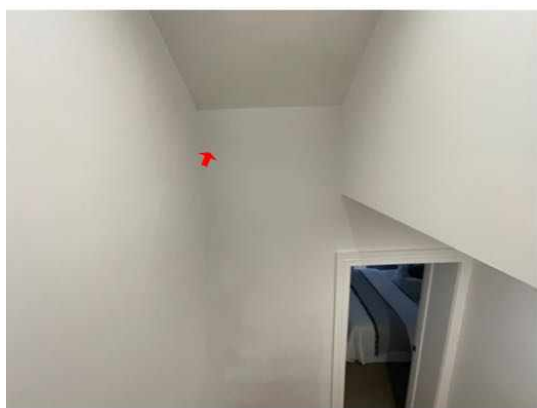
Finding 3.07

Building: Main Building
 Location: Stairs - Internal
 Finding: Damp - Rain penetration
 Information: Rain penetration (also known as penetrating damp) is a common form of dampness that can occur through walls, roofs or openings (e.g. windows).

Common causes include faulty or missing flashing, lack of sealant and lateral damp.

The cause of the water leak should be addressed to prevent further damage. It is recommended that the water leak be resolved prior to any repairs of the damaged area, which may require localised replacement of building materials and refinishing.

I recommend appointing a builder to see what necessary works are required.

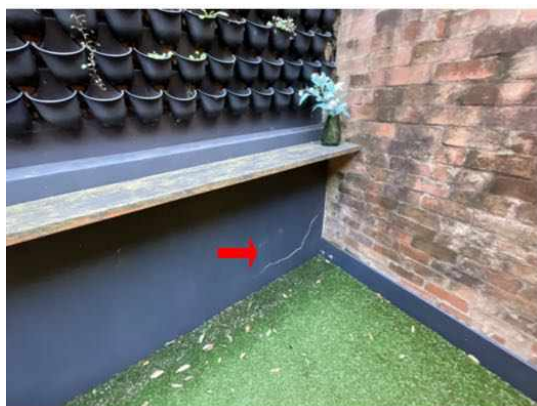
Finding 3.08

Building: Yard
 Location: Yard - Back
 Finding: Render - Drummy
 Information: Drummy rendered areas were identified at the time of inspection. The term 'drummy' refers to render that has become detached from its fixing, despite it still being solid. Such defects are generally caused by physical or moisture damage to the area. Drummy render may also be a direct result of poor workmanship during the construction process.

Render may swell and shrink with changes in air humidity if the area has sustained moisture damage. Any exposure to moisture is capable of causing rendered areas to become drummy and/or cracked over a prolonged period of time. Drummy render generally requires chipping off and re-rendering or painting.

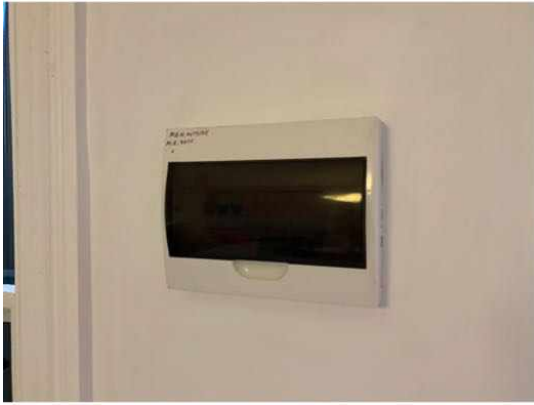
Finding 6.01

Building:	Main Building
Location:	All Areas
Finding:	Termite Management System - no evidence of a chemical installation
Information:	The application of a post-construction chemical termite barrier is highly recommended for all properties, particularly if live termite activity has been found on the site previously. Such barriers are highly effective in preventing termite attack on any timber building elements throughout the property.

A durable notice should be placed in the switchboard unit to indicate current termite barriers. At the time of inspection, it appeared as though no termite management system has been installed, with no evidence to suggest preventative works taking place.

The client may consider gaining further advice from a pest controller as to the costs and procedures involved with this application. It is recommended that obtaining such advice be a short-term priority.
