Building and Timber Pest Inspection Report VR

Inspection Date: Mon, 6 Feb 2023

Property Address: 119A Campbell St, Surry Hills NSW 2010, Australia

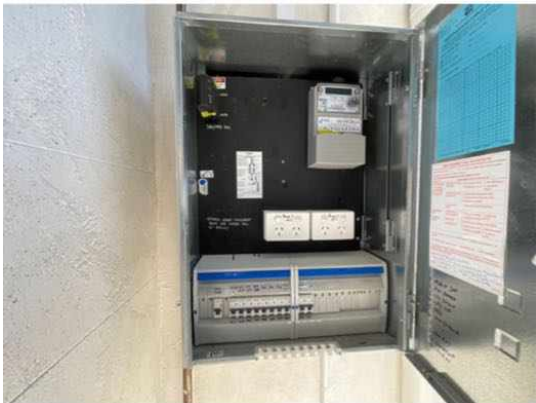
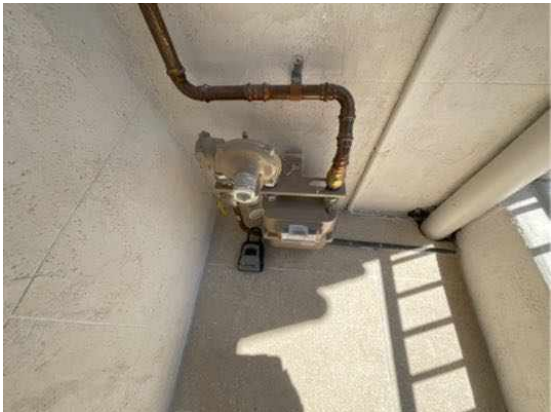
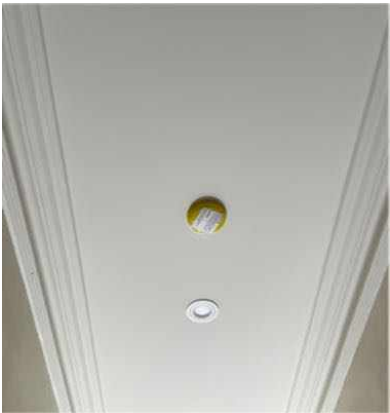
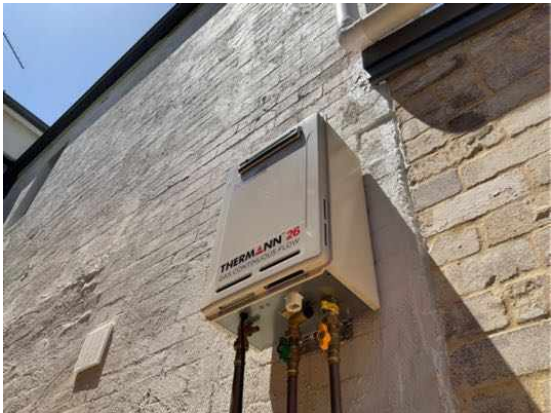
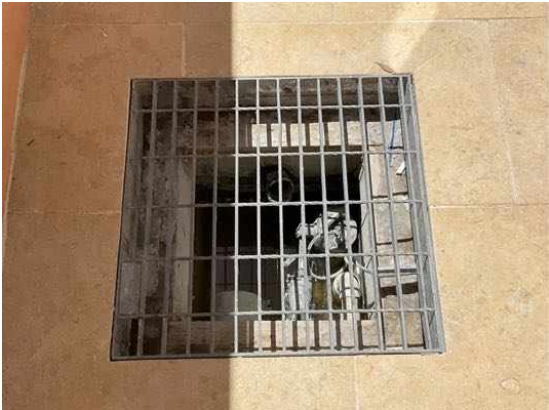
Building: Main Building
Location: All Areas
Finding: Photos Added
Information: Additional photos are provided for your general reference.

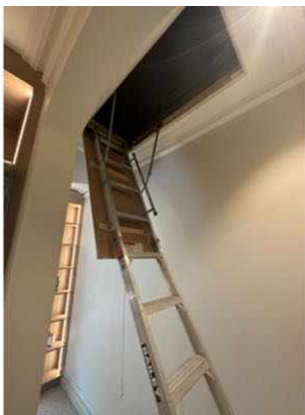
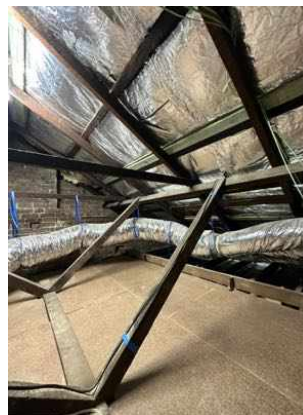
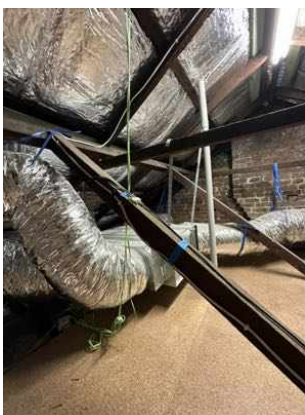
Building: Main Building
 Location: Roof Void
 Finding: Photos Added
 Information: Additional photos are provided for your general reference.
