# Building and Timber Pest Inspection Report VR

Inspection Date: Thu, 9 Feb 2023

Property Address: 34 Napier St, Paddington NSW 2021, Australia

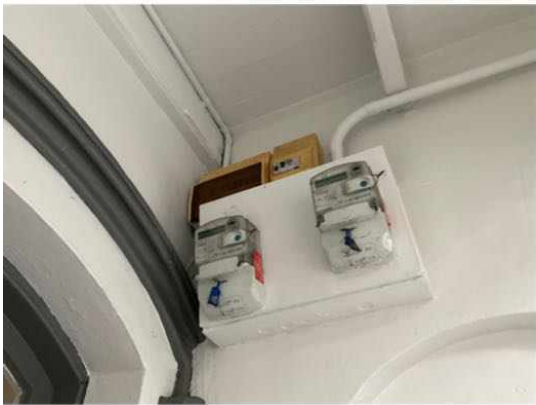
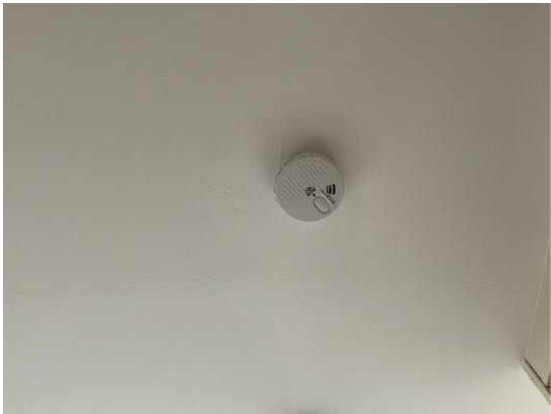
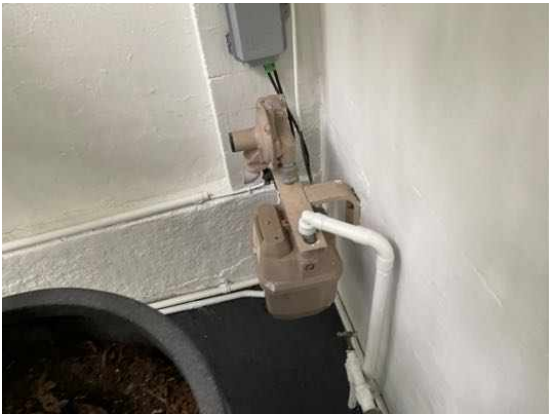
Building: Main Building  
Location: All Areas  
Finding: Photos Added  
Information: Additional photos are provided for your general reference.
