Building and Timber Pest Inspection Report VR

Inspection Date: Wed, 15 Mar 2023

Property Address: 363 S Dowling St, Darlinghurst NSW 2010, Australia

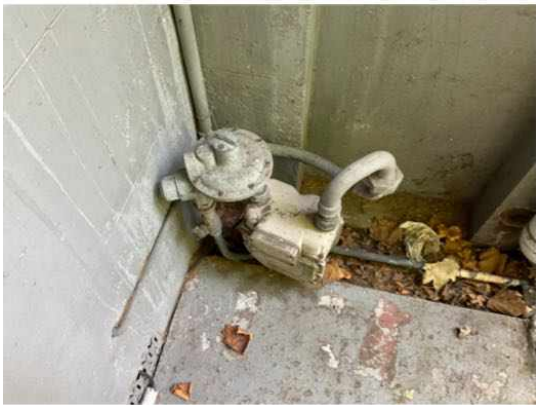
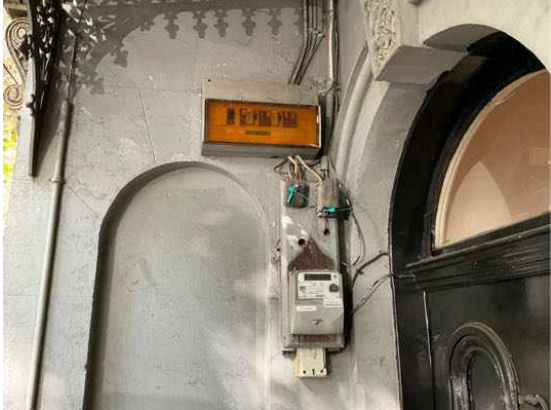
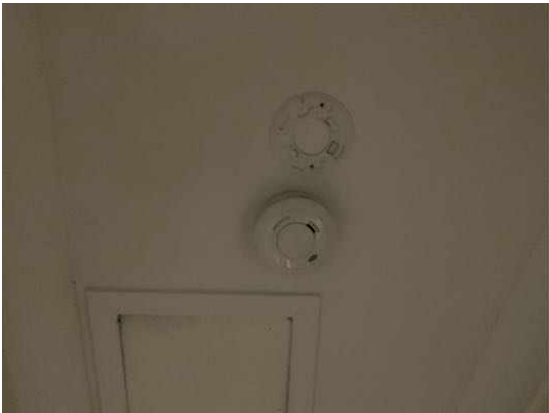
Building: Main Building
Location: All Areas
Finding: Photos Added
Information: Additional photos are provided for your general reference.

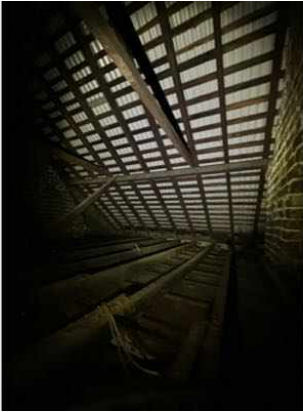
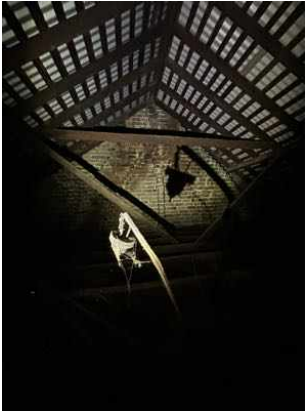
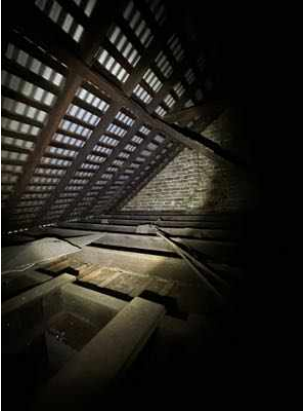
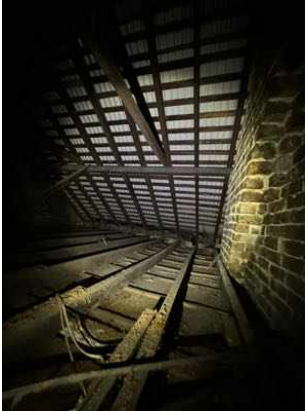
Building: Main Building
Location: Roof Void
Finding: Photos Added
Information: Additional photos are provided for your general reference.
