Building and Timber Pest Inspection Report VR

Inspection Date: Tue, 5 Sep 2023

Property Address: 447 Crown Street, Surry Hills

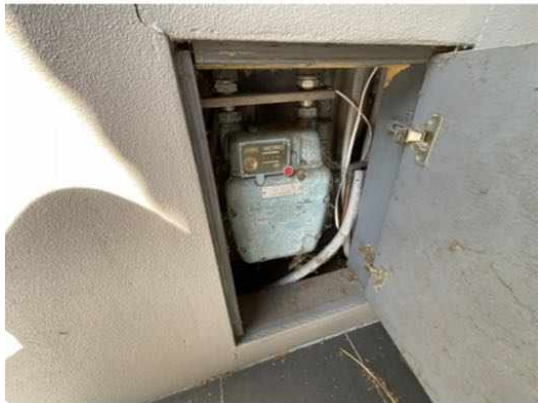
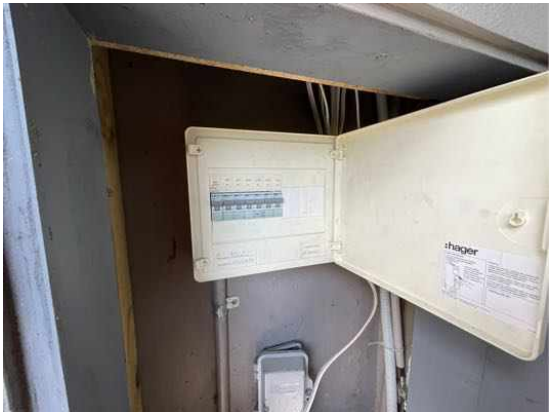
Building: Main Building
Location: All Areas
Finding: Photos Added
Information: Additional photos are provided for your general reference.
