Building and Timber Pest Inspection Report VR

Inspection Date: Fri, 13 Oct 2023

Property Address: 2 Ryder Street, Darlinghurst

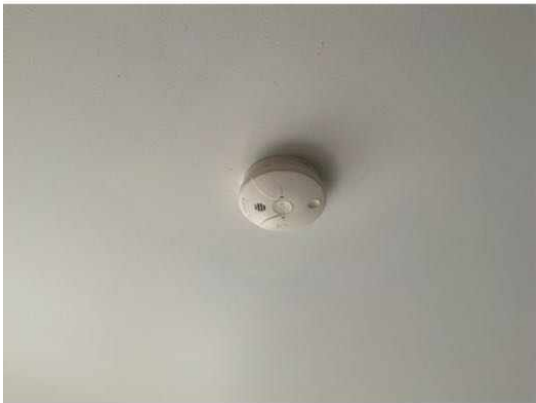
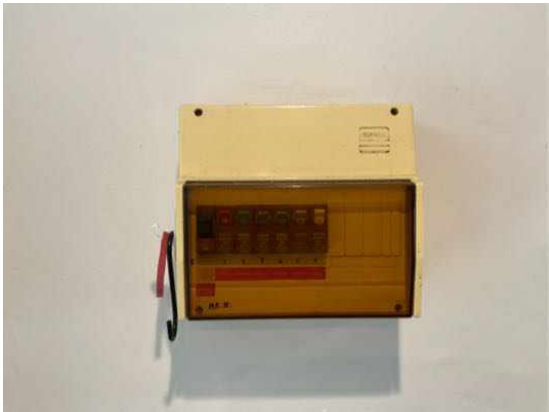
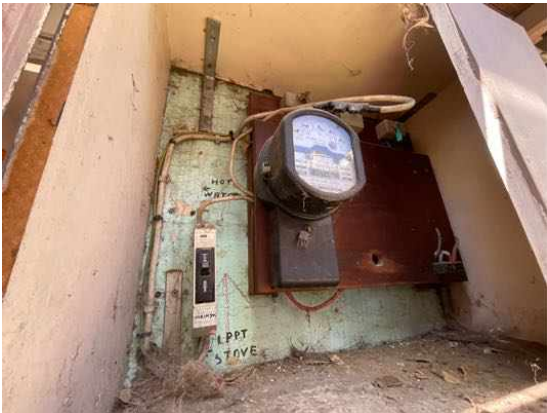
Building: Main Building
Location: All Areas
Finding: Photos Added
Information: Additional photos are provided for your general reference.
