Building and Timber Pest Inspection Report VR

Inspection Date: Tue, 17 Oct 2023

Property Address: 27 Mort Street, Surry Hills

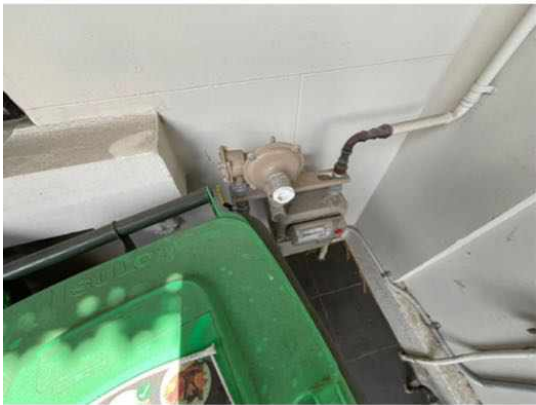
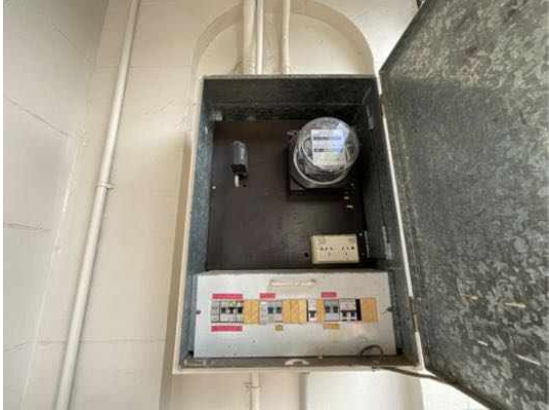
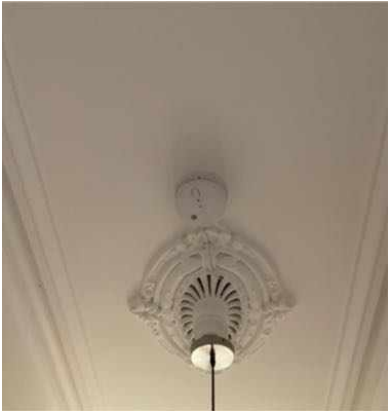
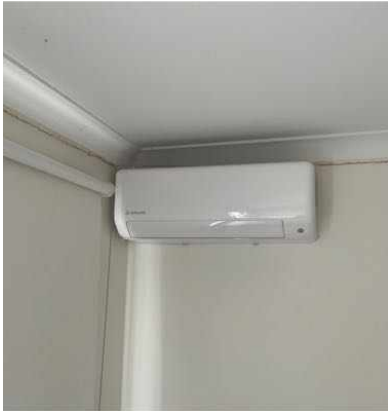
Building: Main Building
Location: All Areas
Finding: Photos Added
Information: Additional photos are provided for your general reference.
