Building and Timber Pest Inspection Report VR

Inspection Date: Sat, 7 Oct 2023

Property Address: 657 South Dowling Street, Surry Hills

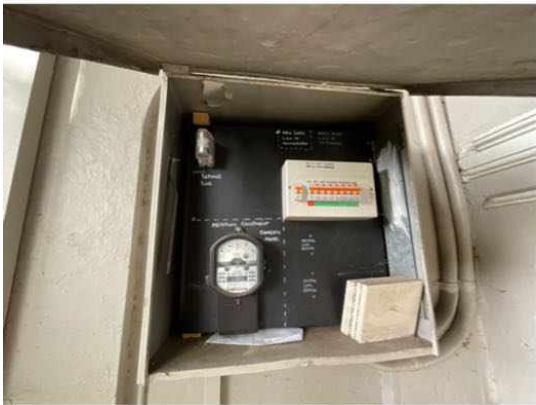
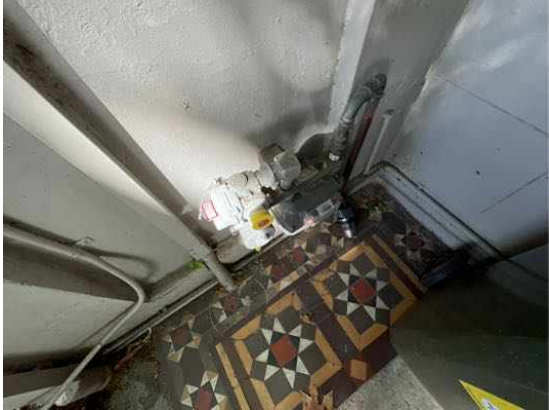
Building: Main Building
Location: All Areas
Finding: Photos Added
Information: Additional photos are provided for your general reference.

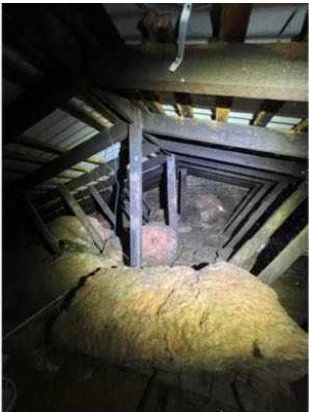
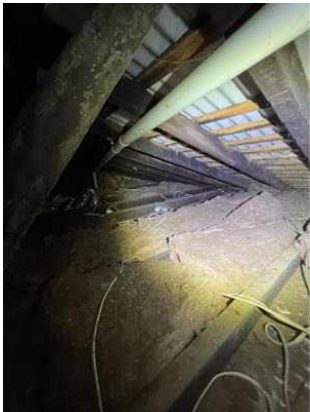
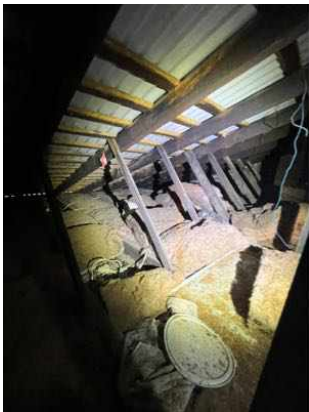
Building: Main Building
Location: Roof Void
Finding: Photos Added
Information: Additional photos are provided for your general reference.
