Building and Timber Pest Inspection Report VR

Inspection Date: Tue, 30 Jan 2024

Property Address: 13A Meagher St, Chippendale NSW 2008,
Australia

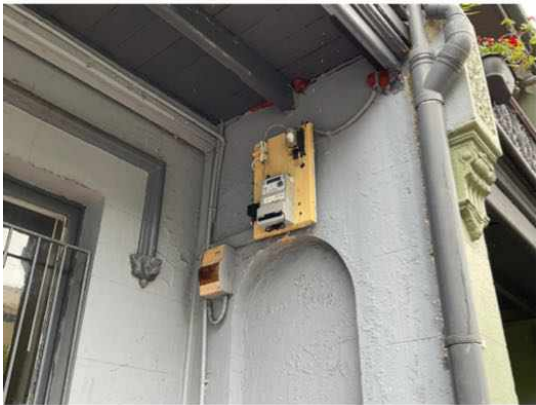
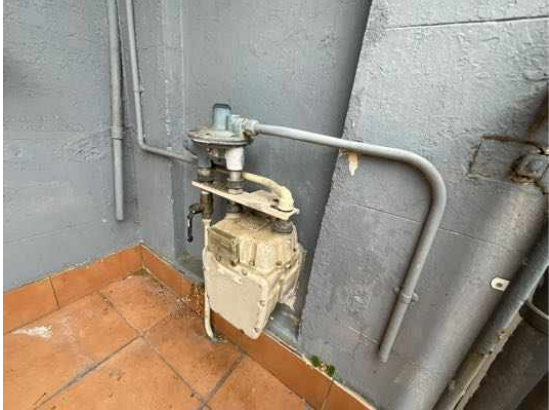
Building: Main Building
Location: All Areas
Finding: Photos Added
Information: Additional photos are provided for your general reference.

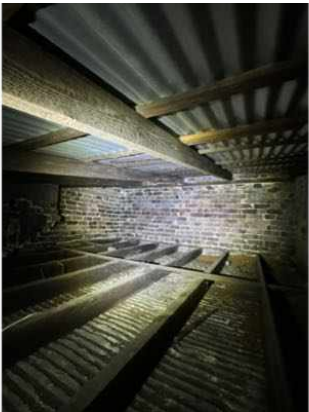
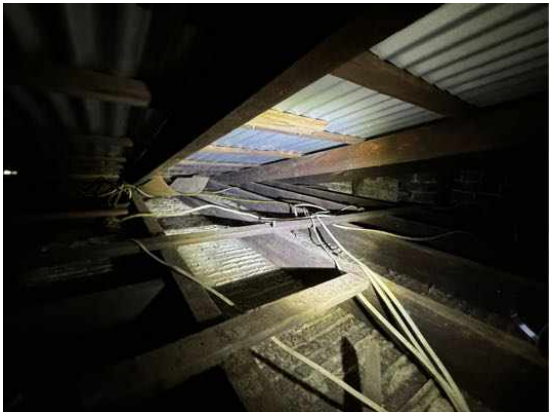
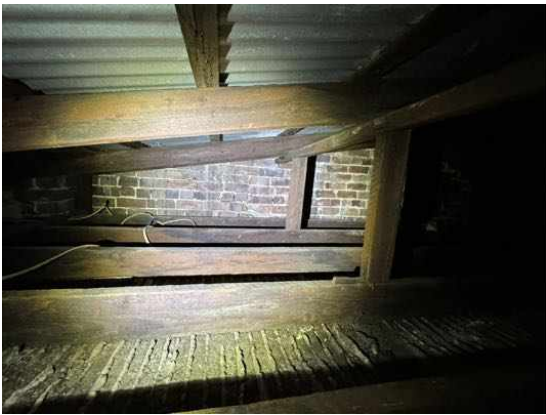
Building: Main Building
Location: Roof Void
Finding: Photos Added
Information: Additional photos are provided for your general reference.
