Building and Timber Pest Inspection Report VR

Inspection Date: Fri, 12 Apr 2024

Property Address: 2 Windeyer St, Woolloomooloo NSW 2011,
Australia

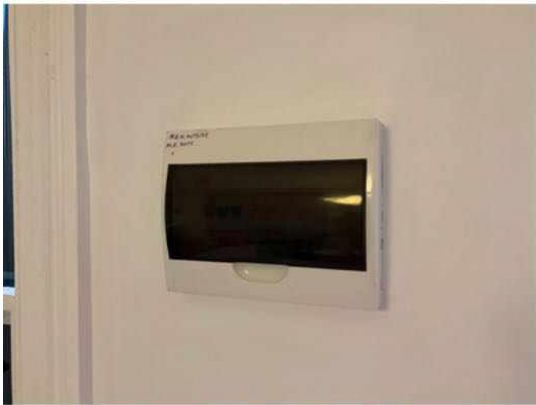
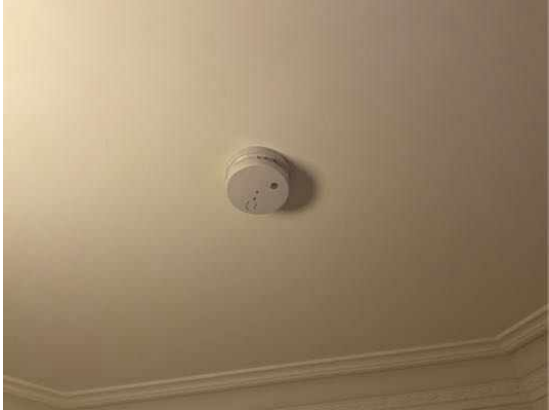
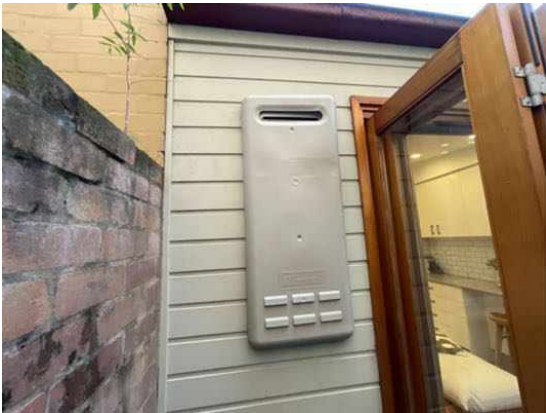
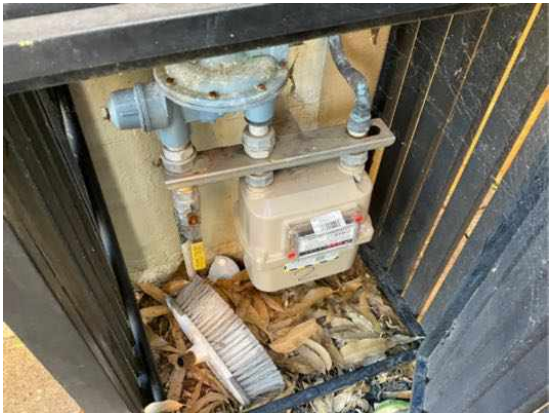
Building: Main Building
Location: All Areas
Finding: Photos Added
Information: Additional photos are provided for your general reference.
